**CHIMNEY RIDGE CONDOMINIUM  
OWNERS ASSOCIATION  
DURHAM, NC**

**SEPTEMBER 24, 2019**

**FULL RESERVE STUDY**

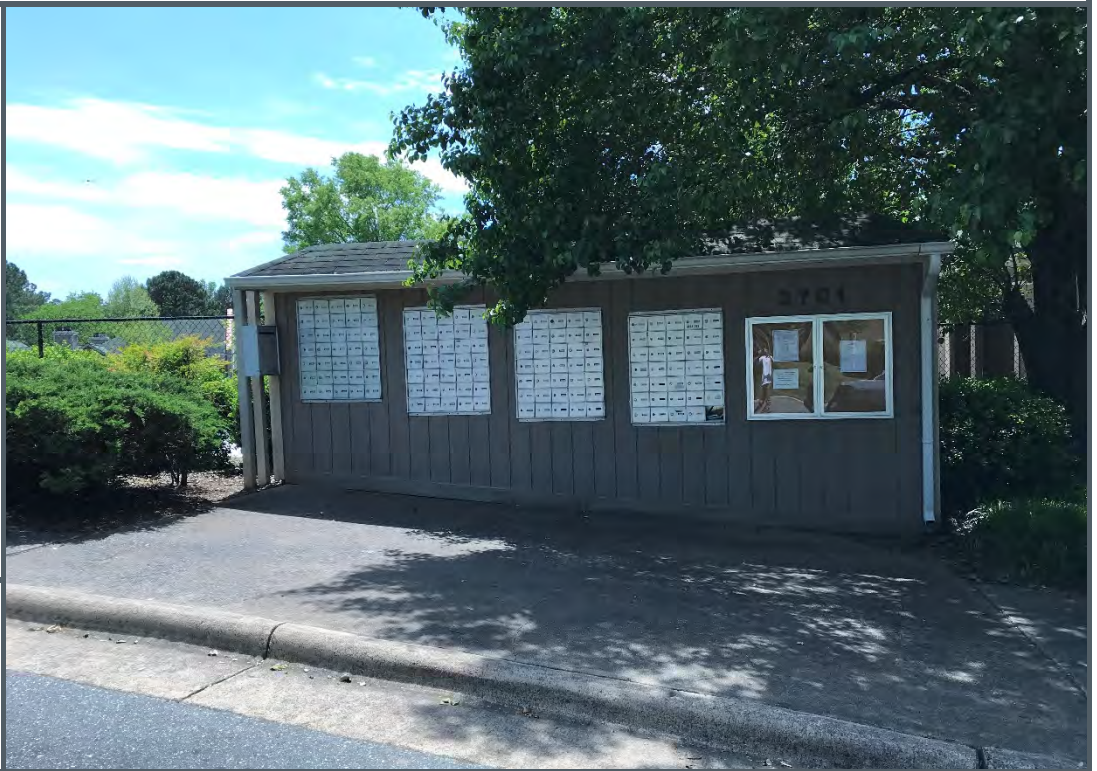
**Photo No.**  
**7**

Roof covering on mail  
kiosk station

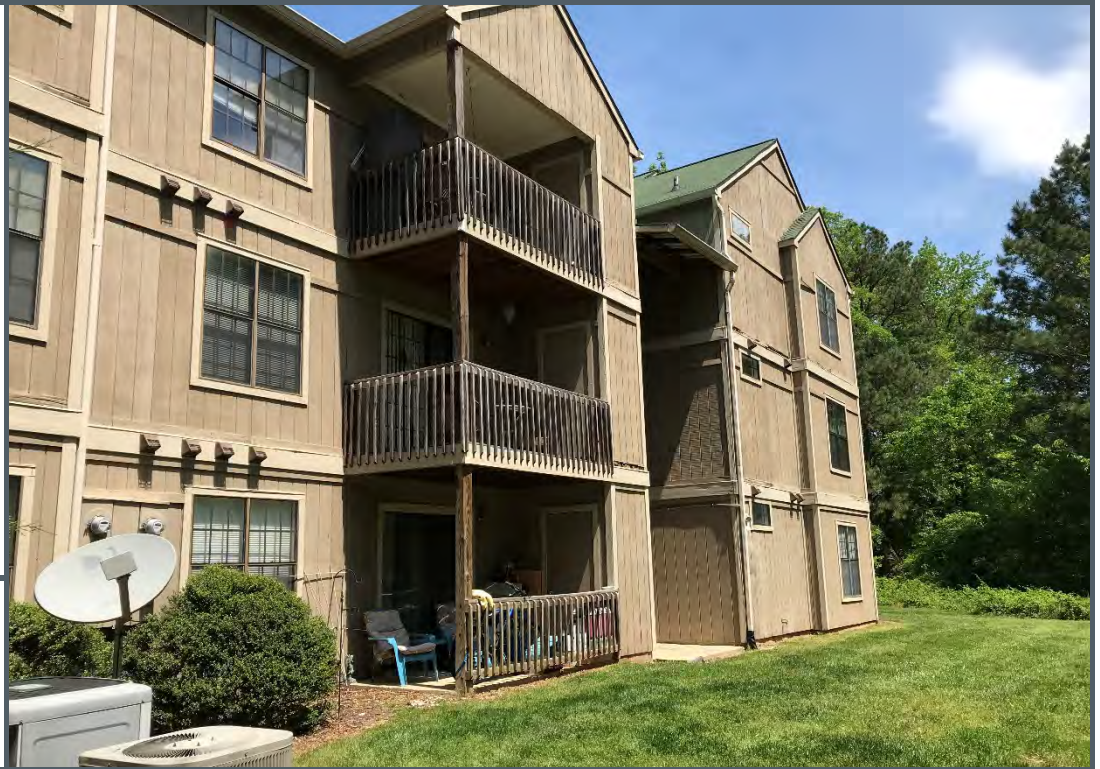
**Photo No.**  
**13**

moisture damaged siding were observed throughout the community. Rot was observed in the chimney chase of building 3804 and the siding boards were warped at the rear-left of building 3704. Typically, we would fully replace the siding throughout the community due to its current condition. However, due to funding constraints, and per the request of the board, we have allocated for sectional replacement, as needed, on an approximately 5-year cycle beginning in 2020. If left unaddressed, moisture intrusion into the buildings could lead to significant structural and finished material damages. Re-painting of the siding and trim replacement will also be required on a regular basis. We recommend repainting/staining the siding/trim and wood decks at each unit in an interval not-to-exceed five (5) years, and we have allocated funds for this cycle beginning in 2020 coinciding with siding repairs. Painting cycles should include repairing sealants/caulking as needed, repairing siding and trim as needed, adequate surface preparations and the application of 2 coats of a high-quality exterior paint on all painted surfaces.

Water damage to siding at rear of building 3704

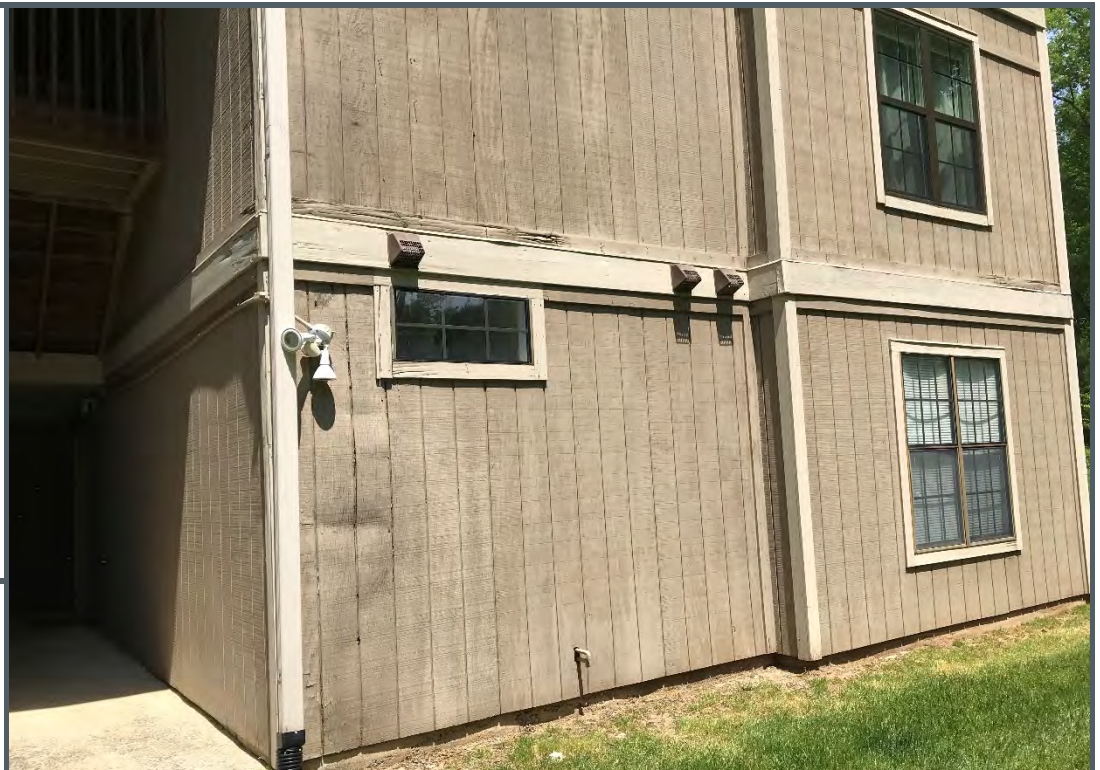
**Photo No.**  
**14**

Typical rot damage  
throughout community

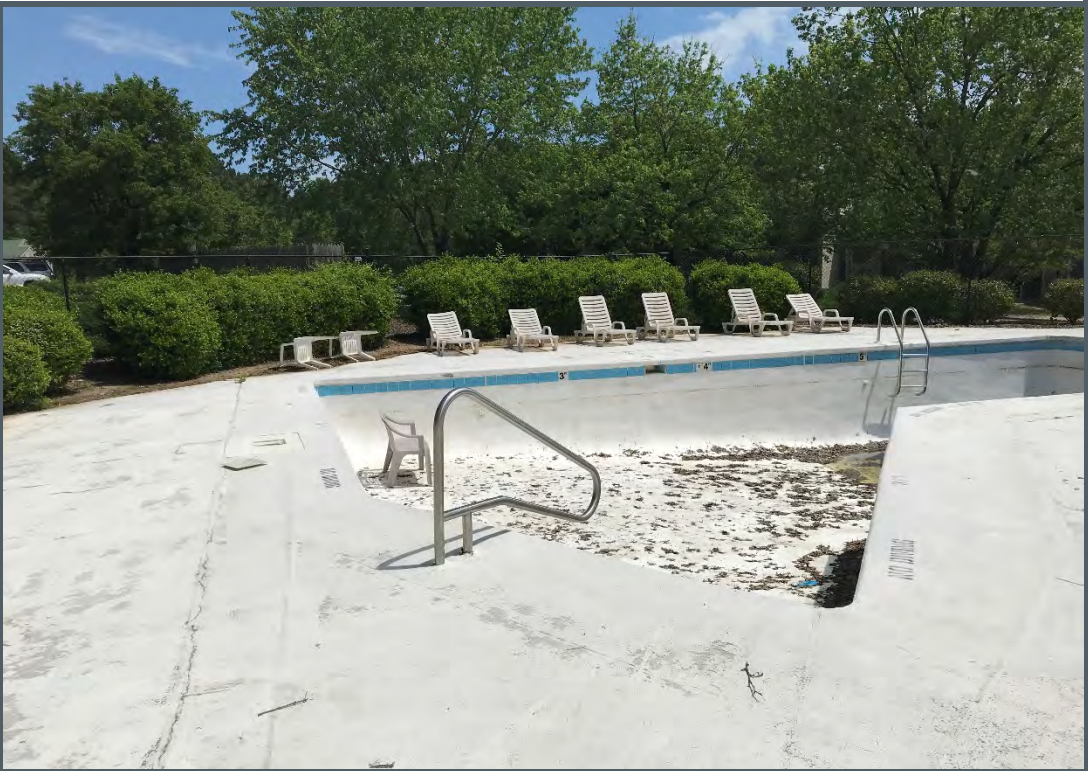
**Photo No.**  
**17**

The concrete pool deck includes a textured slip-resistant coating that appeared to be in fair to poor condition. Over time, the pool deck textured coating will begin to deteriorate and delaminate from the concrete surface.

Vegetation and spalling were observed between the joints of the concrete panels. We have allocated funds to replace the textured coating on a 10-year cycle beginning in 2021. An area of wood decking is also installed on the southwest side of the pool. The wood decking appeared to be in fair condition with visible warping and deterioration in some of the decking. This type of decking typically has an approximate useful life of 20 years. We have allocated funds to replace the wood decking in 2027.

Vegetation growth through concrete decking around pool

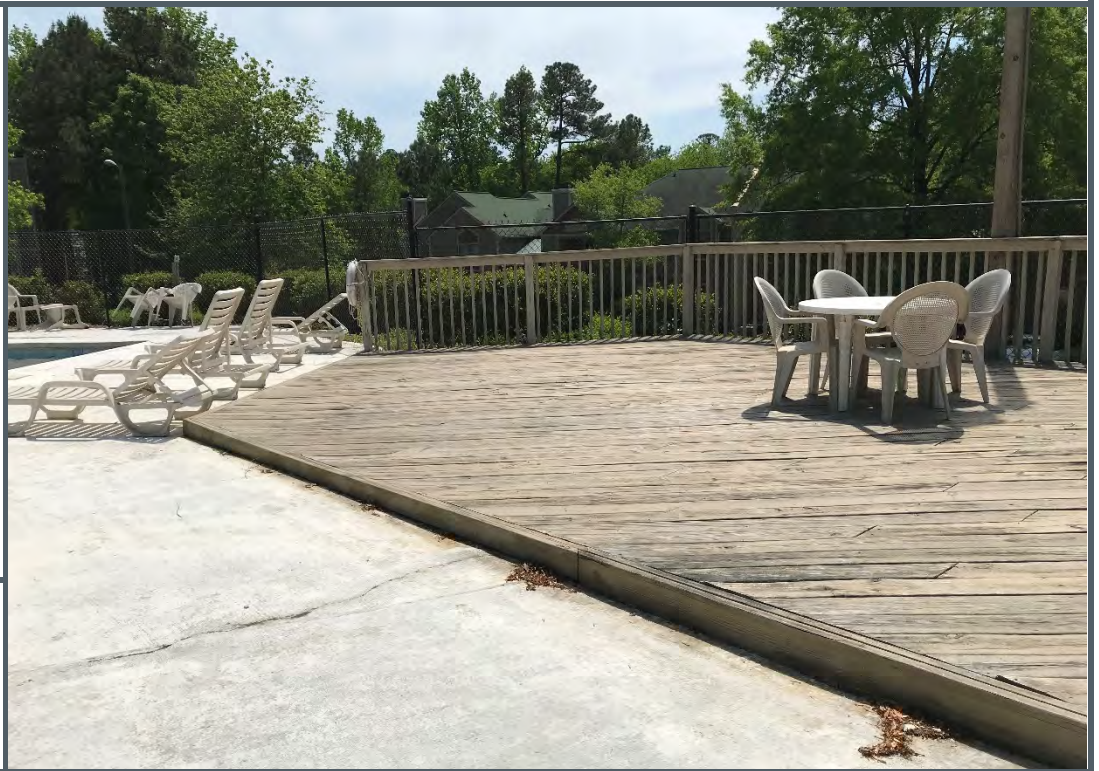
**Photo No.**  
**19**

We noted chain link fencing materials installed around the perimeter of the pool. The fencing materials around the pool appeared to be in generally good condition. We have allocated funds to replace the chain link fencing around the pool on a 25-year cycle. We have allotted funds to replace the pool fencing in 2038.

Fencing around pool

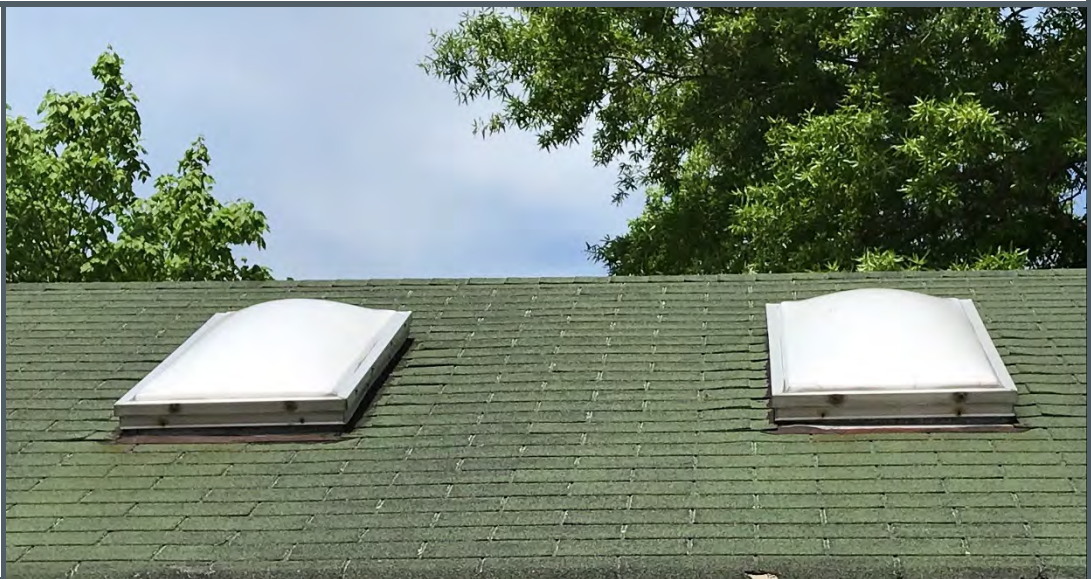
**Photo No.**  
21

**Description**  
Roof on pool building

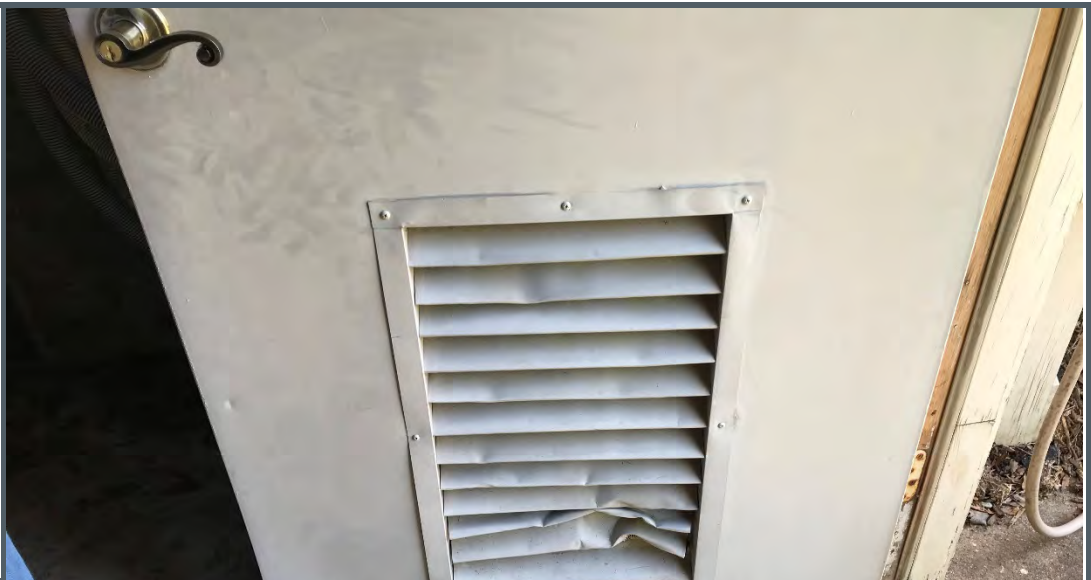
**Photo No.**  
22

The steel door to the lower level of the pool building was damaged and corroded. We have allocated funding to replace the door for safe-keeping of the pool mechanical equipment in 2020. The doors to the men's and

**Description**  
Pool equipment room door

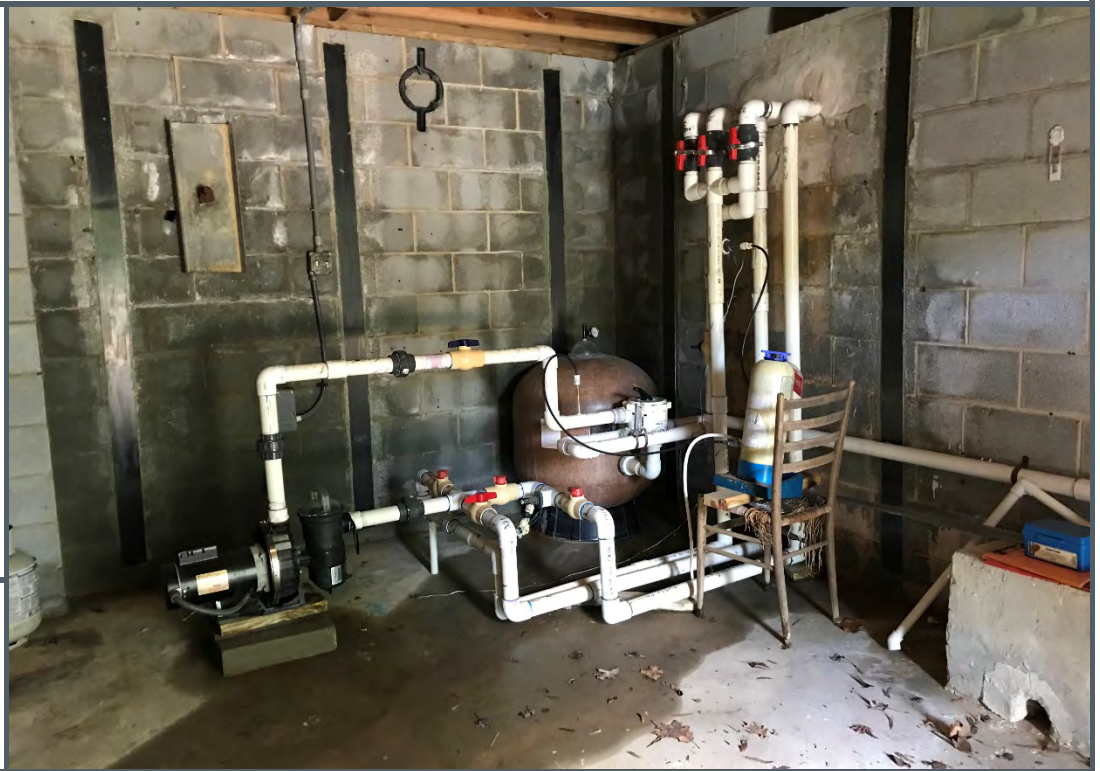
**Photo No.**  
**23**

The pool pump and filtration equipment include a 3-horsepower pump and one sand filter serving the pool. Pool pump and filtration equipment is typically replaced as components fail. The sand in the filter will likely require replacement on an approximately 5-year cycle. We have provided funds to replace components of the pump and filtration system on a 3-year cycle beginning in 2022.

Pool pump and sand filter equipment

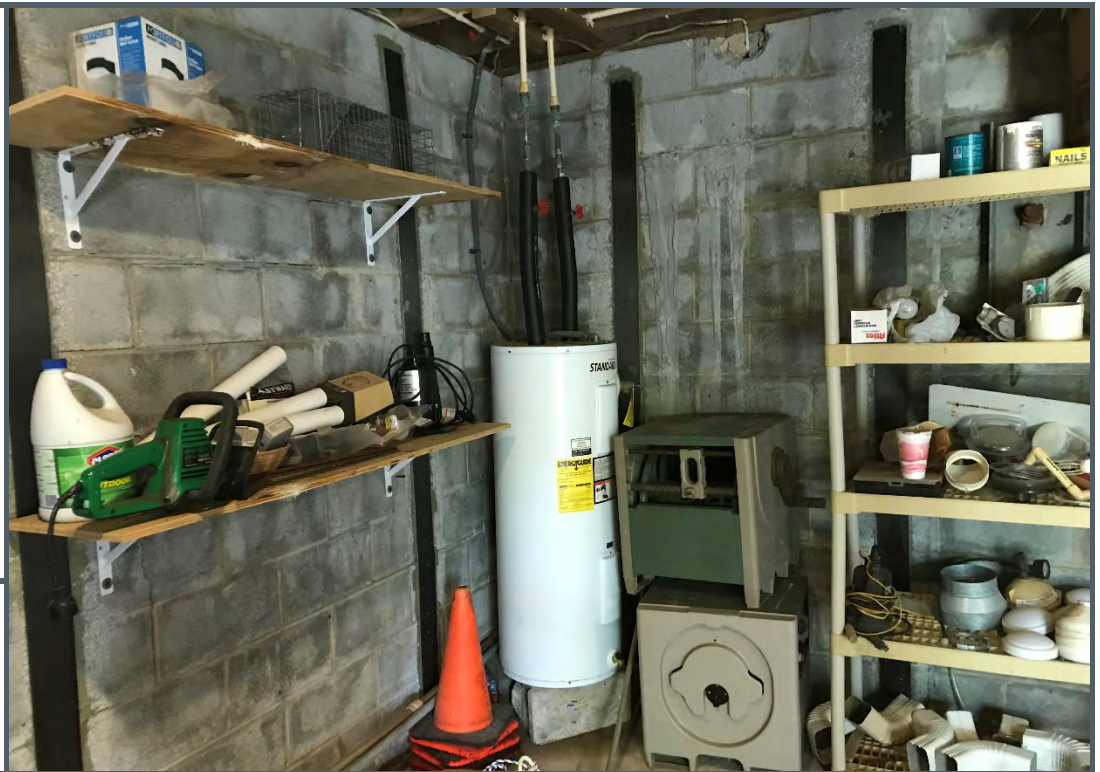
**Photo No.**  
**24**

The pool building is served by an electric water heater in a mechanical room with the pump equipment and electric panels. The water heater was manufactured in 2008. Water heaters have an expected useful life of approximately 15 years, and we have allocated funds for replacement as such beginning in 2023.

Water heater in pool equipment room

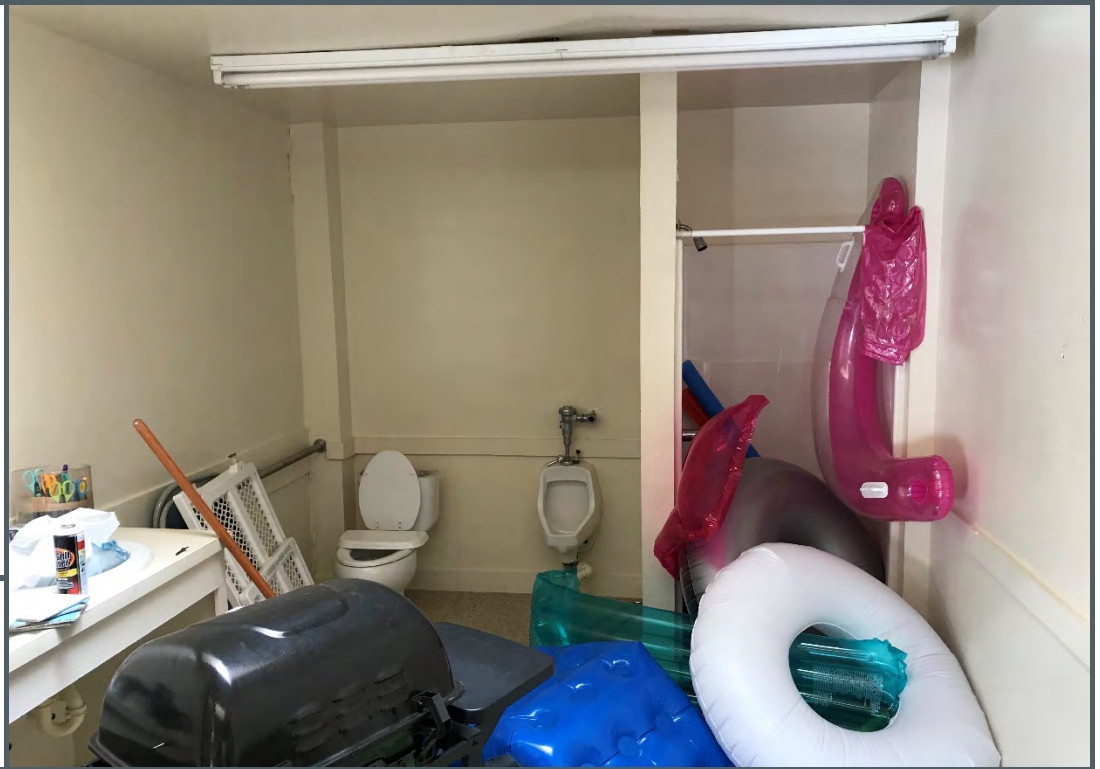
**Photo No.**  
25

Each restroom includes stalls with partition walls and doors, sinks, and baby changing stations. The restroom fixtures generally appeared to be in good condition. We have allocated funds to refurbish the restrooms on a 15-year cycle beginning in 2032. This would include replacing partition walls/doors, replacing sinks and replacing toilet fixtures as needed. We assume painting and minor repairs to the finished walls and flooring in the restrooms will be covered by an annual maintenance budget.

Men's restroom at pool area

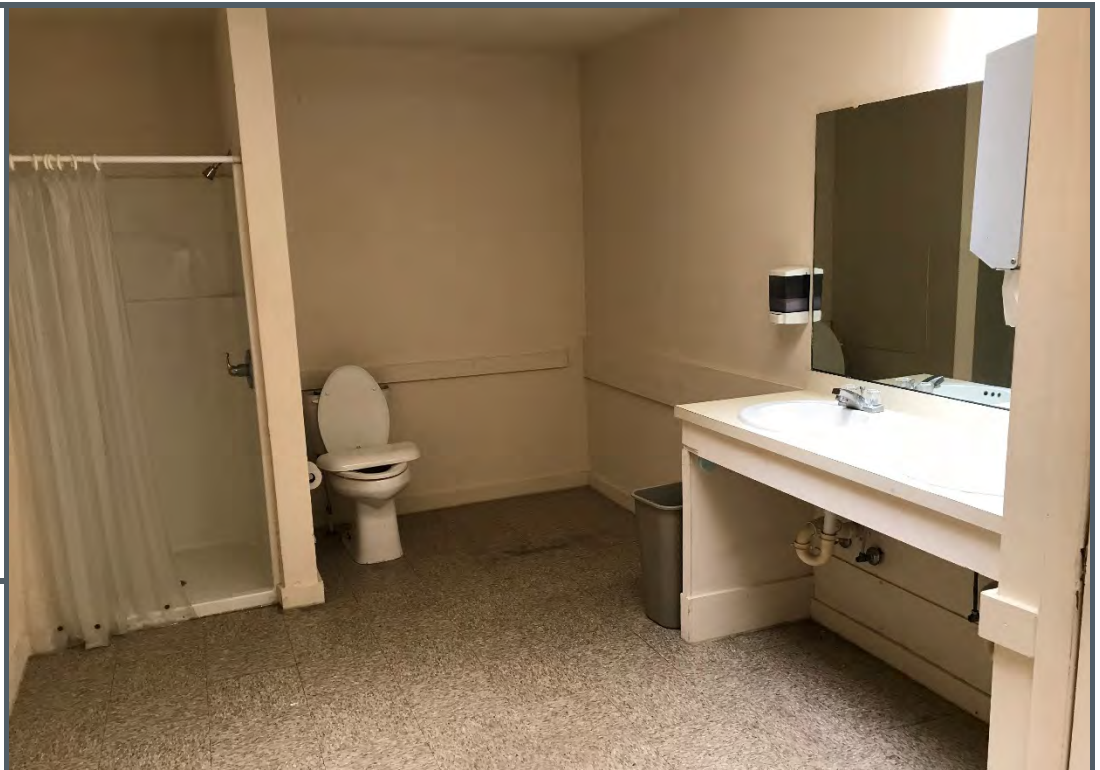
**Photo No.**  
26

Women's restroom at pool area
