**GLENKIRK NEIGHBORHOOD
ASSOCIATION
CARY, NC**

OCTOBER 13, 2021

**FULL RESERVE STUDY
Update**

GILES & FLYTHE
ENGINEERS

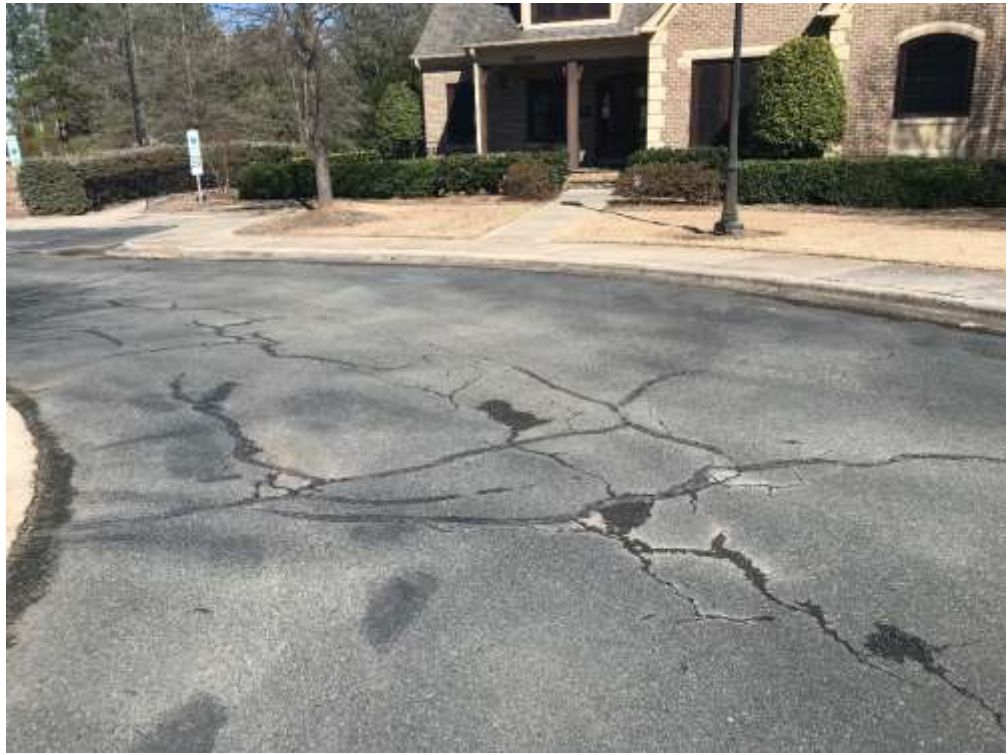
Photo No.
1

We understand that the maintenance of the private asphalt paved parking area near the pool is the responsibility of the Association. The asphalt paving was in fair condition at the time of inspection, with longitudinal and fatigue cracking throughout. Typically, we recommend the application of an oil resistant sealant to asphalt paved surfaces on an approximately 7-year cycle. At this same time, all cracks should be properly filled, patched, and sealed. We have provided an allocation of funds to perform seal coat applications on an approximately 7-year cycle beginning in 2031 after the resurfacing project discussed below. We assume isolated areas of potholes and damage will be repaired, as needed, using funds from an annual maintenance budget.

Description
View of pool parking
area pavement

Assuming sealing and crack repairs occur in the interim, asphalt paving should last approximately 20-25 years prior to replacement. We have allocated funds to resurface the current asphalt paving in 2024. This would include milling and removing the top 2"-3" of asphalt paving throughout all paved areas, repairing base course as needed, and installing a new 2"-3" thick layer of asphalt over all paved surfaces.

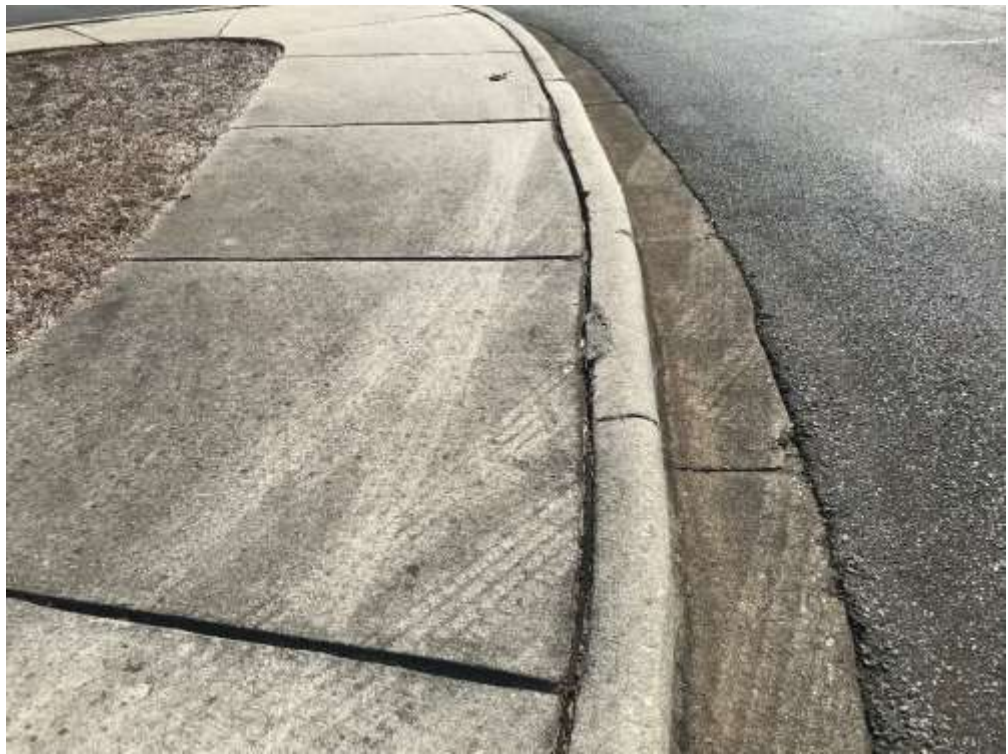
Photo No.
2

The association is responsible for maintaining the concrete walkways and curbing around the pool parking area, as well as the concrete pool decking. The concrete flatwork generally appears to be in good to fair condition. Minor cracks and displacements were observed in the pool decking, and previous repairs were made consisting of crack filling, grinding, and replacing sections of the concrete. Minor chipping in the stone veneer was observed on the front walkway to the clubhouse. Over time, it is likely that cracking will continue to develop and worsen in concrete surfaces due to differential settlement. As cracking develops, it is likely that sections of the flatwork will require repairs. We have allocated funds for repair/replacement of portions of the concrete surfaces (flatwork and curbing) around the parking area and pool, as needed, on an 8-year cycle beginning in 2024. Repairs may include grinding to reduce unevenness at cracking or saw-cutting, removing, and replacing sections of the concrete. We have assumed isolated areas of upheaval or possible trip hazards would be repaired through an annual maintenance budget in the interim.

Description
Typical concrete
flatwork and curbing

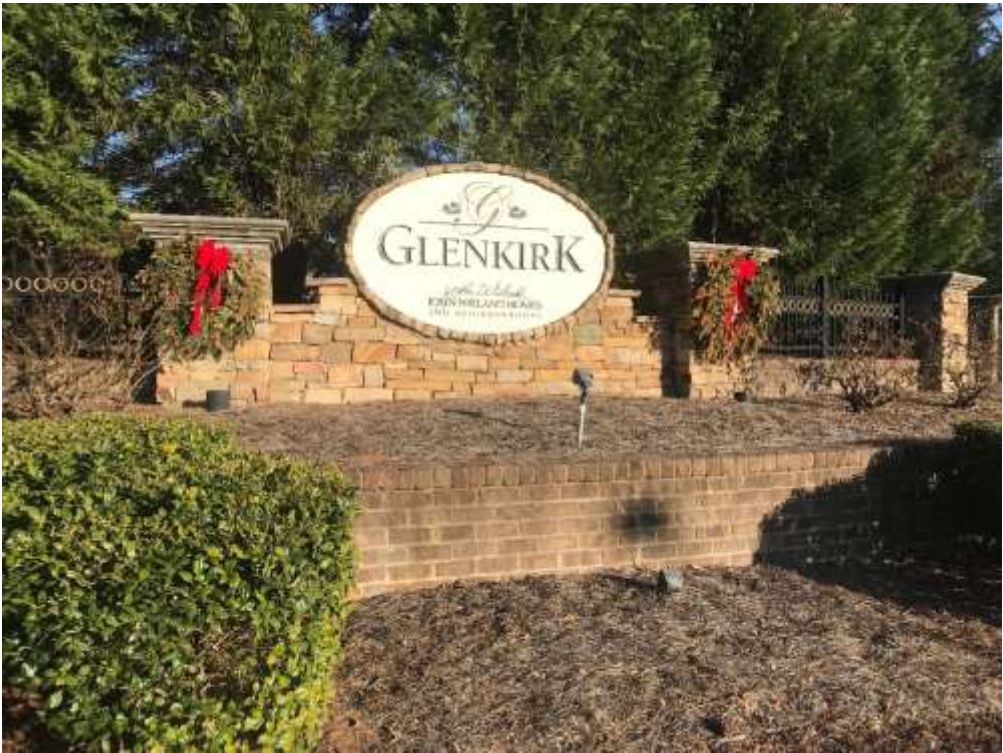
<p>Photo No. 11</p>

Entrance sign monuments are located at the clubhouse entrance and at both ends of the community on Olde Weatherstone Way. The entrance signage consisted of brick and stone veneer monuments with painted inlaid signage. The entrance signs appeared to be in good to fair condition with minor fading and flaking in the coloring. The brick and stone veneer was in good condition and should require minimal maintenance throughout the term. A landscape lighting system is also installed around the entrance monuments. We have provided an allocation of funds for repairs to the entrance monument structures, as needed, on a 15-year cycle beginning in 2025, which includes the landscape lighting around the monuments. We anticipate lesser/minor repairs such as bulb replacement and lens cleaning for the landscape lighting would be funded from the annual maintenance budget.

<p>Description</p> <p>Typical entrance monuments</p>

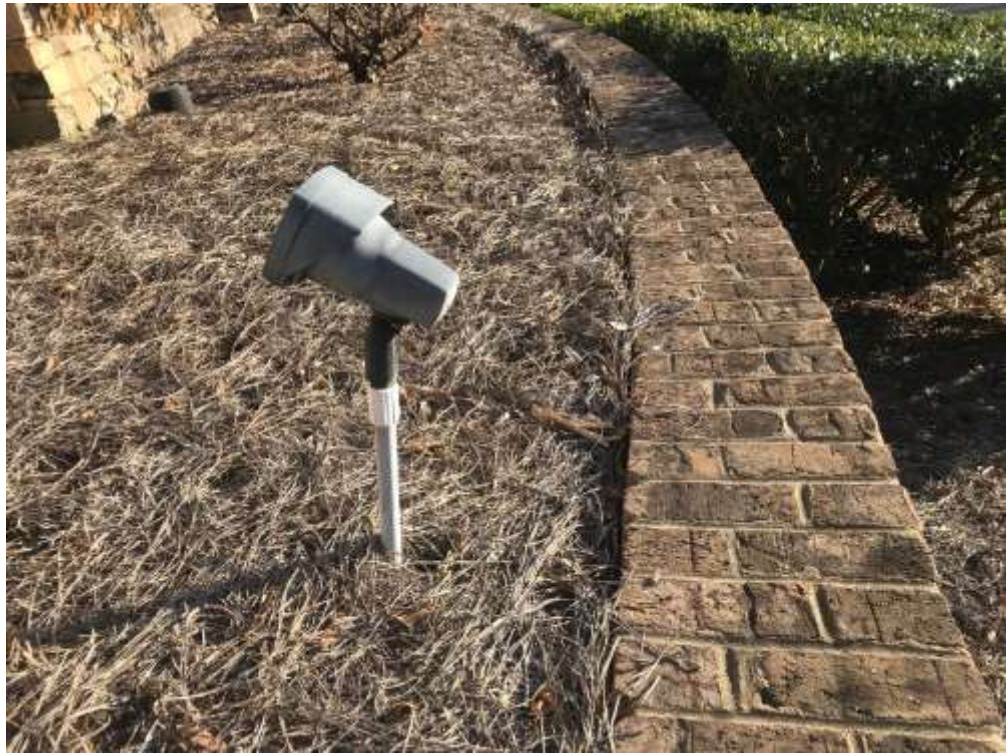
Photo No.
13

Up-lighting systems at
entrance monuments

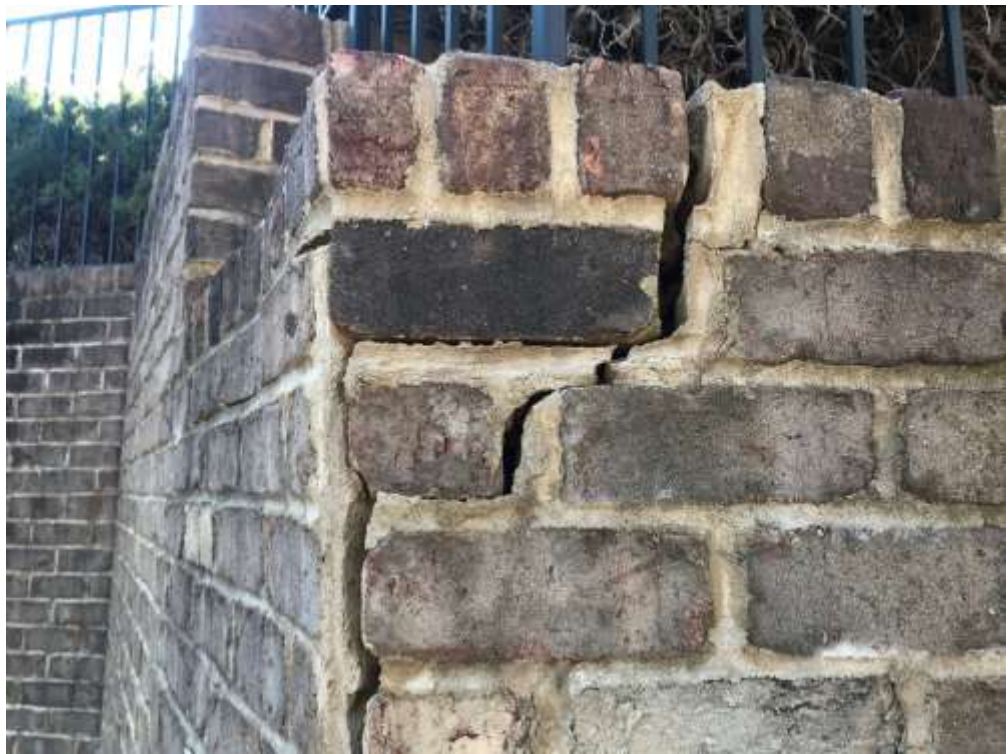
Photo No.
14

A brick retaining wall is located along the walkway at the rear-left of the clubhouse. Minor bowing was noted, and a significant crack was observed at the corner of the retaining wall. This wall should be monitored for evidence of structural failure. To save for the eventual replacement cost, we have provided an allocation of funds to repair/replace the wall in 2035.

Cracked/bowed brick
retaining wall at rear-left
of clubhouse

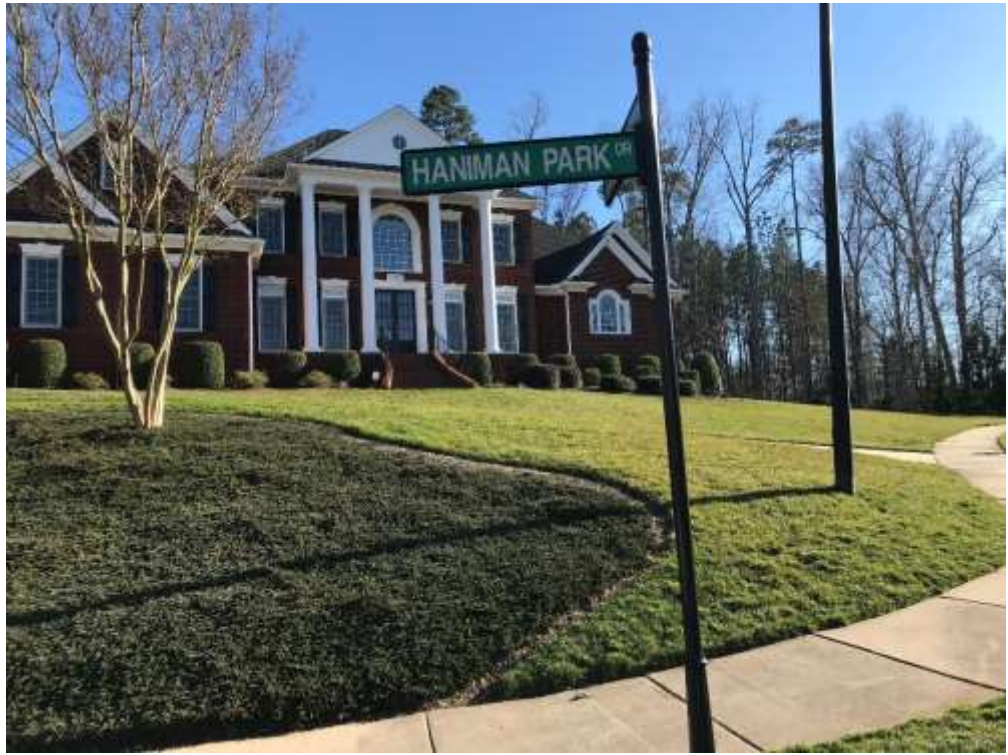
Photo No.
15

The street signs and posts throughout the community are an upgrade from the Town of Cary standard, and the Association is responsible for maintenance of the posts and signs. The signs appeared to be in good condition, and we have provided an allocation of funds to replace the posts/signs in 2027 on an approximately 20-year cycle. Actual lifespans will vary due to environmental exposure and potential damage.

Description
Typical street signs

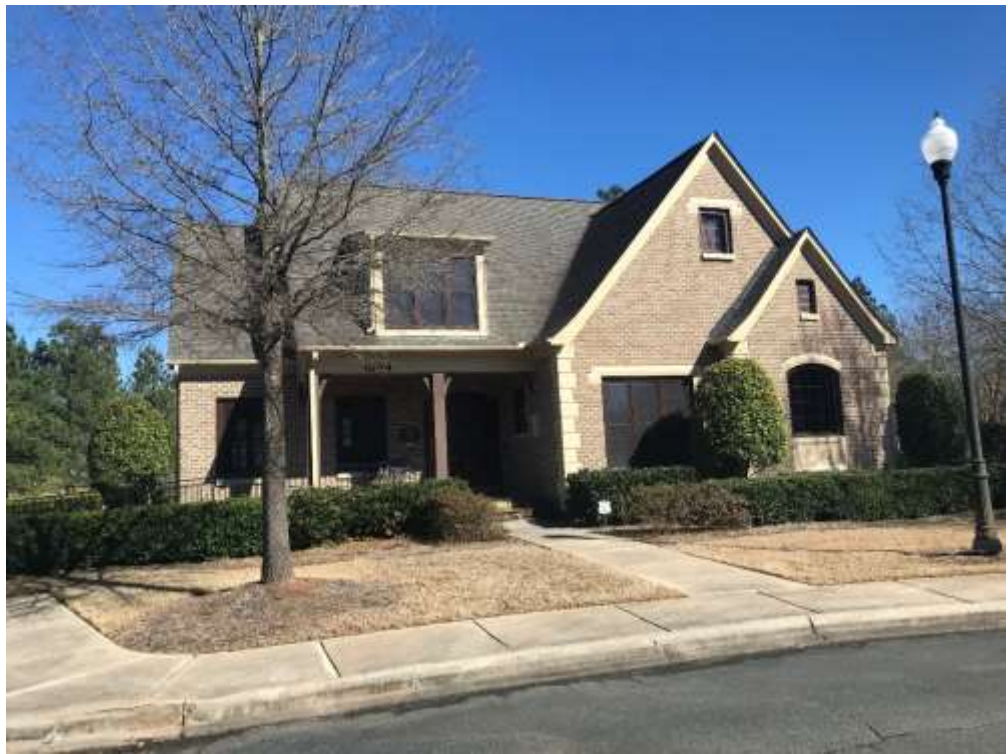
Photo No.
16

Description
View of clubhouse

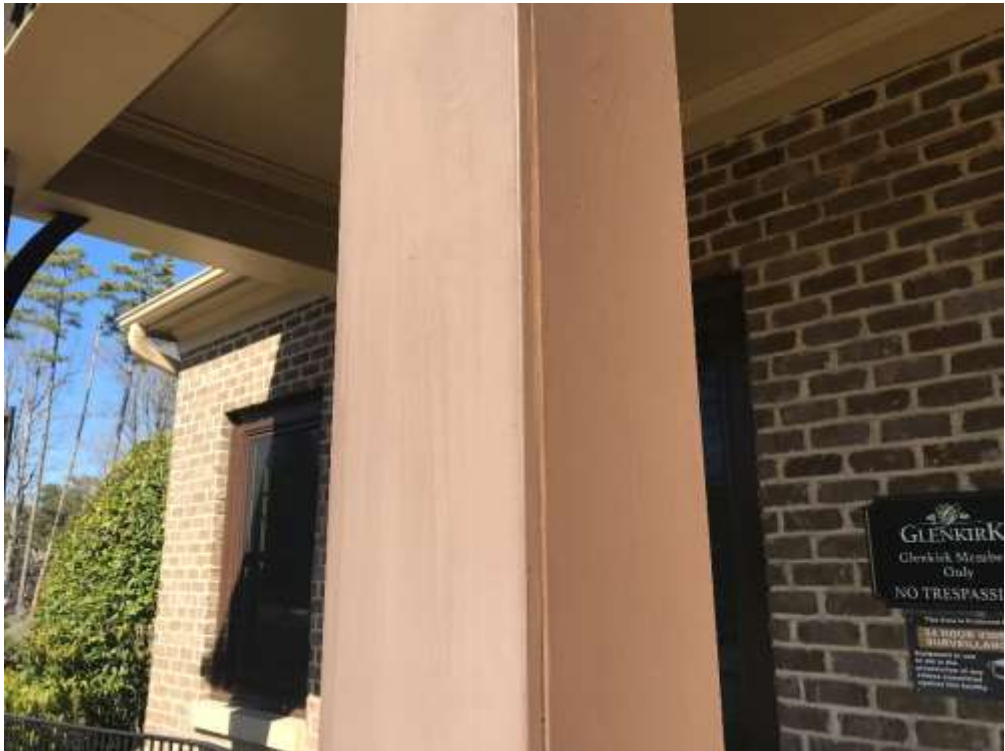
<p>Photo No. 19</p>

<p>Description</p> <p>Minor fading in paint on trim components</p>

siding on the pool building in 2025 on an approximately 7-year cycle. Painting cycles should include repairing sealants/caulking as needed, repairing siding and trim as needed, adequate surface preparations, and the application of two coats of a high-quality exterior paint on all painted surfaces.

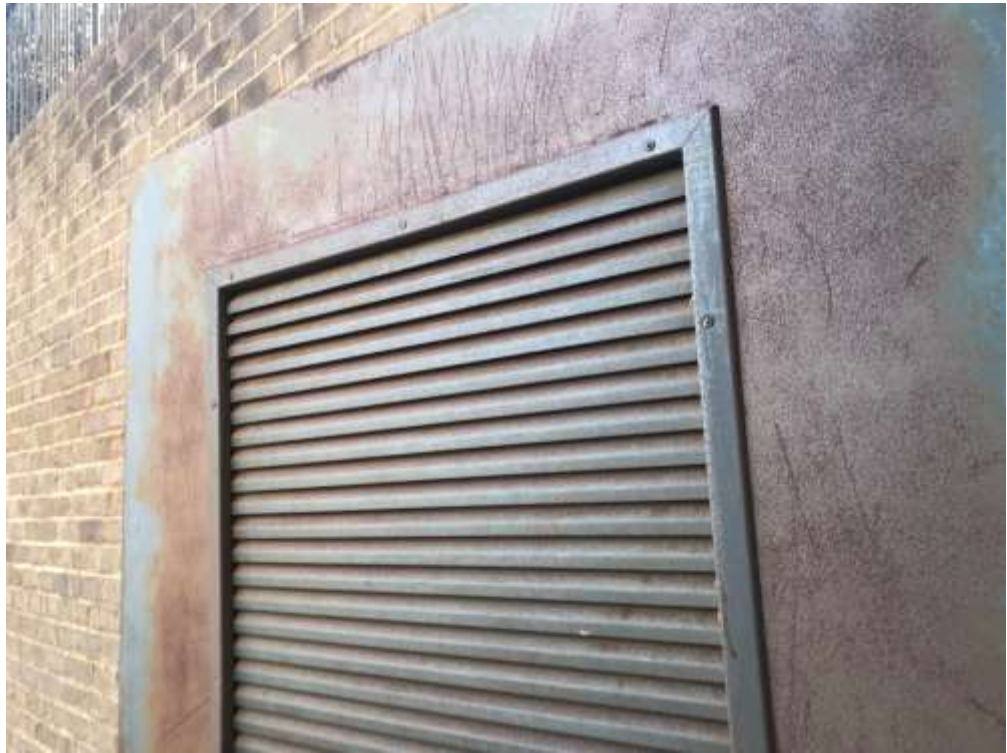
Photo No.
21

Deteriorated mechanical/
chemical room door

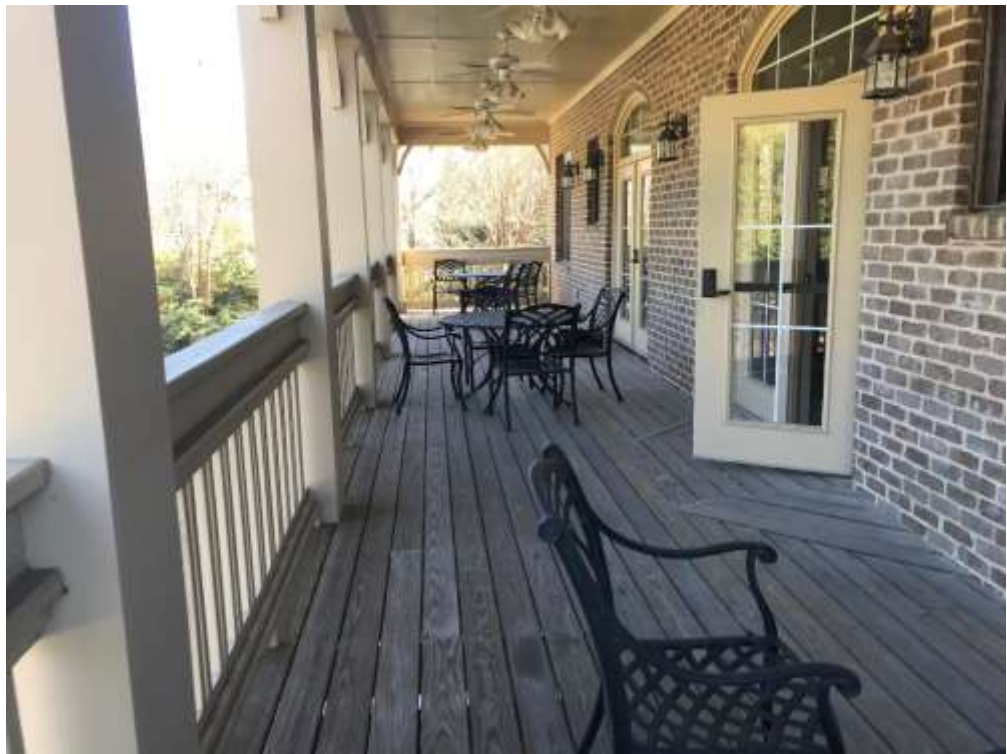
Photo No.
22

The rear deck consists of pressure-treated decking installed on pressure-treated wood joists, girders, and posts. We anticipate that the decking will require replacement on an approximately 15-20 year cycle and have included funds to replace in 2025.

Wood decking and
furniture on rear of
clubhouse

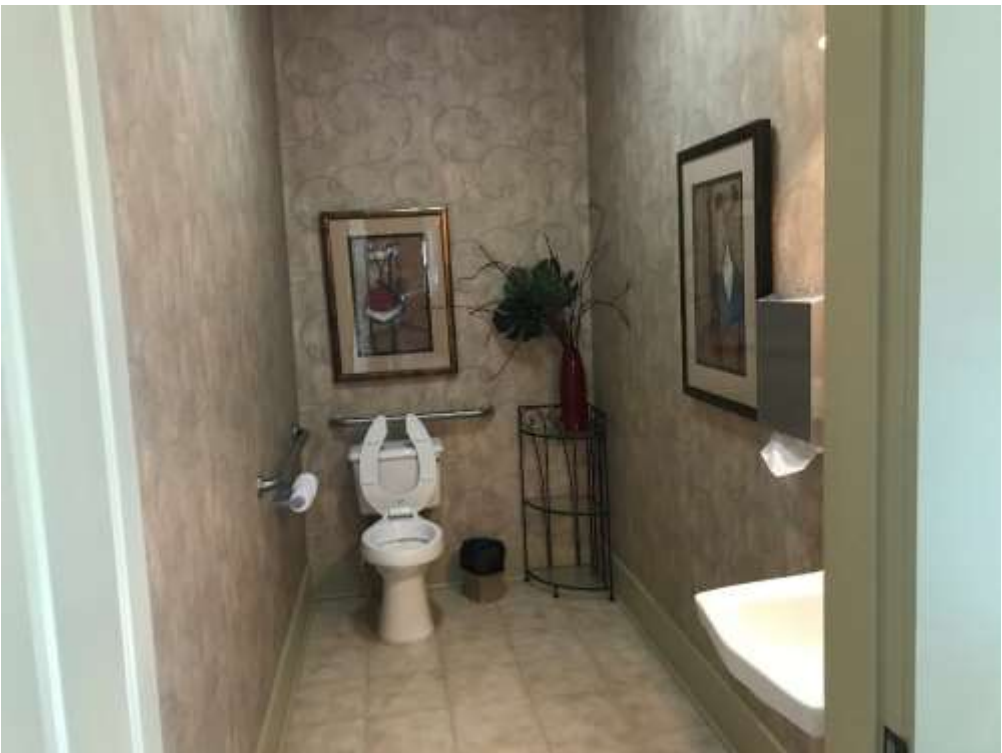
<p>Photo No.</p> <p>24</p>

The upstairs restrooms include toilets and sinks with grab bars, and appeared to be in relatively good condition. We have provided an allocation of funds to refurbish the upstairs restrooms in the clubhouse in 2035 on an approximately 25-year cycle. The downstairs restrooms include partition walls with sinks and toilet fixtures that appeared further aged, likely due to more frequent use as the pool restrooms. We have provided an allocation of funds to refurbish the downstairs restrooms in 2025 on an approximately 25-year cycle. This would include replacing partition walls/doors, replacing sinks, and replacing toilet fixtures as needed. We assume painting and minor repairs to the finished walls and flooring in the restrooms will be covered by an annual maintenance budget.

<p>Description</p> <p>Typical upstairs restroom</p>

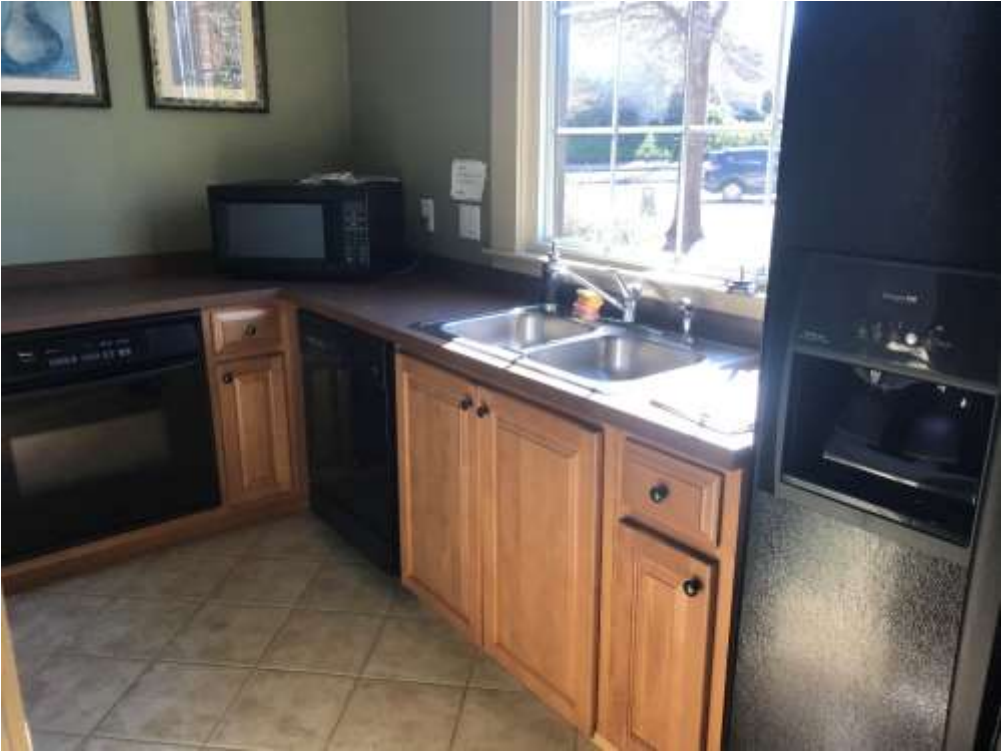
<p>Photo No.</p> <p>25</p>

The clubhouse includes a kitchen with wood cabinetry and laminate countertops. It also includes a refrigerator, dishwasher, oven, microwave, and sink. We assume the appliances will be replaced as they fail using funds from an annual operating budget. We have provided an allocation of funds to replace the cabinets and countertops in 2035 on an approximately 25-year cycle.

<p>Description</p> <p>Kitchen area</p>

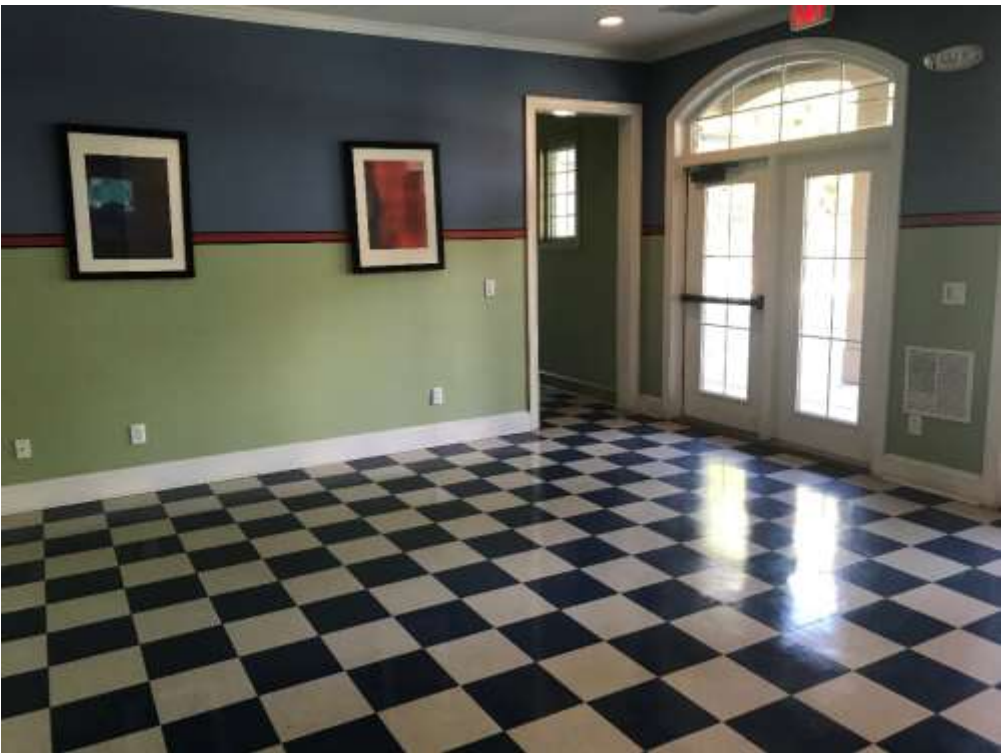
<p>Photo No.</p> <p>26</p>

<p>Description</p> <p>Downstairs common area</p>

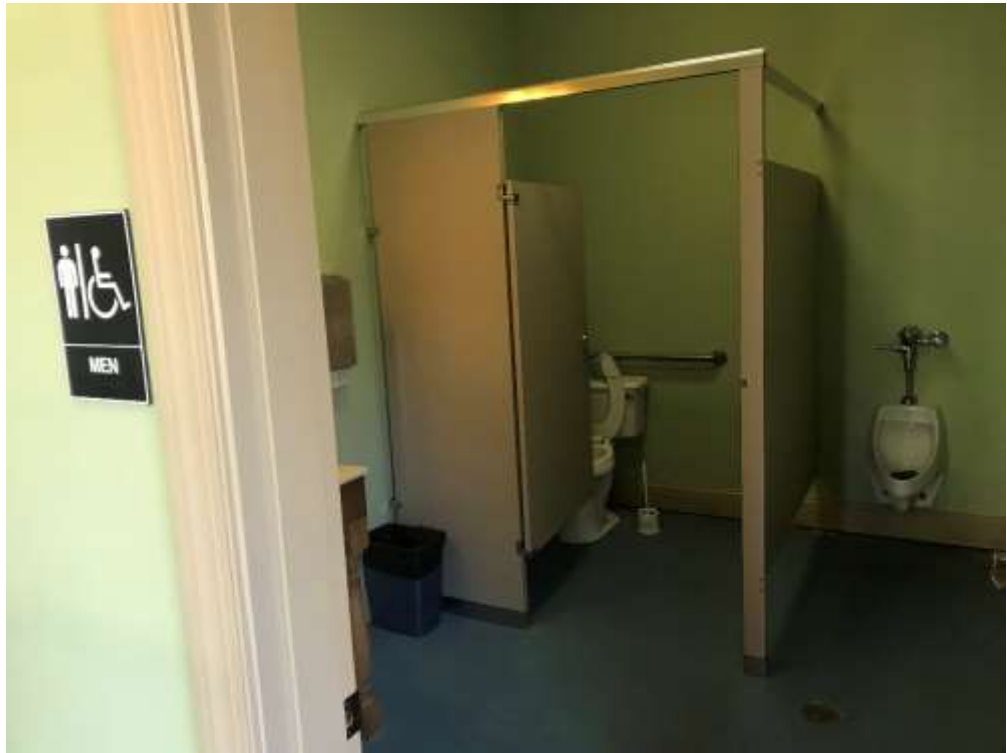
Photo No.
27

Typical downstairs restroom

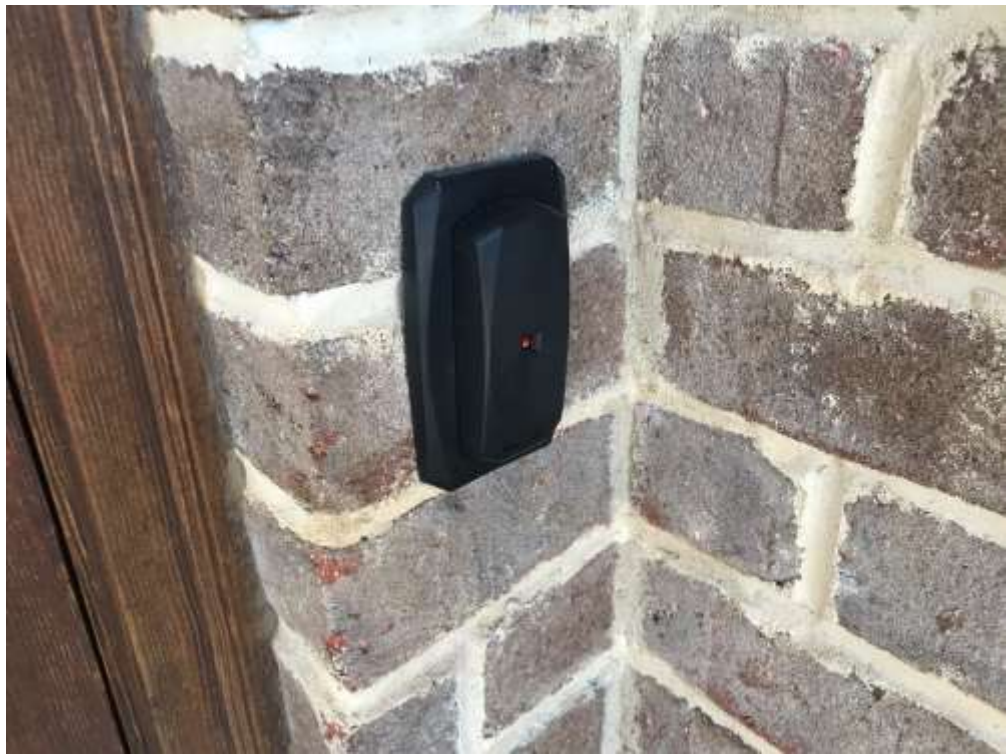
Photo No.
28

The pool area and clubhouse include a key-fob electronic access control system and several security cameras. The key-fob system was operational during the inspection and appeared to be in good condition. Reportedly, the access and security cameras were replaced in 2020. We have allocated funds for repairing/upgrading the access control and security systems on a 10-year cycle beginning in 2030.

Key fob access

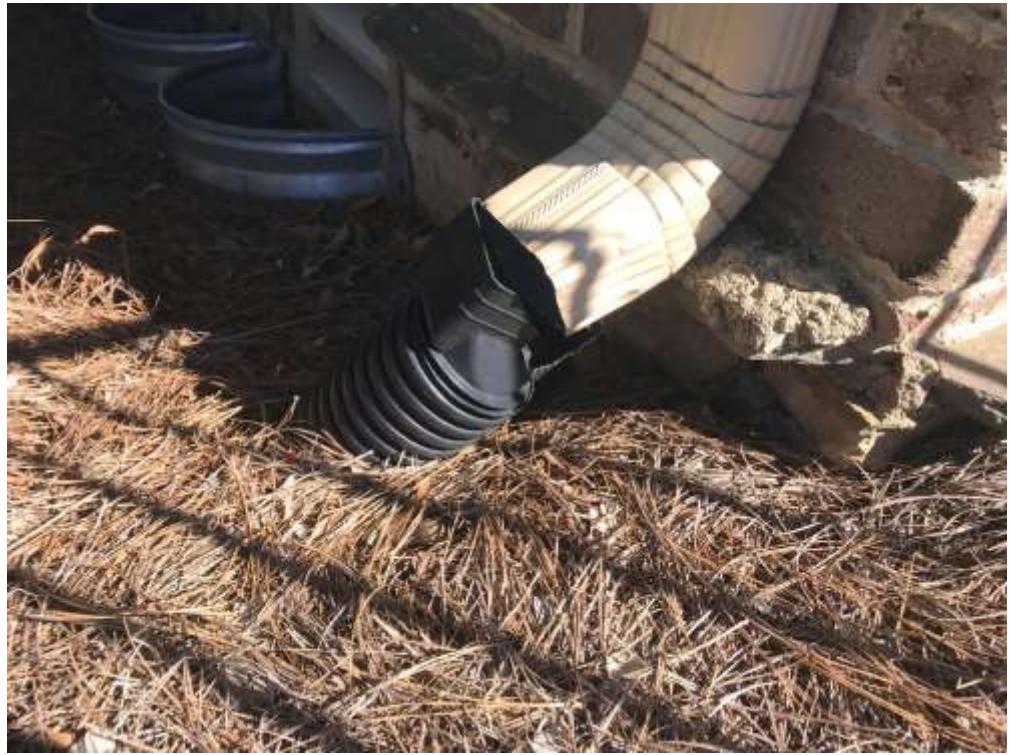
Photo No.
29

Detached downspout at front-left of clubhouse

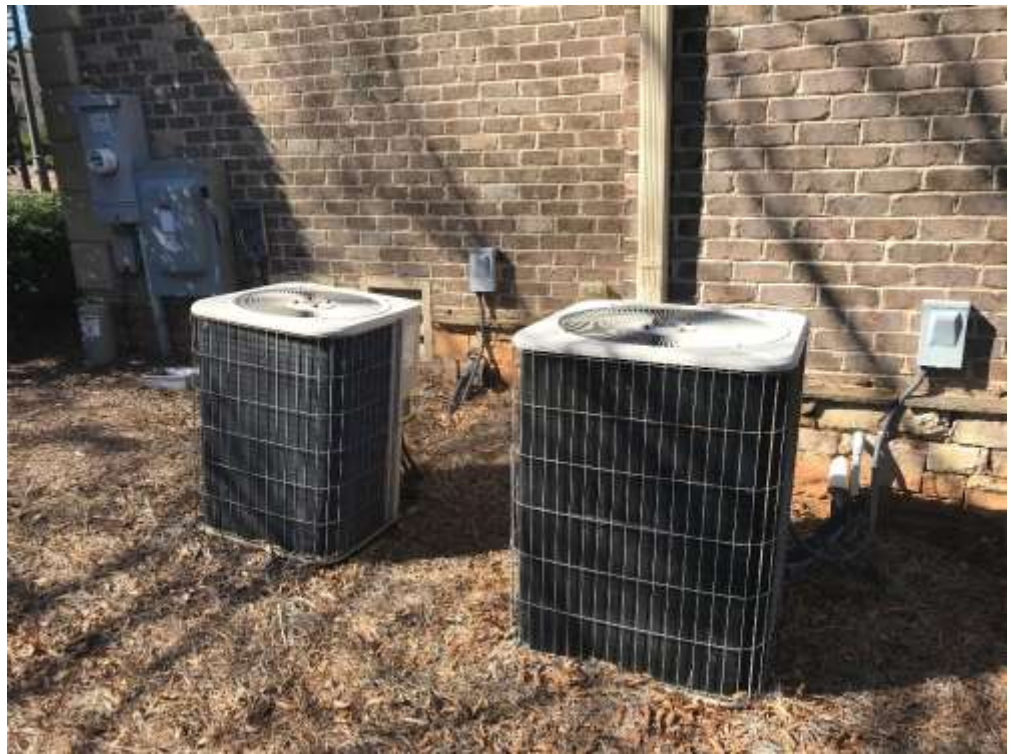
Photo No.
30

The clubhouse is conditioned by Lennox 5-ton and 2.5-ton split-system HVAC systems with manufacture dates of 2004. Typically, HVAC systems will have an expected useful life of approximately 10-15 years. We have provided an allocation of funds to replace the split-system HVAC equipment in 2022 on an approximately 15-year cycle.

Clubhouse HVAC components

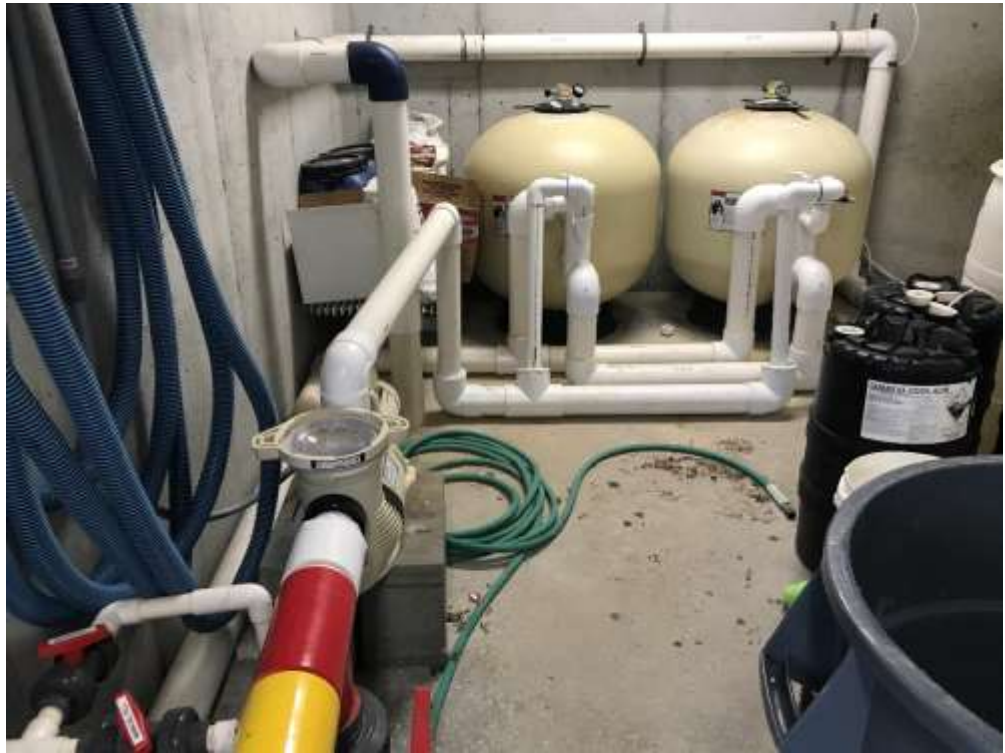
Photo No.
31

The pool pump and filtration equipment include a 5-horsepower pump, as well as (2) sand filters serving the pool. Pool pump and filtration equipment is typically replaced as components fail. The sand in the filter will likely require replacement on an approximately 5-year cycle. Reportedly, the pool pump was replaced in 2018. We have provided funds to replace components of the pump and filtration system on a 3-year cycle beginning in 2023.

Pool pump and filtration equipment

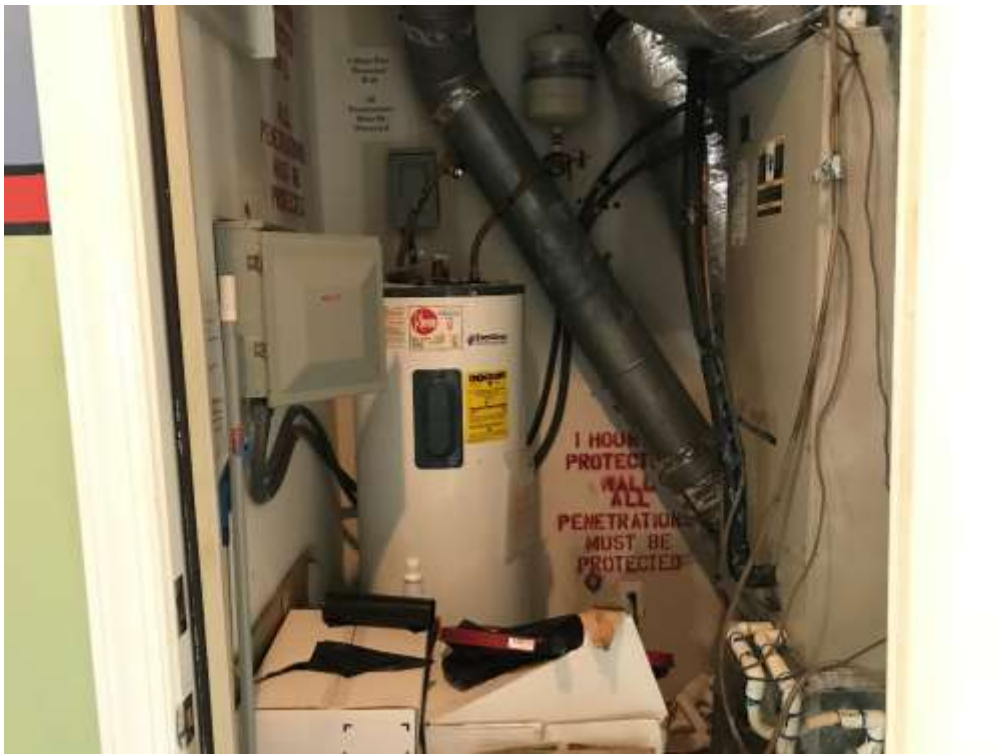
Photo No.
32

The clubhouse is served by a Rheem 50-gallon, electric water heater with a manufacture date of 2004. Water heaters have an expected useful life of approximately 15 years, highly dependent on use. We have provided an allocation of funds to replace the water heater in 2022 on an approximately 15-year cycle.

Clubhouse water heater

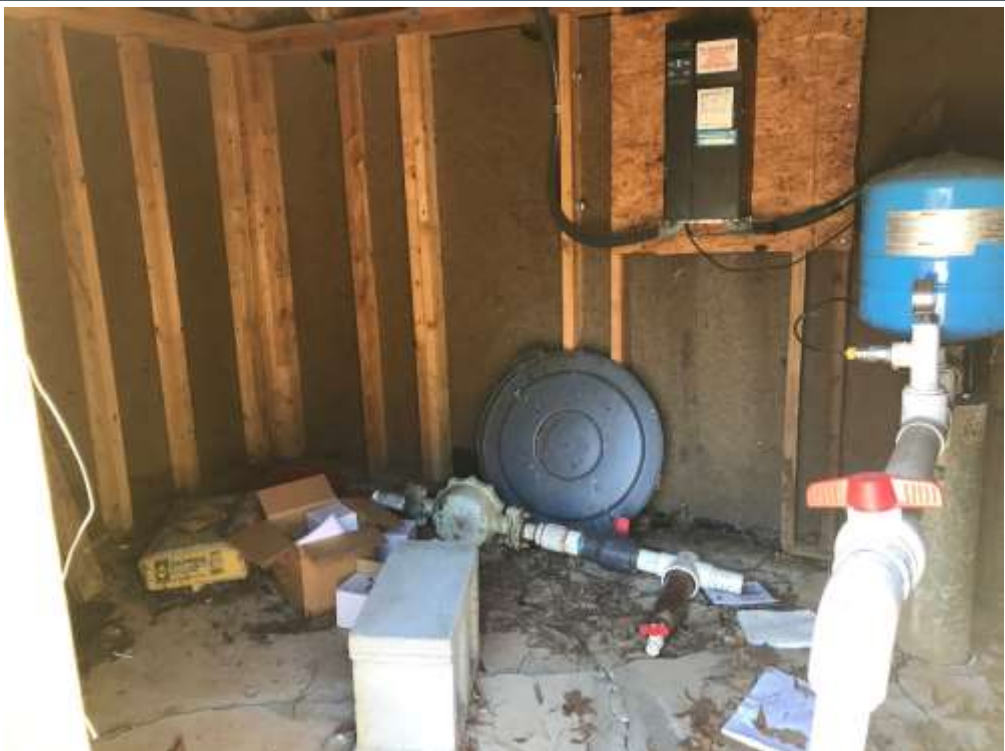
A well is located adjacent to the parking area to supply water to the irrigation system that serves the landscaped areas around the clubhouse building and entrance signage. We have allocated funds for major repairs (well pump replacement, circuit board, piping, heads, and controls) to the irrigation system on a 10-year cycle beginning in 2027. Repairs would likely include replacement of pumps, valves, timers, and controllers as needed. We anticipate lesser/minor repairs to sprinkler system piping and head replacement would be funded from the annual maintenance budget.

<p>Description</p> <p>Well pump equipment</p>

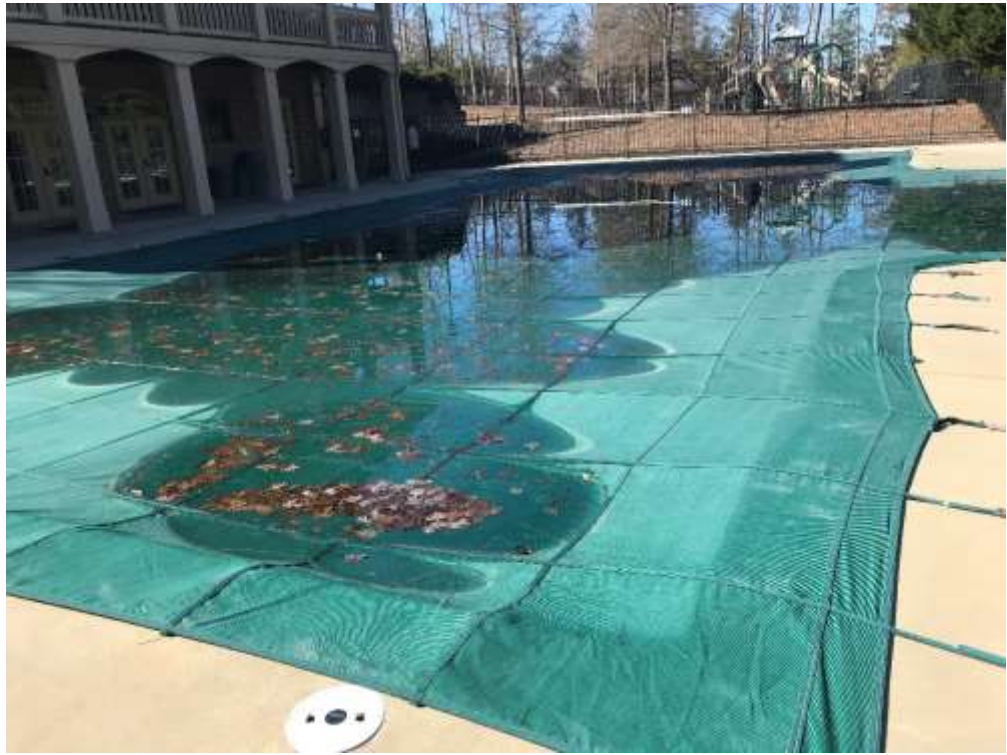
Photo No.
35

The pool was covered at the time of inspection, but appeared to be in good condition in the limited area of visibility when lifting a portion of the cover. Typically, pools should be drained, minor cracks repaired, and recoated on an approximately 10 to 15-year cycle. The pool was reportedly resurfaced in 2016. We have budgeted funds for full resurfacing repairs on a 12-year cycle beginning in 2028. We assume pool ladders and rails will be replaced using funds from an annual maintenance budget, as needed. We have also provided an allocation of funds to replace the pool cover on an approximately 8-year cycle beginning in 2024, as exposure to sunlight and weather will cause deterioration over time.

Description
View of pool and cover

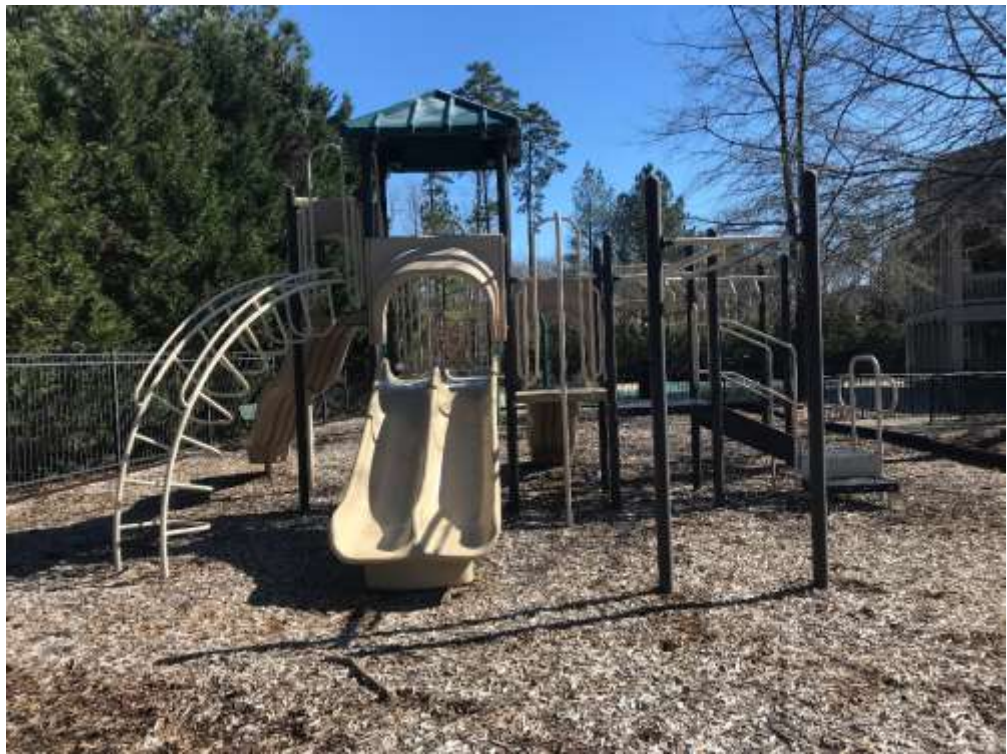
Photo No.
36

Description
View of playground equipment

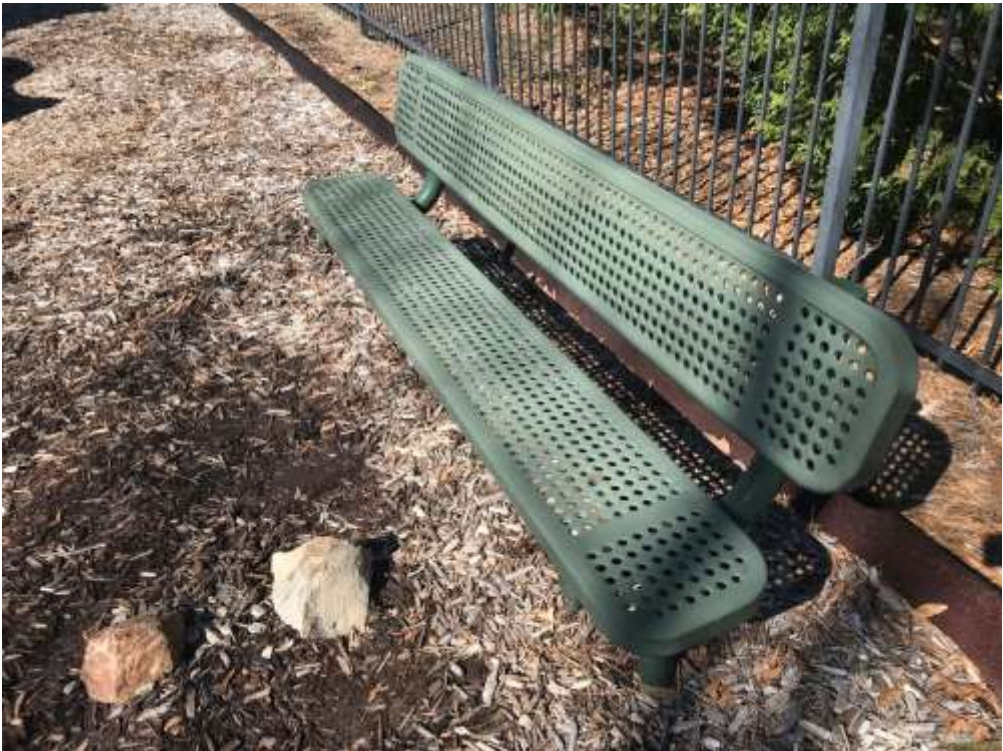
<p>Photo No.</p> <p>39</p>

<p>Description</p> <p>Deterioration in bench</p>
