**GROVE AT FALLON PARK  
HOMEOWNERS  
ASSOCIATION  
RALEIGH, NC**

**NOVEMBER 22, 2019**

**FULL RESERVE  
STUDY UPDATE**

**GILES + FLYTHE**  
ENGINEERS

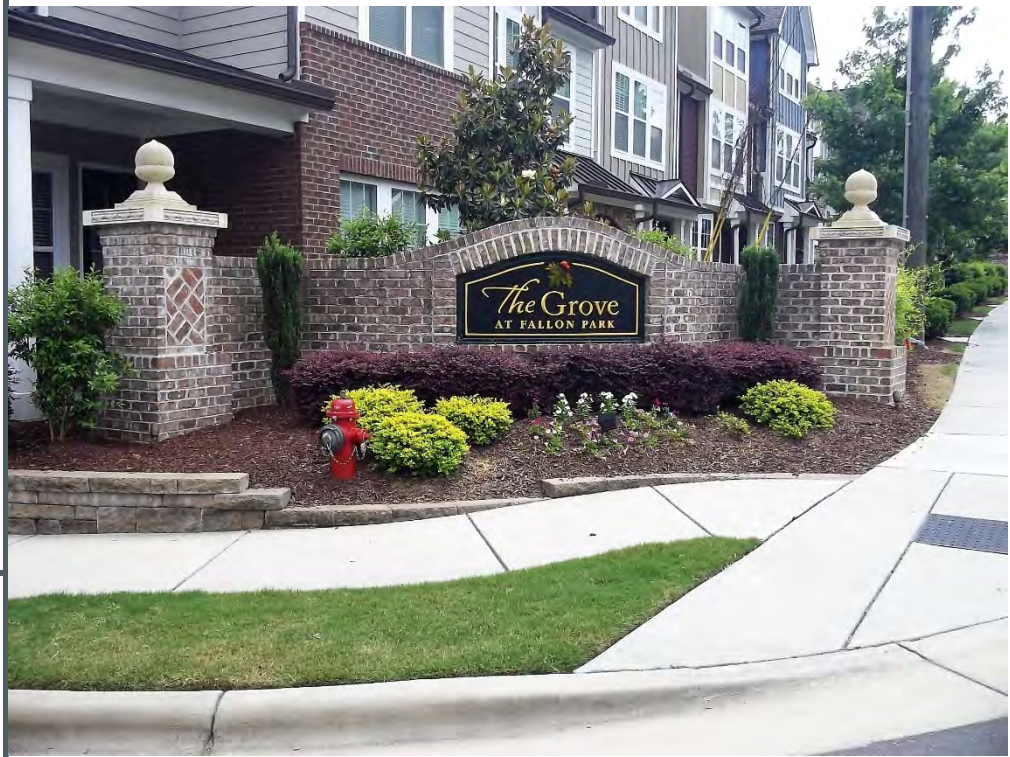
**1**

Overall view of  
community entrance sign

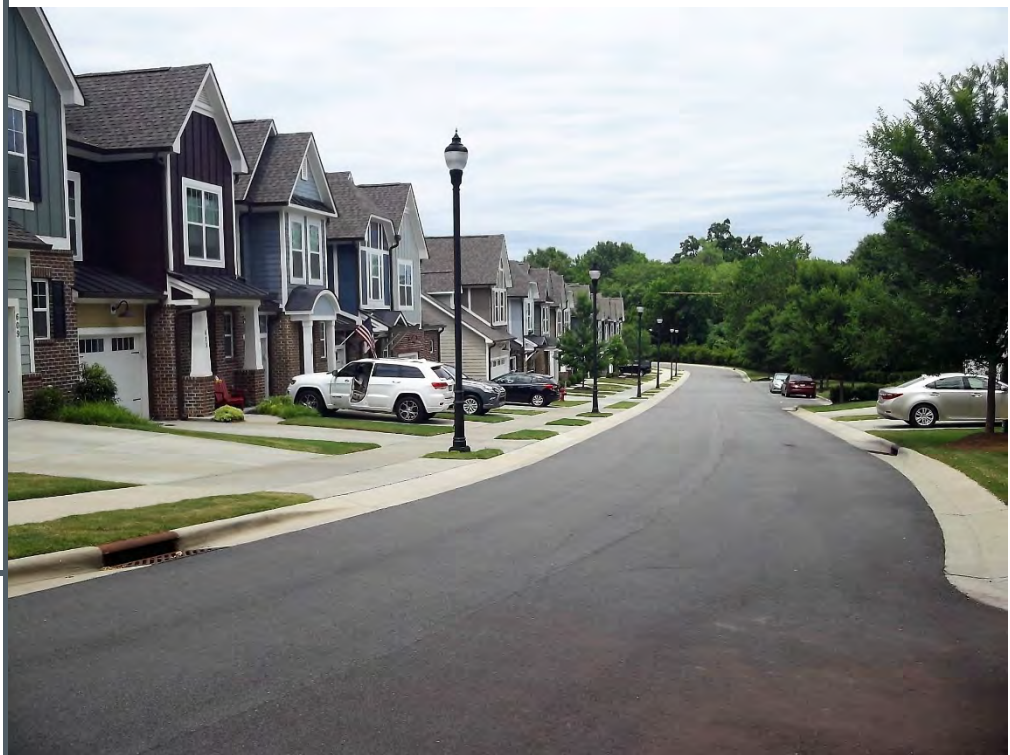
**2**

Overall view of  
community

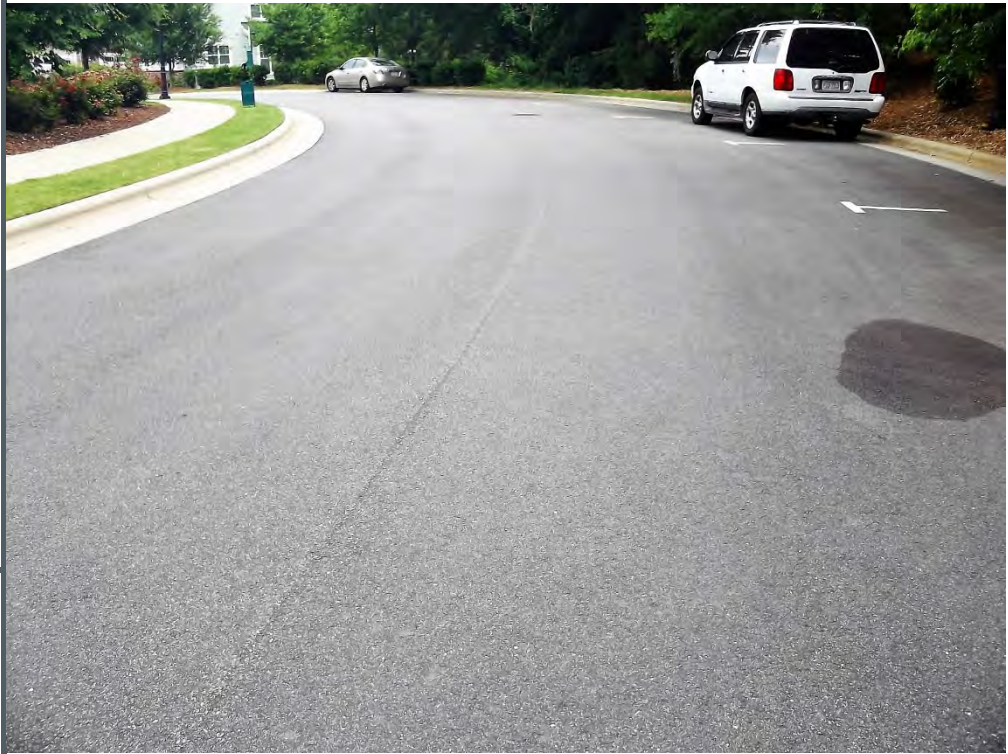
3

The streets and alleyways within the community are asphalt paved and are privately maintained by the Association. Overall, they appeared to be in relatively good condition. We did not observe excessive cracking in the street paving; however, we did observe limited areas of longitudinal cracking and slippage crack development in the alleyways. We have allocated funds to perform full-depth repairs on these cracked areas of pavement beginning in 2022. To help maintain a reasonable life of the paving, we have also included funds for filling minor cracks as they develop and the application of a seal coat on a 7-year schedule, beginning in 2025. The minor areas of restriping on the streets are also included in this allocation. Asphalt paving has a normal useful life of approximately 20 years in a residential setting, after which time we recommend resurfacing the pavement. Resurfacing would include milling the old pavement, repairs to inadequate areas of subgrade and the installation of an approximately 2” thick layer of new asphalt. We anticipate this work will be performed on a 20-year schedule, beginning in 2037.

Typical view of asphalt paved community street

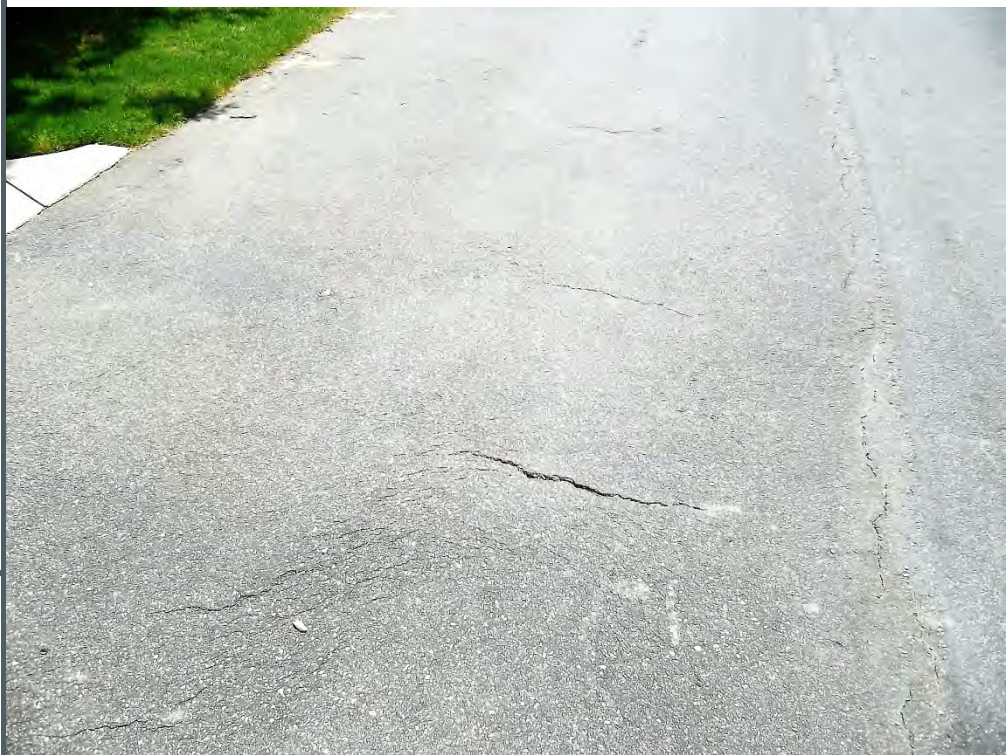
4

Slippage crack development in asphalt paved alley

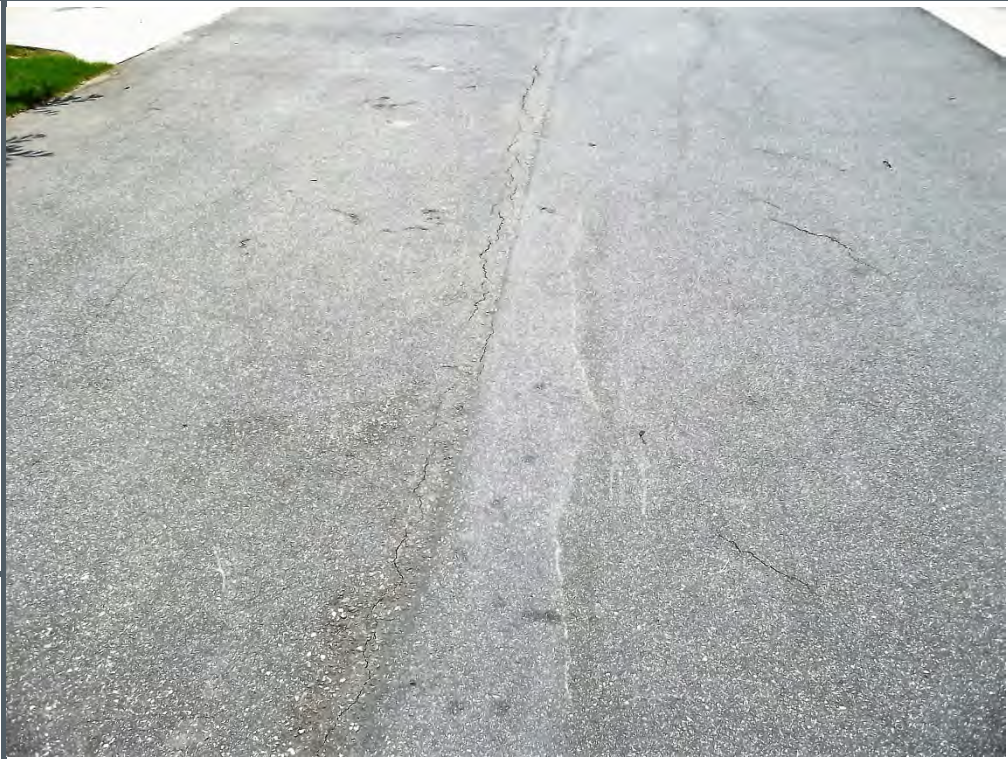
**Photo No.**  
5

Crack development in asphalt paved alley along longitudinal seam

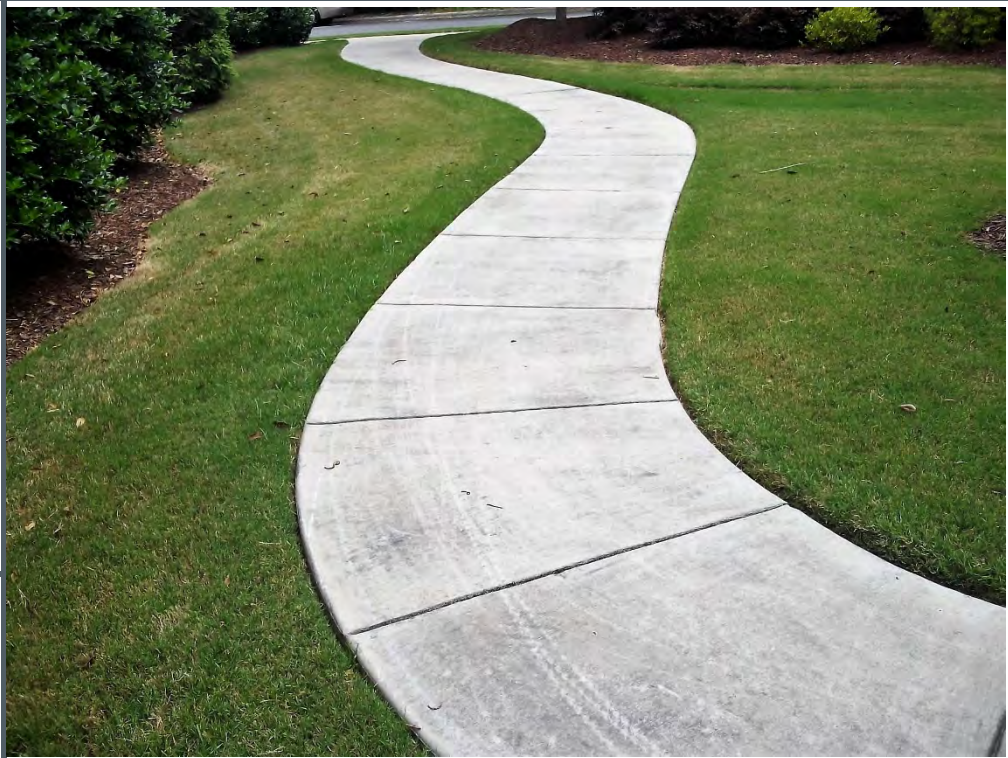
**Photo No.**  
6

Flatwork in the community consists of a concrete sidewalk along one side of each of the community streets and walkways and driveways at the individual townhome units. The flatwork generally appears to be in good condition. We have allocated funds for periodic replacement of flatwork in anticipation of future cracks, heaving and/or settling that are common in concrete construction. We have assumed that 5% of the total area will require improvement every 8 years beginning in 2026.

Typical view of concrete flatwork - sidewalk

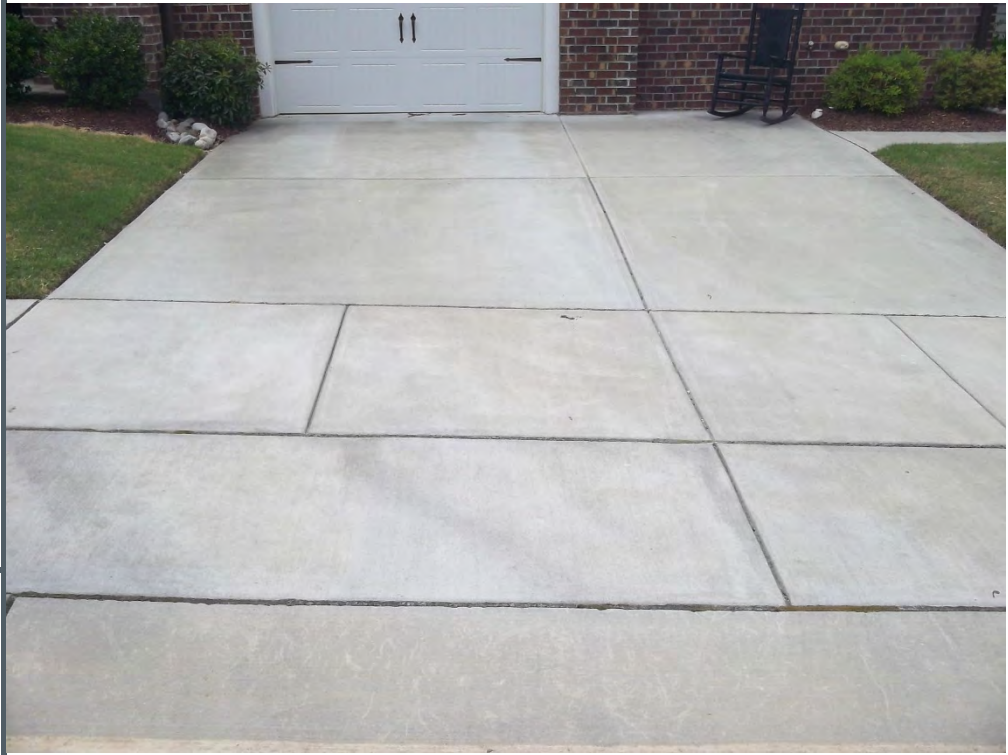
**Photo No.**  
**7**

Typical view of concrete flatwork - driveway

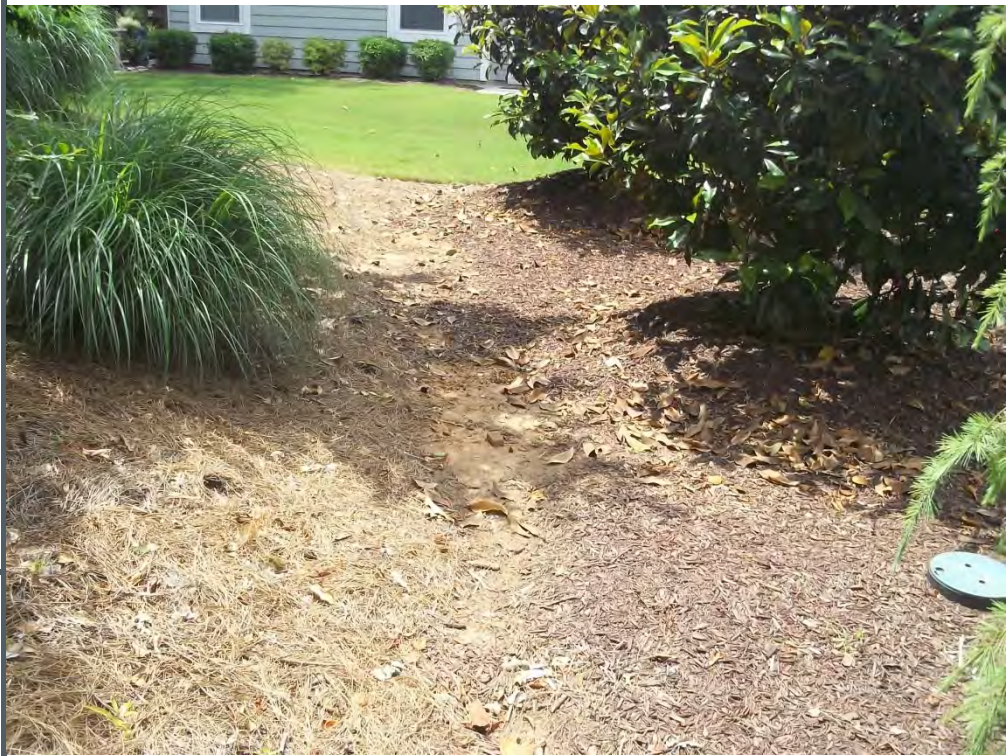
**Photo No.**  
**8**

Stormwater on the site drains via surface flow or swales toward catch basins in the curbs and landscaped areas. We have allocated funds to repair/improve the drainage systems on a 5-year cycle beginning in 2023. Repairs will likely include retrenching of swales to improve flow, extending gutter downspouts away from building foundations, maintenance of underground systems, installation and repair of rip rap or turf reinforcement on steep slopes, installing French drains or other types of subsurface drainage systems. These types of repairs can be moderate (re-trenching swales, flushing pipes), to very expensive (new underground pipe systems). We have included a moderate budget to help cover these costs.

View of minor soil erosion in common area

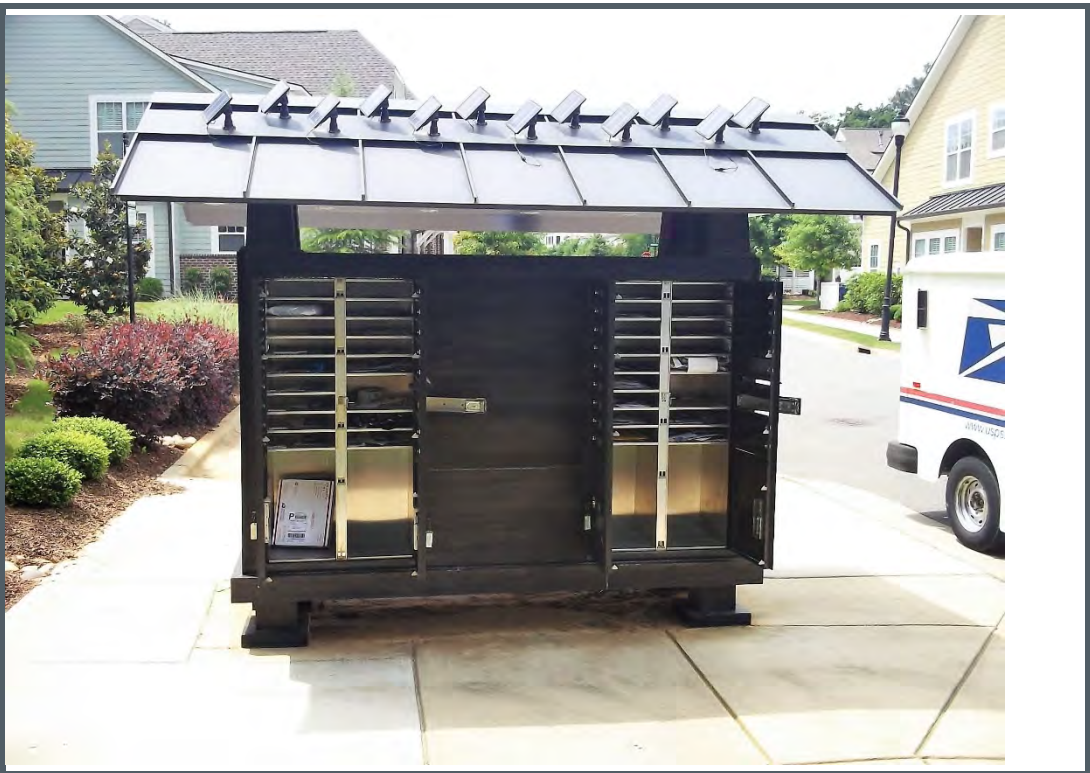
**Photo No.**  
9

There is a shelter for the mail kiosks at the south side of the community. The kiosks are open to air on all sides but are covered with a roof. We anticipate these units will require replacement on an approximate 20-year schedule and have included funds to do so in 2037.

**Description**  
Overall view of mail  
kiosk structure

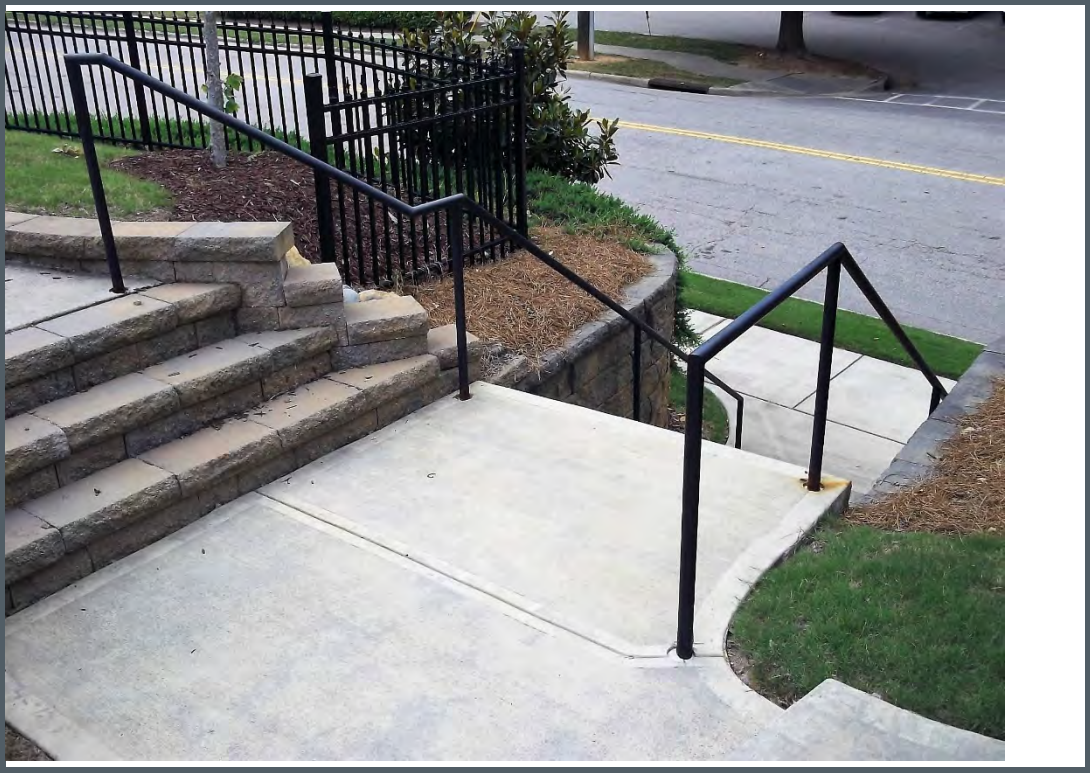
**Photo No.**  
10

**Description**  
View of site stair  
handrail and fencing

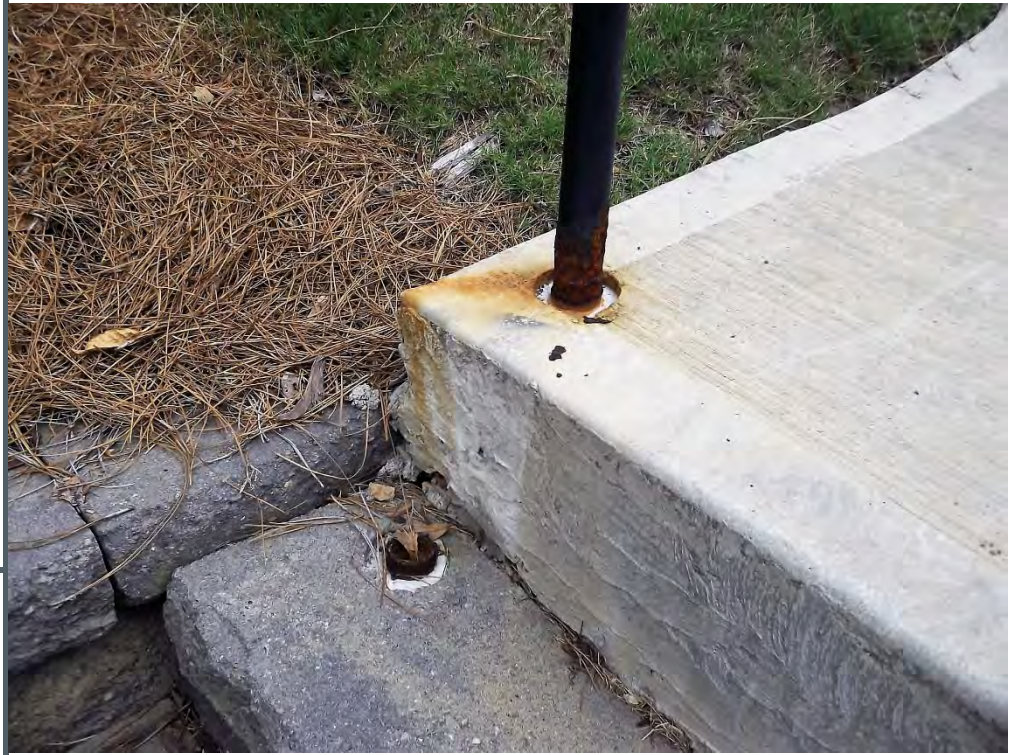
**Photo No.**  
**11**

Anodized aluminum fencing has been installed along the tops of the retaining walls and at the front yards of the townhome buildings along Noble Road. In addition, steel handrails are provided at the site stairs providing access from the property to the right-of-way along Noble Road. The fencing is in relatively good condition. The handrails are adequate; however, we observed corrosion development on the handrails. We have allocated funds for repairing and repainting the fencing and rails on a 15-year schedule beginning in 2032. We assumed minor repairs to the handrails in the interim will be funded from a general operating budget.

Corrosion development  
on site stair handrail

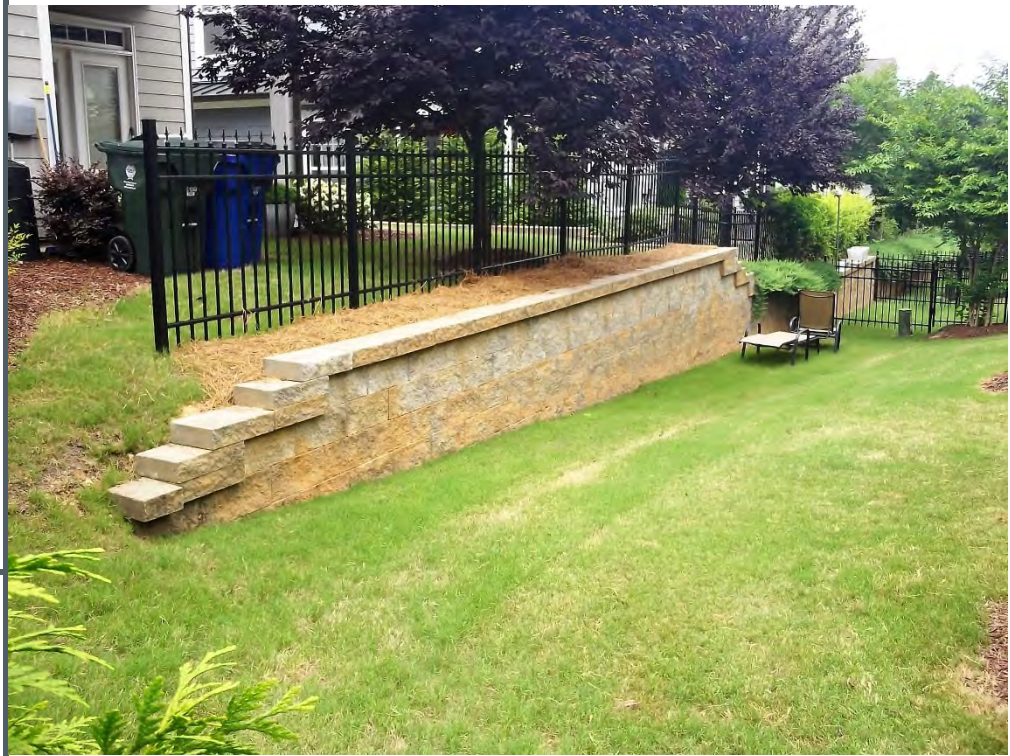
**Photo No.**  
**12**

Concrete segmental block retaining walls are located along Noble Road at the northwest corner of the community and between the backyards of the townhome buildings along Fallon Grove Way. The walls were of varying height and length and appeared to be in relatively good condition, and we did not observe significant rotation or indications of excessive horizontal movement in the walls. Maintenance and repair of the walls are the responsibility of the Association. We do not anticipate significant repair work will be required in the next 20 years, provided the associated drainage systems are well maintained.

Typical view of site  
retaining wall and  
associated fencing

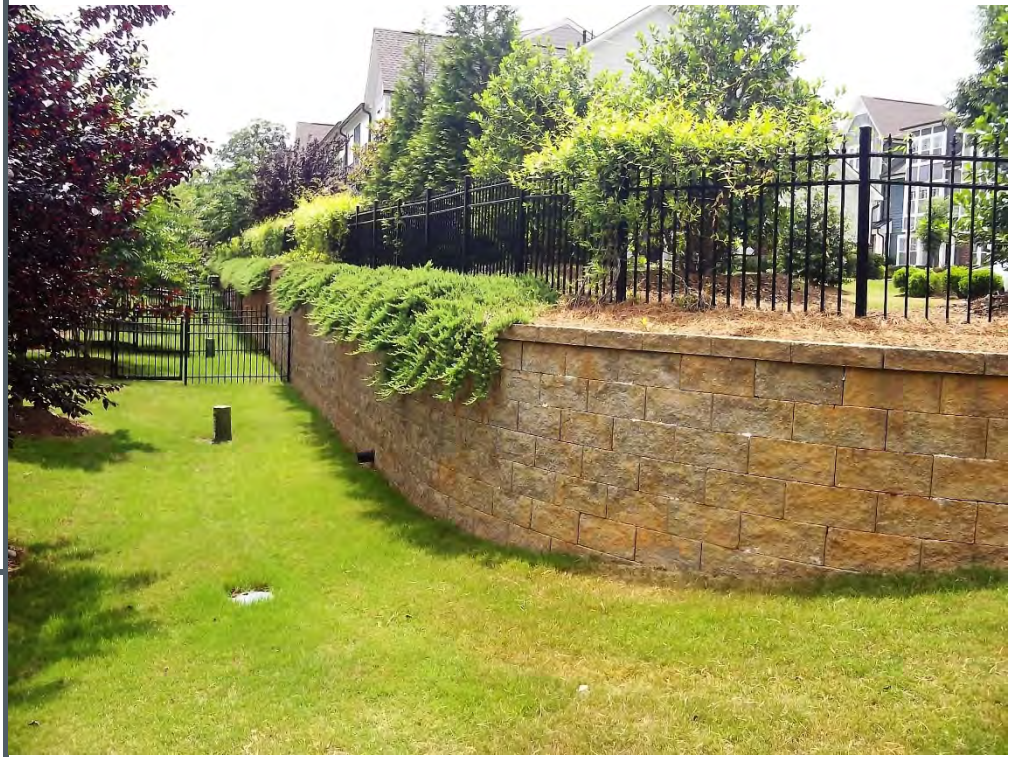
**Photo No.**  
**13**

Typical view of site retaining wall and associated fencing

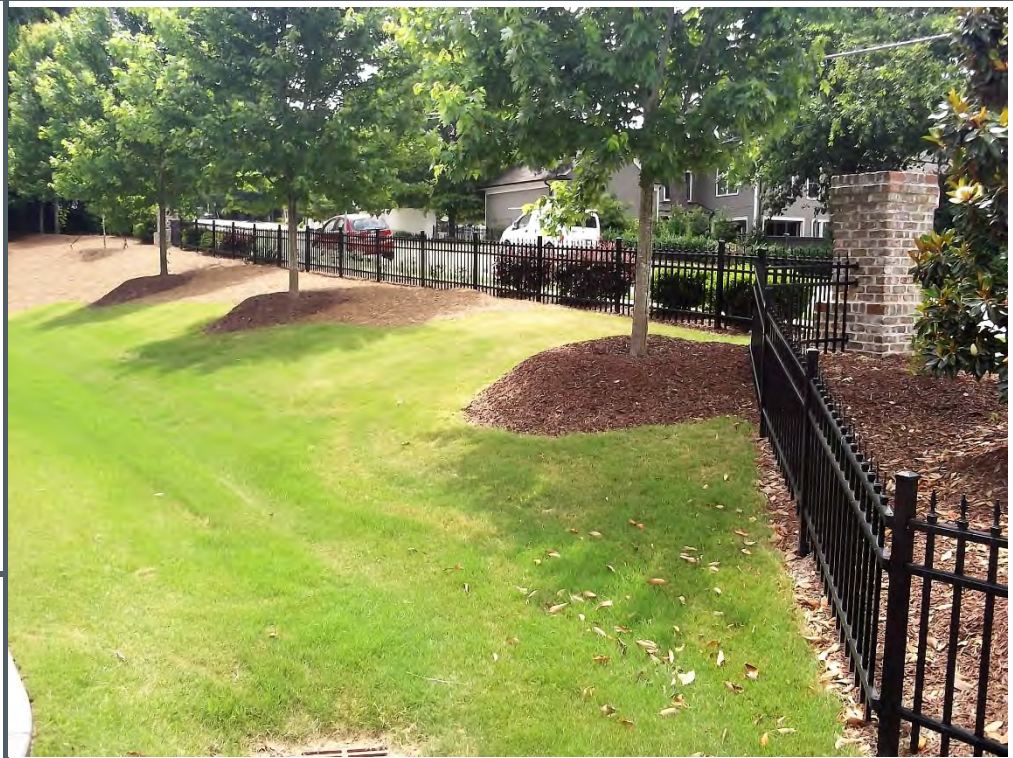
**Photo No.**  
**14**

View of common area fencing

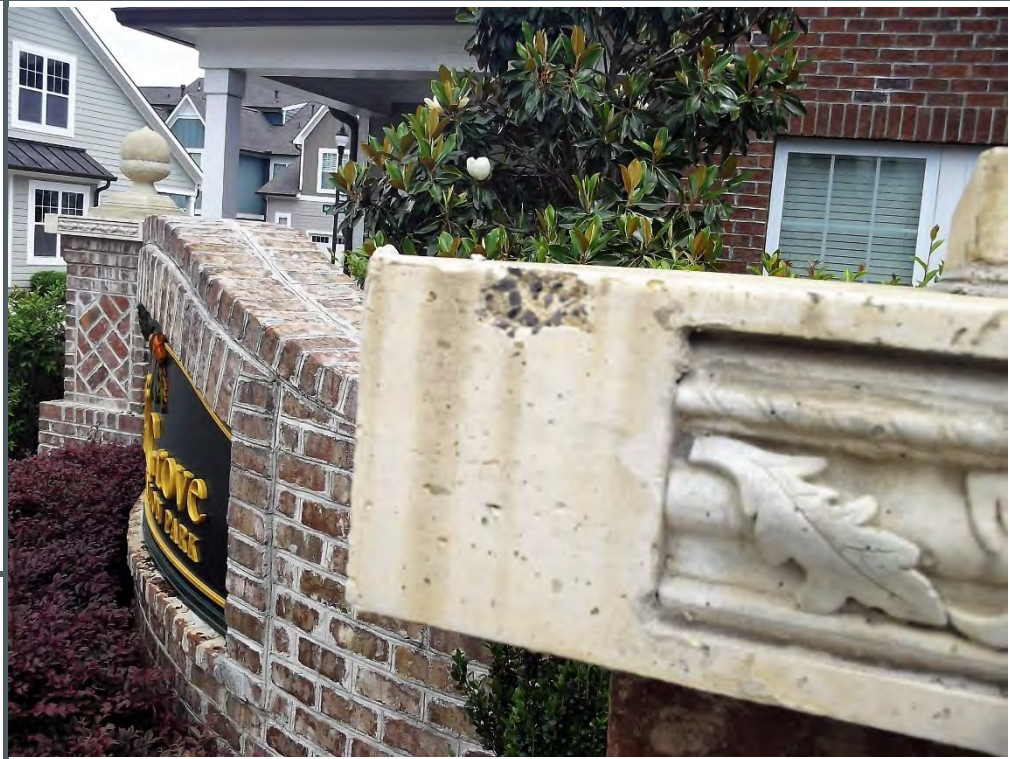
**Photo No.**  
**15**

The two entrances into the community along Noble Road are marked with masonry monument signs. The monument is constructed of concrete masonry units with brick veneer, and the sign indicates the community name and logo with raised lettering on a composite inlay. We have allocated funds for miscellaneous repairs to the entrance sign along with the associated landscape lighting systems on a 10-year schedule beginning in 2027.

Minor damage to  
entrance sign pedestal  
cap

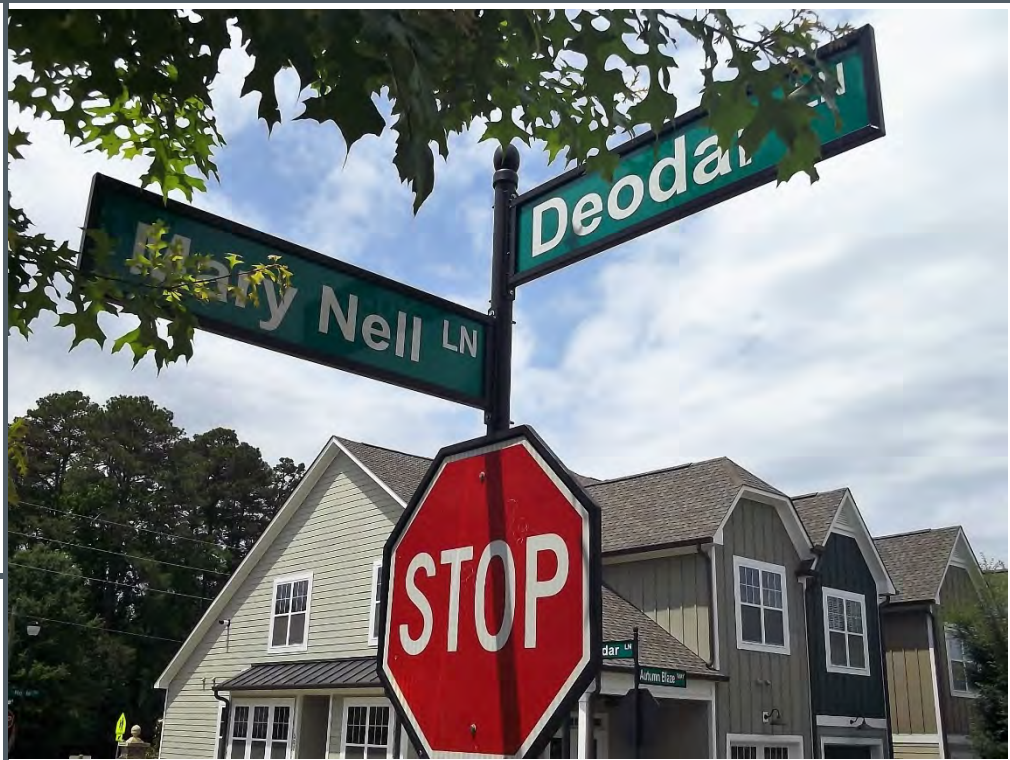
**Photo No.**  
**16**

The street and traffic control signs within the community are maintained by the Association. They appeared to be in relatively good condition. We have included funds to replace the signs on a 20-year cycle beginning in 2037.

Typical view of street  
signs

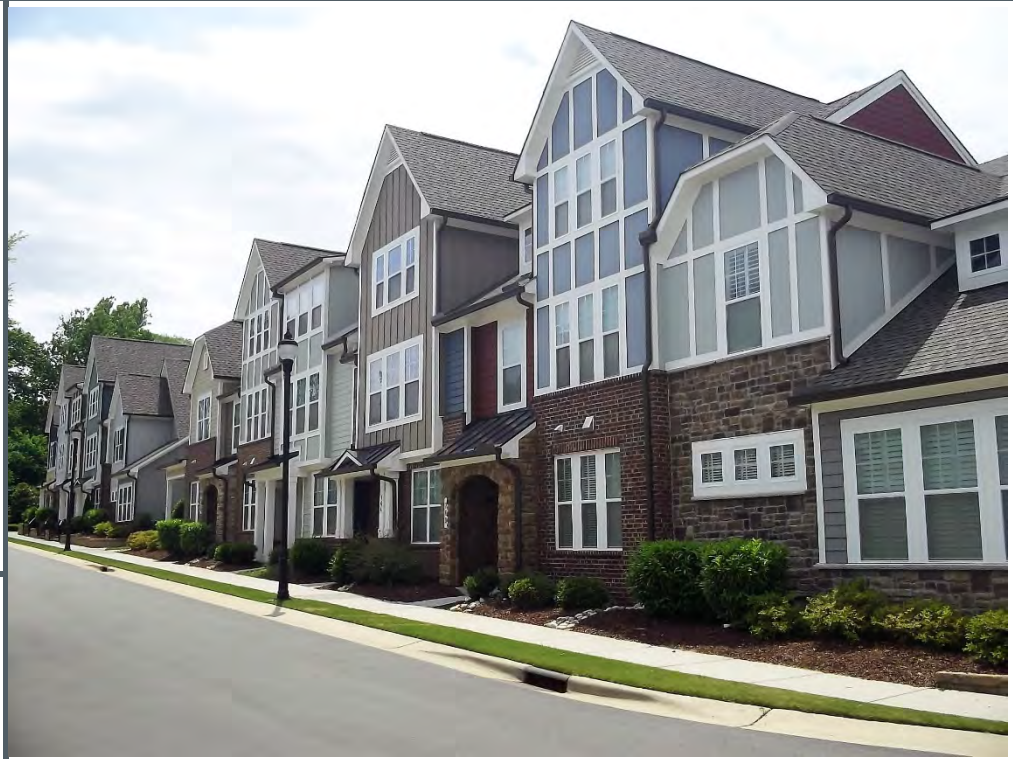
**Photo No.**  
**17**

Typical view of  
townhome buildings

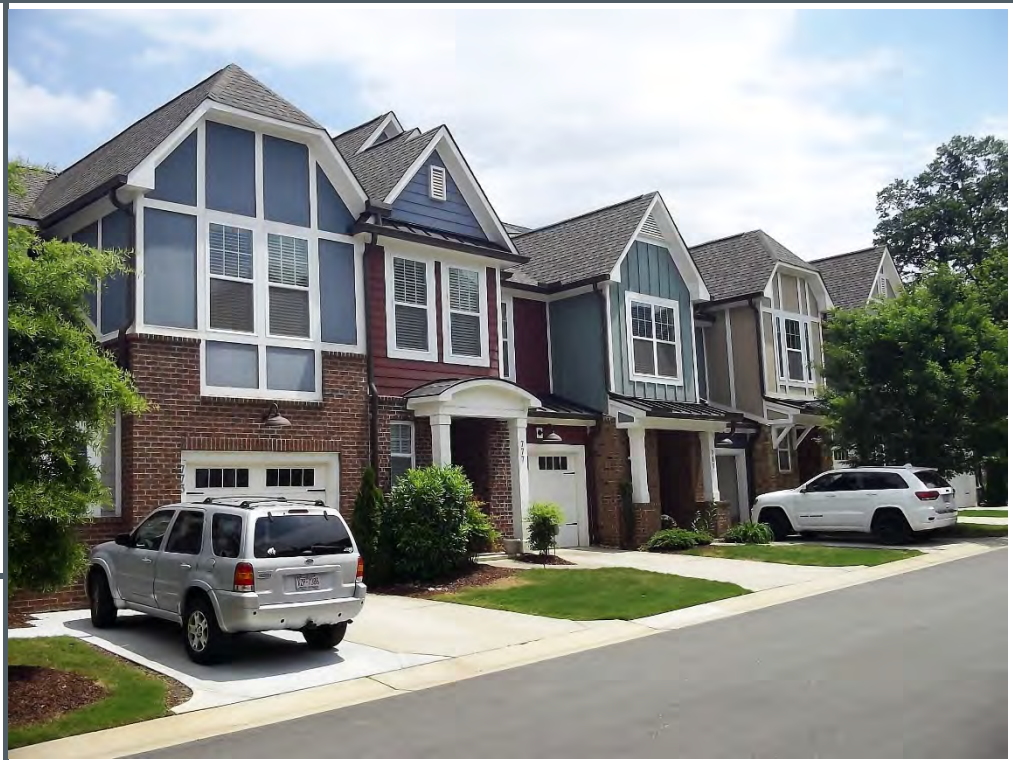
**Photo No.**  
**18**

Typical view of  
townhome buildings

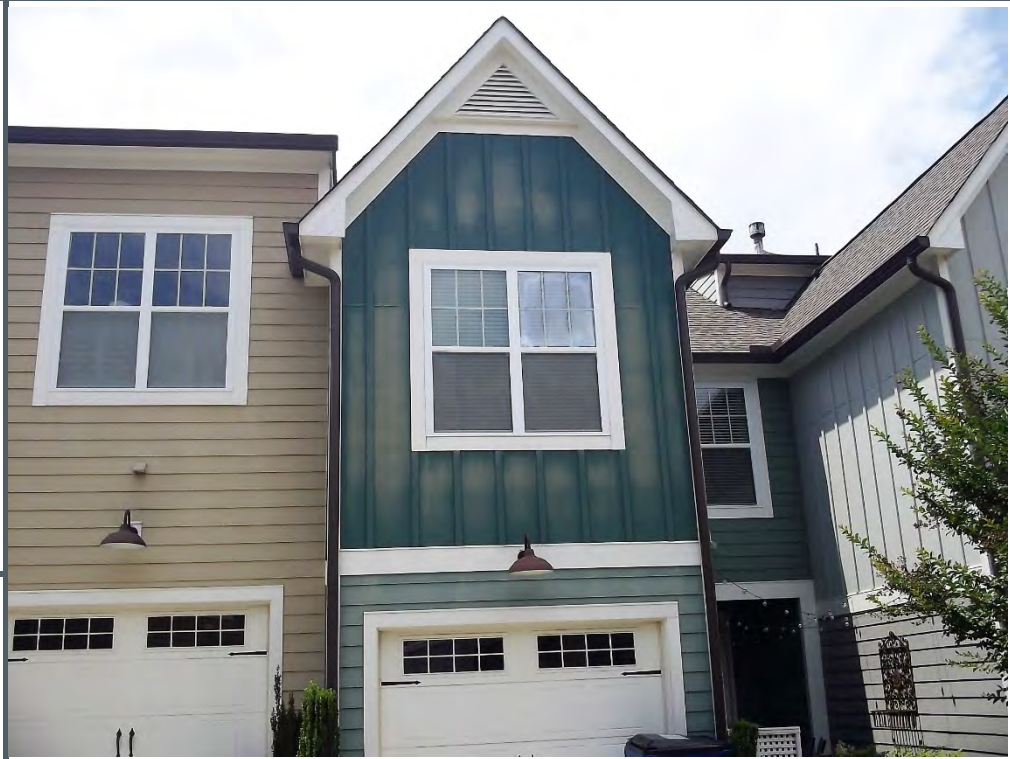
**Photo No.**  
**19**

The buildings in the community are clad primarily in fiber cement siding with accent sections of adhered stone and brick veneer. We have included funds for repainting the buildings on a 7-year schedule beginning in 2020. Similar to the roofing project, we have assumed the work will be performed in three phases. We do not anticipate significant expenses will be required for the repair and maintenance of the masonry veneer; however, a modest budget has been included for repainting the metal handrails at some of the units with steps at the front entrance.

Typical view of painted exterior surfaces of townhome buildings

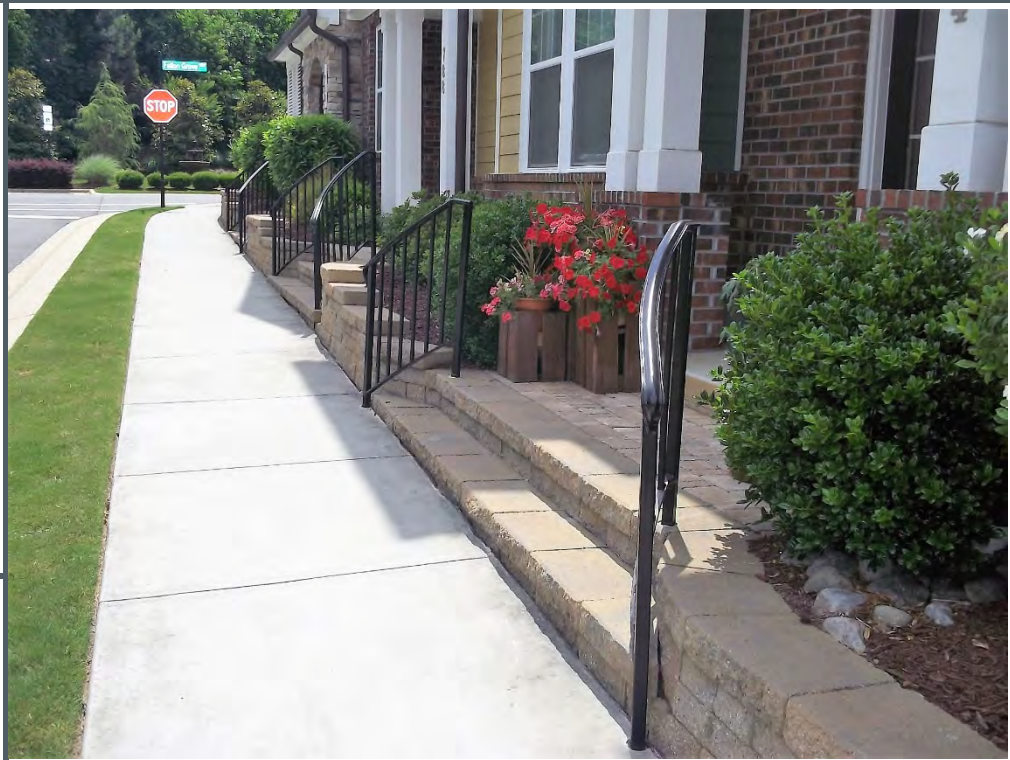
**Photo No.**  
**20**

Typical view of front porch handrails at select units

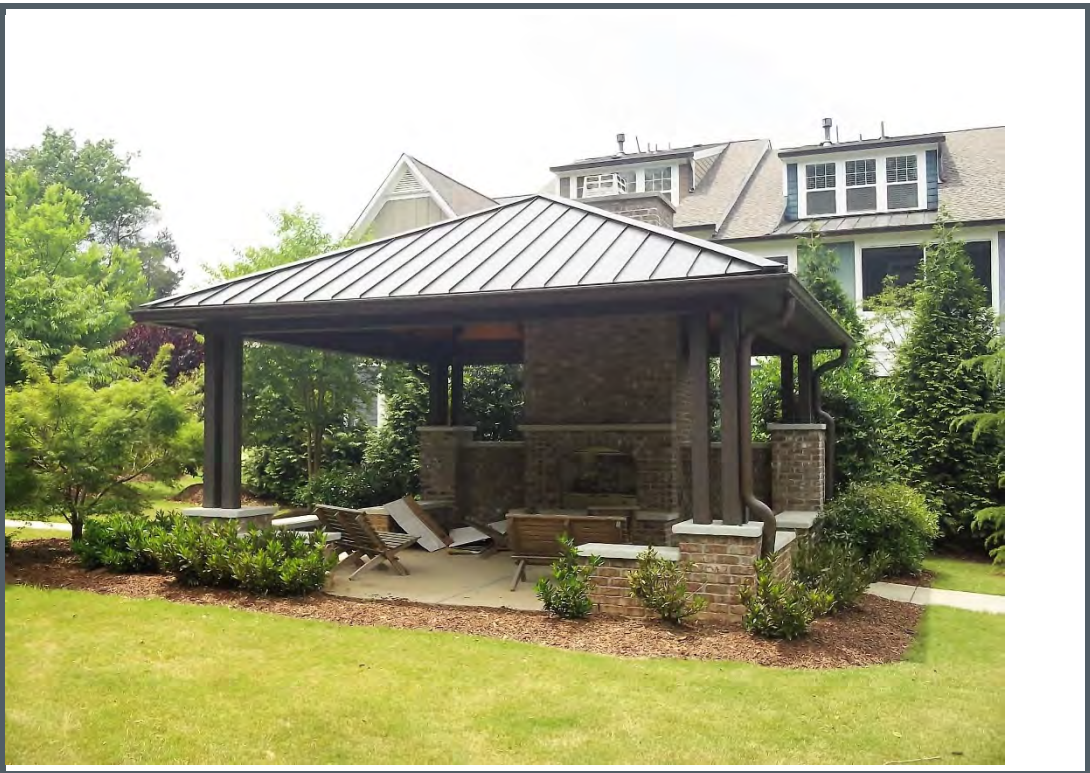
**Photo No.**  
21

An open-air, pavilion is located at the south side of the community. The pavilion is covered with a metal roof supported by stained wood columns and stone masonry pilasters. It is finished with a stained wood ceiling, a fireplace with a gas insert and various outdoor furniture pieces. We do not anticipate the roof or masonry elements will require significant repair during the term of this study; however, we have included funds for restaining the exposed wood components on a 7-year schedule beginning in 2024. Per discussions with the board, repairs of the fireplace components and outdoor furniture will be funded from the general operating budget as required.

**Description**  
Overall view of pavilion

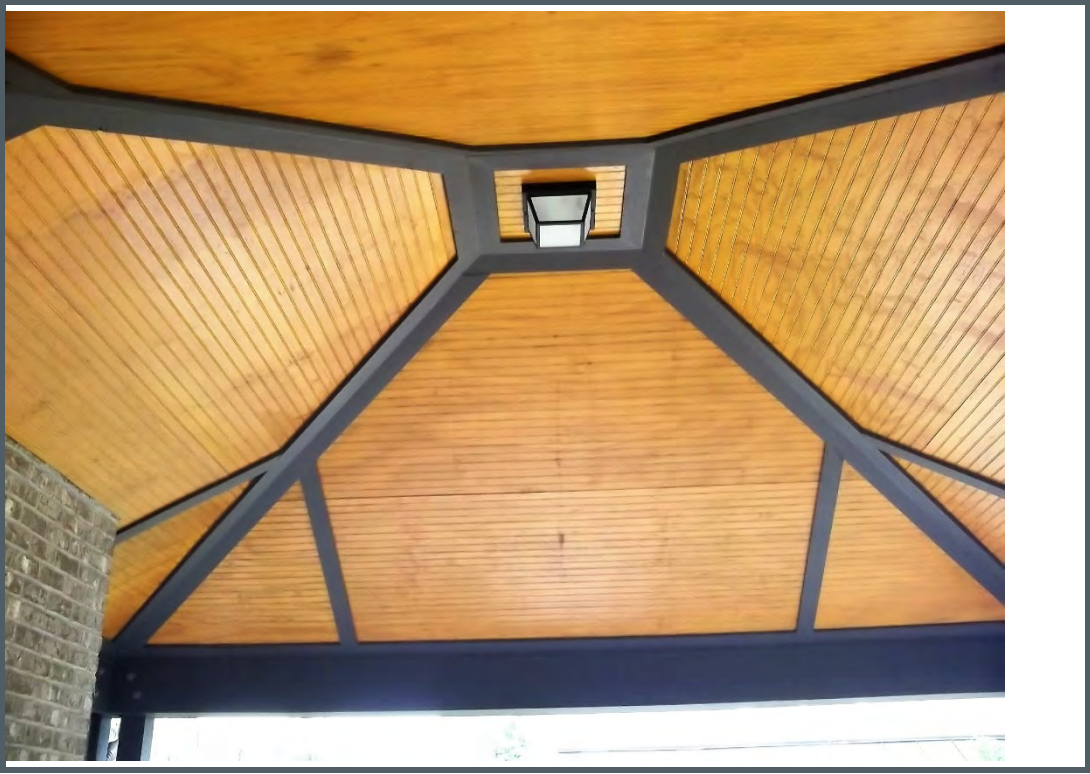
**Photo No.**  
22

**Description**  
View of stained ceiling at pavilion

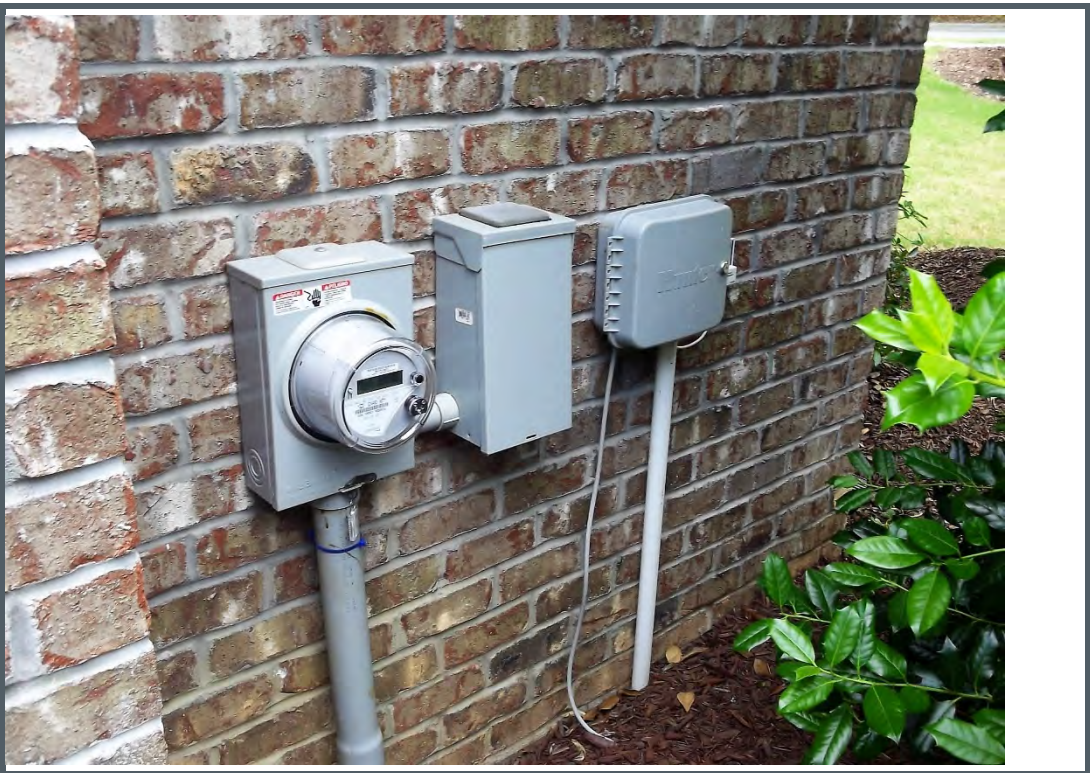
**Photo No.**  
23

Landscape irrigation and lighting systems are in place for the turf areas and planting beds in the common areas, particularly at the main community entrance signs and around the pavilion. The mail kiosk building is also finished with solar powered lighting. We have allocated funds for repairs and replacement of the lighting system components on an approximate 10-year schedule beginning in 2027. Based upon discussions with the board, the landscape irrigation system is scheduled to be decommissioned or funded from the general operating budget.

**Description**  
View of landscape  
irrigation controller

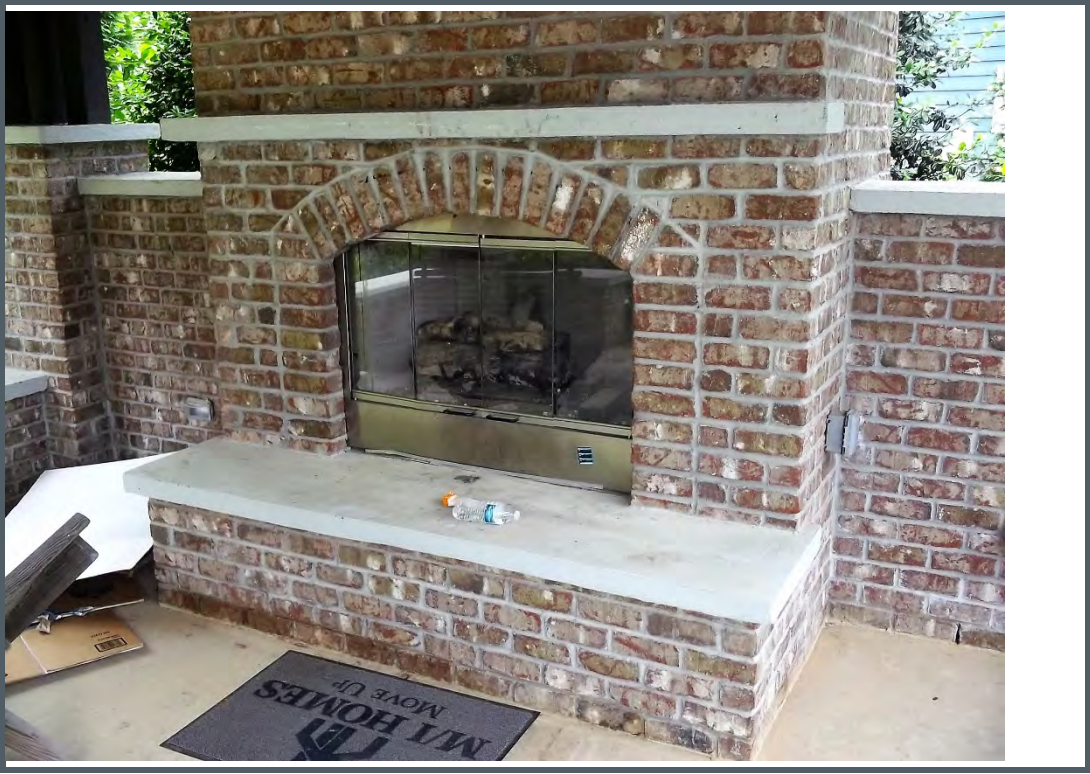
**Photo No.**  
24

**Description**  
View of outdoor  
fireplace at pavilion

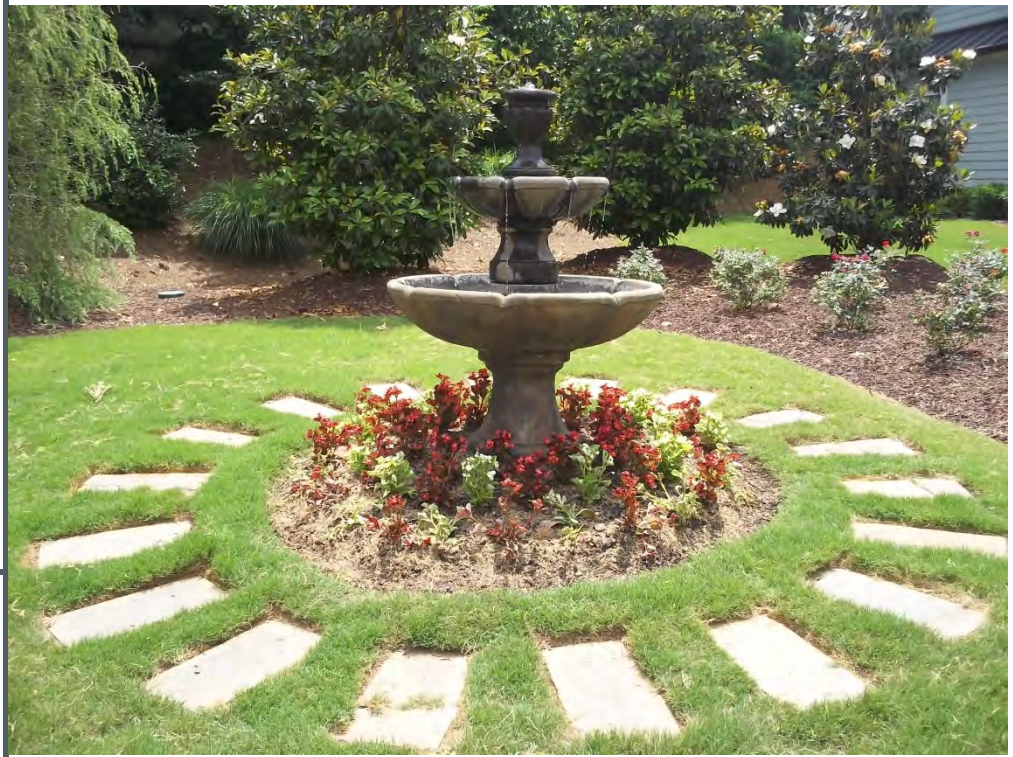
**Photo No.**  
**25**

A fountain feature has been installed in the common area adjacent to the mail kiosk. The system appeared to be running correctly at the time of our inspection; however, we assume any required repairs will be relatively minor and funded from a general operating budget, or the components will be decommissioned.

View of common area fountain
