Drainage Plan

Heritage Woods, Woodcroft

Durham, NC

October 30, 2012 & November 1, 2012
Revised June 22, 2013

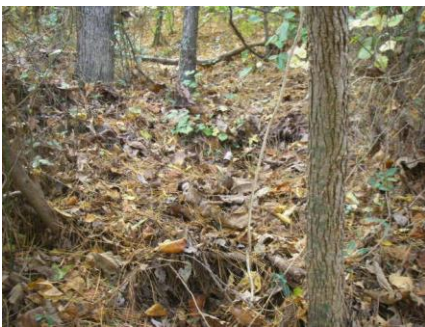
Neglected open channel

1. The to-be newly installed and existing drainage systems should be periodically checked and cleaned as necessary.
 - a. Open stream channels should have new vegetation removed.
 - i. Small trees/saplings should be clipped. Waiting until a tree needs to be “chain sawed” cost additional money to remove.
 - ii. Weed type vegetation may be removed OR sprayed to kill.
 - iii. Recommend open channels receive an annual inspection/cleaning.

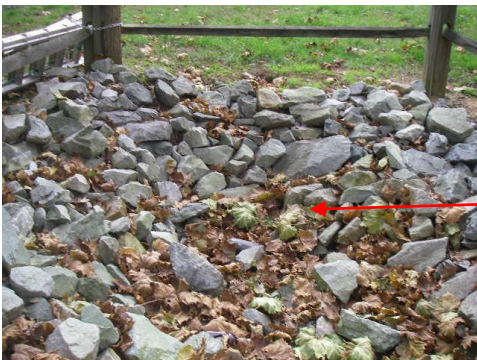
Sample – culvert opening completely covered (culvert opening along Timber Ridge, see attached GIS map)

- b. Culvert outlets should be cleaned by removing silt build-up and checking for/removing foreign debris. Rip/rap should be re-arranged as necessary.
 - i. Recommend that the culvert outlets be checked annually. This may be reduced once a history is developed that indicates less frequent cleaning is required.

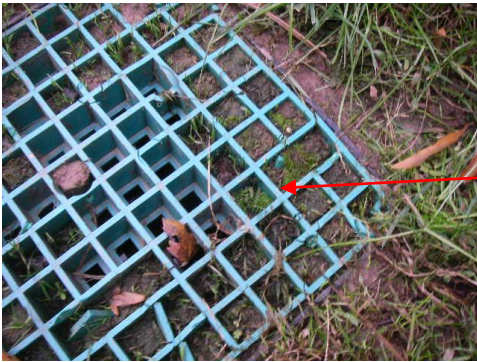
Sample – catch basin
needing cleaning

- c. Collected debris should be removed from catch basins.
 - i. The top grate should have collected debris (leaves, grass clippings, etc.) removed.
 - ii. The cover should be removed and any silt build up removed before it clogs outlet pipes.
 - iii. Recommend that catch basins' grates be checked twice a year. Covers should be removed and silt checked/removed every couple of years. This may be reduced once a history is developed that indicates less frequent cleaning is required.

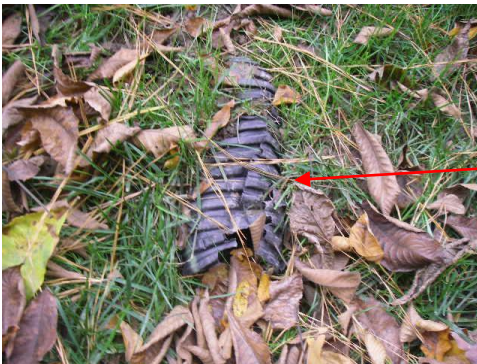
Sample – damaged
(crushed) leader

- d. Gutters need to be cleaned a minimum of twice a year (more frequently if in heavily wooded area). This is critical if leaders (downspout piping) are used. Debris in gutters will clog leaders and the leaders will need to be replaced.
- e. Leader (piping connected to downspouts) outlets should be checked annually to assure their outlets flow freely and the pipes are not damaged. Landscape maintenance personnel should be made aware of the importance of protecting the leader outlets.

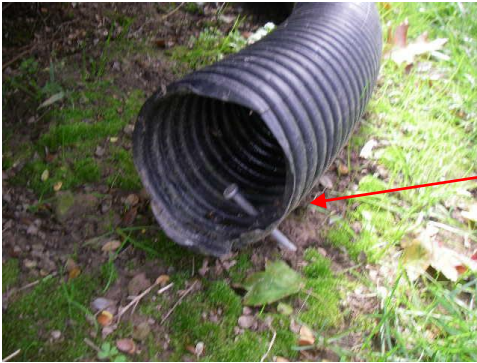
Sample – pinned leader outlet

- f. Leader-to-downspout connections should be checked annually for proper joining. The outlet position should also be checked at the same inspection. Most leader outlets have been pinned (good practice) to assure they are properly discharging.

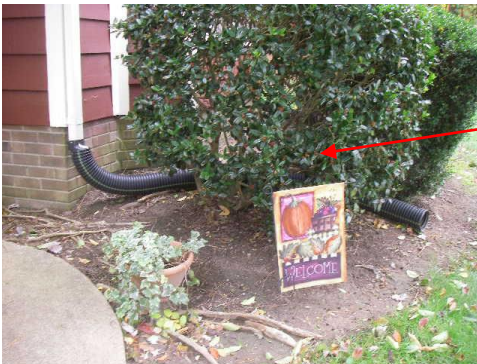
Convert leader to splash block

- g. All landscape coverings that are installed through the years need to be added such that they do not obstruct drainage system components.
2. In some locations, it may be more desirable to use splash blocks in lieu of leaders to direct downspout discharge. Splash blocks will not clog; leaders will. For example, the downspout in front of 100 Wethersfield could be converted to a splash block. Care must be exercised to prevent an erosion issue when using a splash block. Leaders should be used where the downspout discharge needs to be directed; a splash block would not properly direct water. Short leaders are easier to replace if necessary.

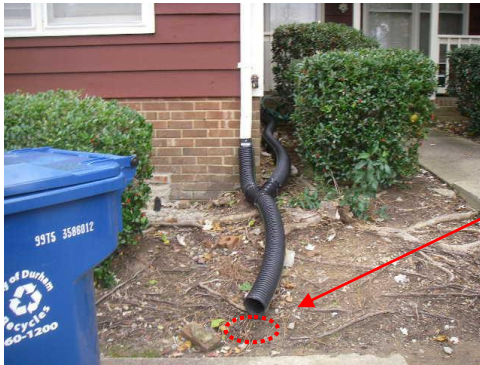
Example: Add light rip/rap at leader discharge to eliminate erosion (in front of 104 Weathersfield)

3. Leader discharge should be checked to assure the discharge does not create an erosion issue. The use of light rip/rap in a small depression at a leader discharge can help break up the water flow and eliminate erosion.

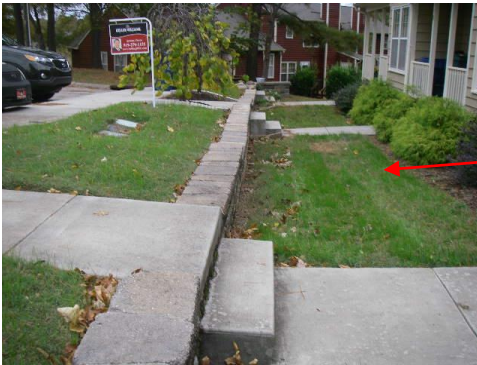
- The soil grade above the small stone wall in front 112 to 120 Weathersfield Drive is sloped towards the wall. Generally, the soil should slope away from the wall; however, based on the surrounding grade this is the best solution. There are four catch basins below the wall to remove water. The area needs to be monitored to assure the water flows over the wall and into the catch basins. Re-seed as necessary.

Area to monitor

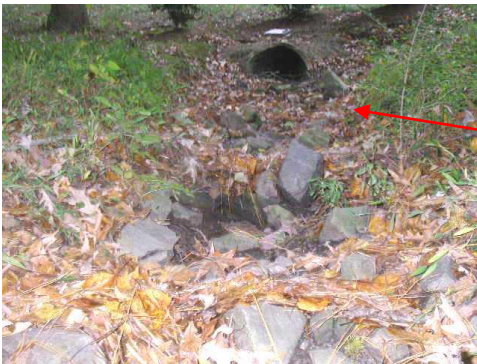
- The outlet channel below the culvert outlet between 122 and 124 Shady Spring Place needs to be lowered. The collected silt has raised the channel bed such that it is partially obstructing the culvert.

Lower channel bed

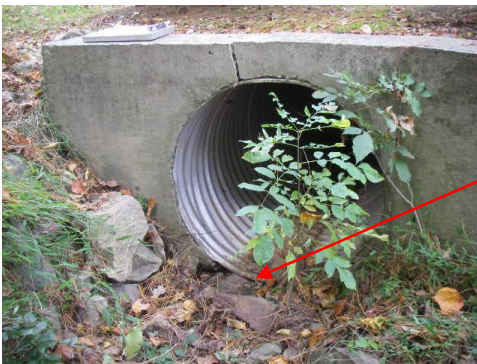
- The culvert behind 128 Shady Spring Place is under-eroded. Hydraulic cement should be added to the eroded area prevent damage to the culvert supporting soils. **This culvert may not be the responsibility of the Heritage Woods HOA.**

Water is running under culvert

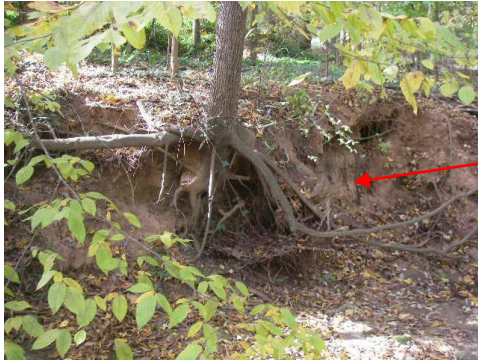
11. There is erosion of the main stream channel behind Heritage Woods, see GIS Map (bottom of Old Maple). Rip/Rap should be installed to prevent further erosion. **This culvert may not be the responsibility of the Heritage Woods HOA.**

Stream bank erosion

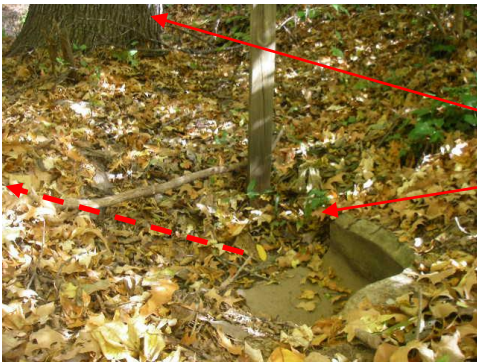
12. The culvert discharge area of the lower Old Maple curb drain needs to be re-defined. Currently, the discharge is directed at a large tree. The channel needs to be cleaned (silt re-moved) and re-cut to go around the tree.

Re-direct away from tree

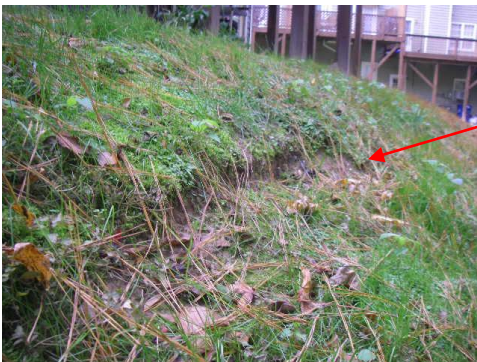
13. Re-grade, mat and re-seed behind 124-136 Shady Spring Place. The lawn in place is a good start; however, there is still erosion occurring and some of the exterior air conditioner units are not properly supported. Re-support of the units should be included.

Sample – erosion
Improperly supported unit

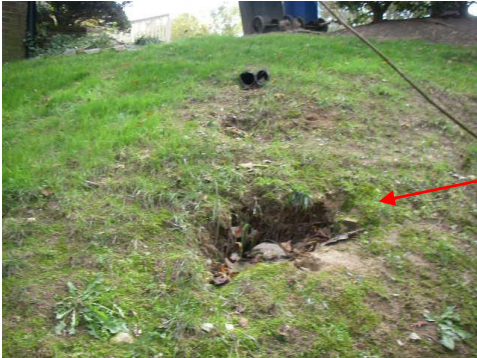
14. Re-grade, mat and seed erosion next to rip/rap channel at the foot of Shady Spring Place.

Re-grade,
matt and seed

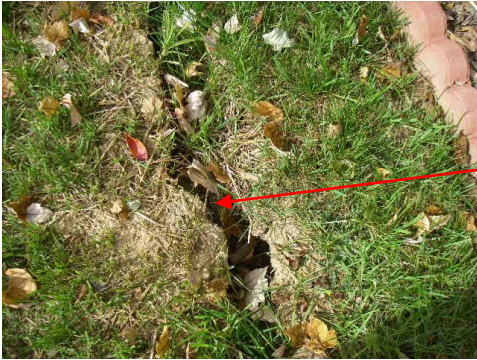
15. Fill void in front of 134 Shady Spring Place. This is a trip hazard.

Fill void

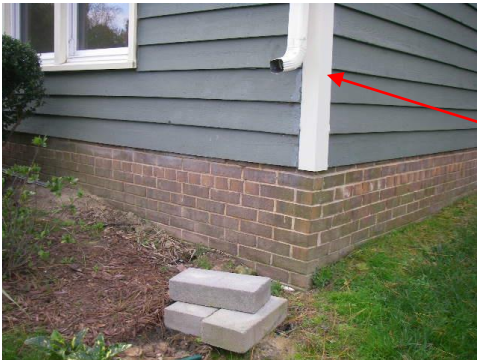
16. The downspout in front of 109 Shady Spring Place is too high and needs to be lowered. A rain barrel was likely previously in place.

Downspout too
high

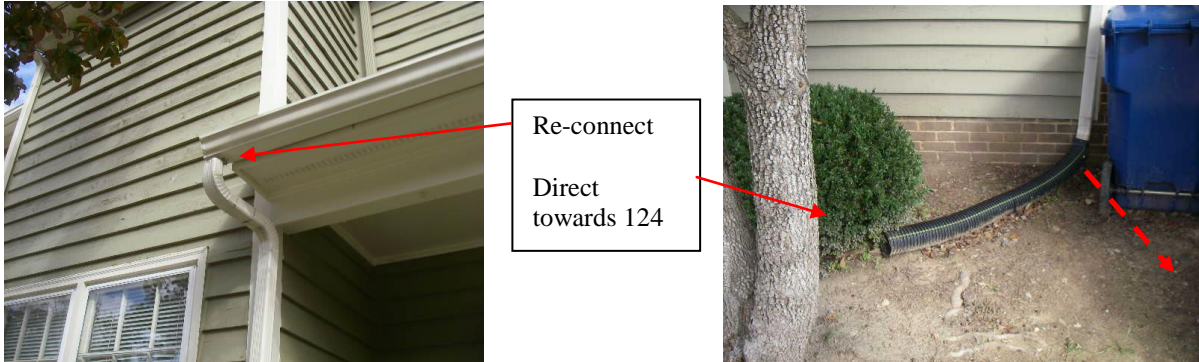
17. Re-connect the downspout to the gutter in front of 126 Shady Spring Place. The leader from the downspout should direct water towards 124.

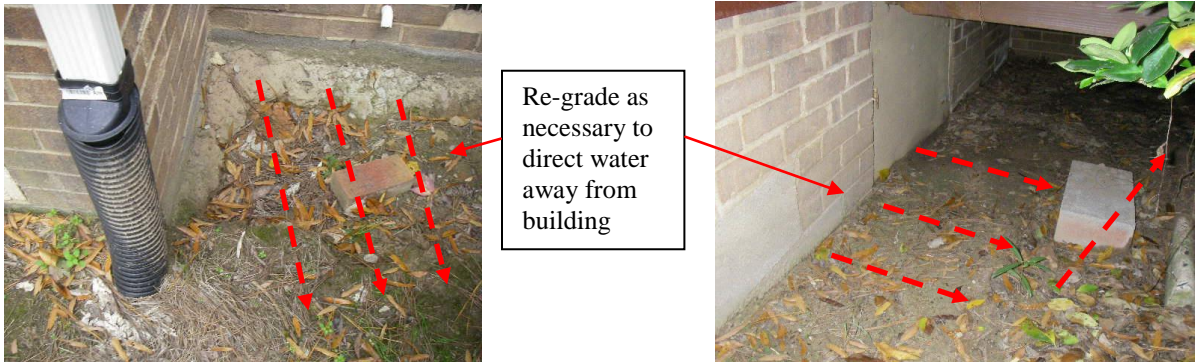
18. Currently, the grade behind 102 Shady Spring Place is such that water is directed towards the crawl space entrance. This area needs to be re-graded to direct water away from the building. Mat and seed as necessary.

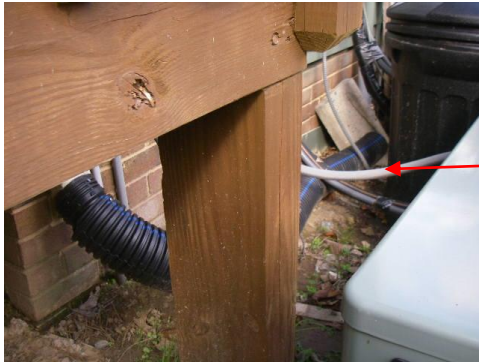
22. The leader behind 102 Old Maple Lane needs to be re-routed to direct water away from the building and the exterior air conditioner units.

Re-route leader

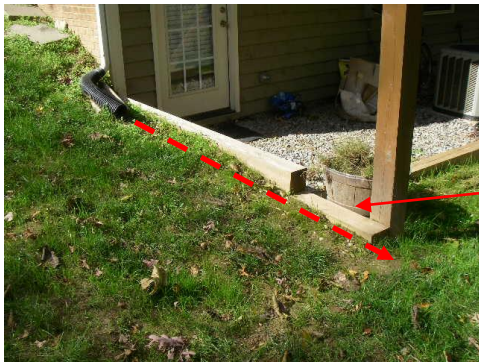
23. Extend the leader behind 106 Old Maple Lane such that water is directed beyond the small wood wall.

Extend leader

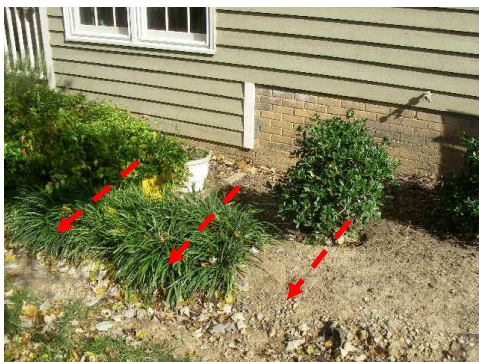
24. Re-grade in front of 110 and 112 Old Maple Lane.

Re-grade as necessary to direct water away from building

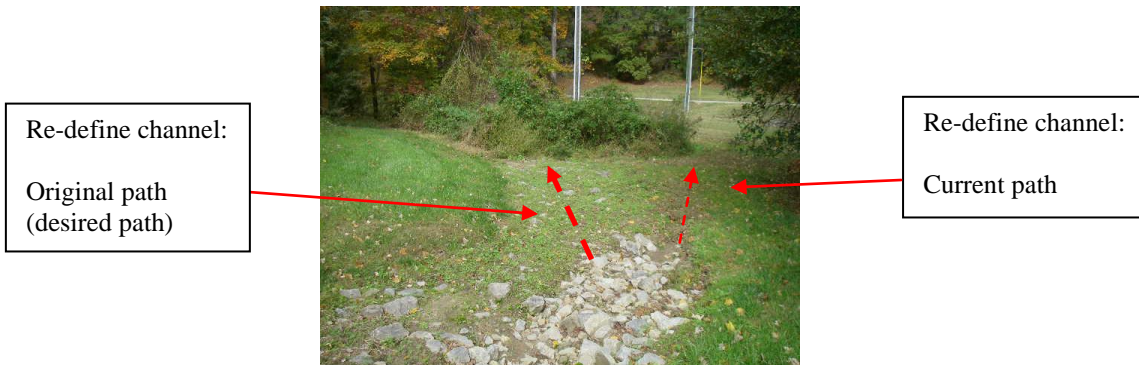
25. The channel behind 114-122 Old Maple Lane needs to be cleaned (silt removed) and the channel re-defined, see Appendix A.

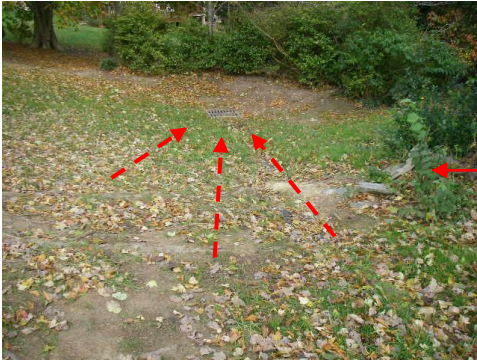
Re-route leader to rear (under step)

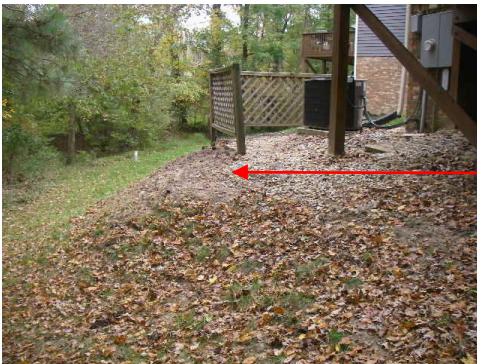
29. The steep hill at the deck landing behind 134 Timber Ridge needs to be stabilized. Grass may work; however, a landscaper should be consulted to determine the best type of vegetation.

Steep hillside to stabilize

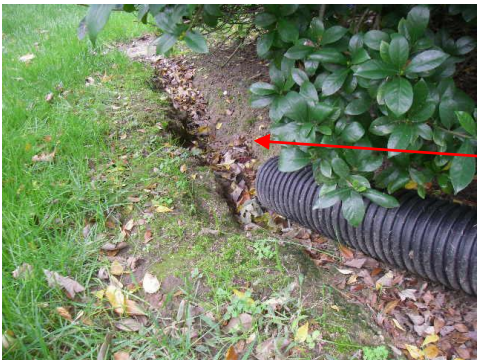
30. Gravel can be added to eroded area (swale) at the leader discharge in front of 126 Timber Ridge Drive.

Add gravel to stabilize

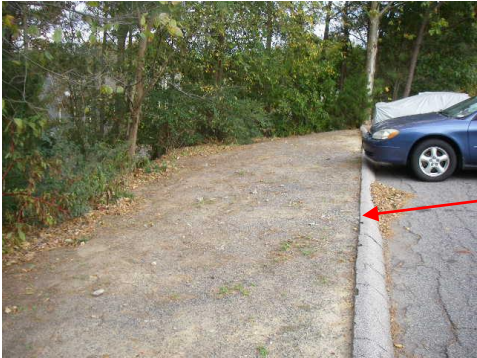
31. Vegetation should be installed in the bare area next to Applecross Court to control erosion and limit the slit in the storm water system. A qualified landscaper should be consulted to assure proper vegetation is installed and maintained.

Bare area
next to
Applecross
parking

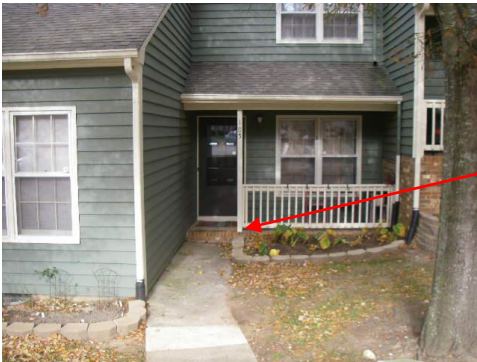
32. The sidewalk in front of 105 Hollow Oak causes water to pond. The sidewalk should be removed and re-installed such that water will be directed to the front yard. Re-grading will be necessary.

Re-slope
sidewalk to
direct water
to front yard

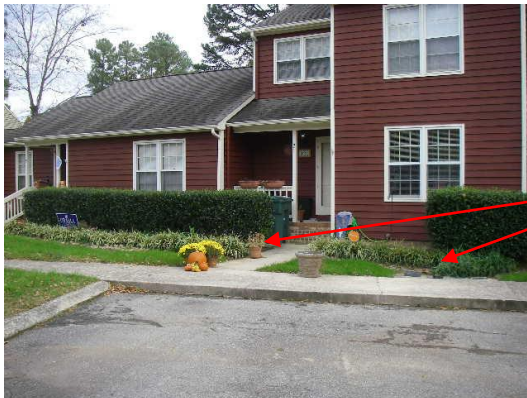
33. The low areas in front of 119 and 121 Hollow Oak should be addressed by adding catch basins as shown below.

Low areas

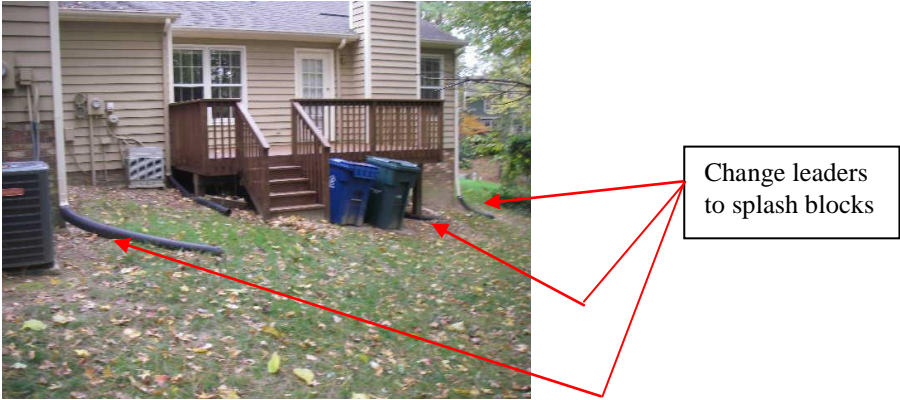
34. Three of the leaders behind 133-129 Hollow Oak can be changed to splash blocks as shown below.

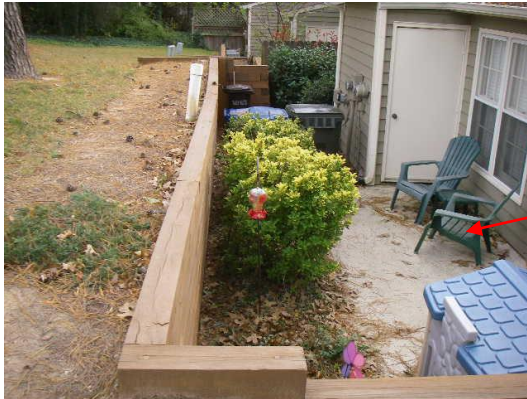
35. The area below the retaining walls behind 111-115 Hollow Oak should be checked for drainage issues. (Does water pond at patios below?) Additional drainage may be necessary. The area was not accessible and therefore, the drainage in this area was not checked.

Check for
ponding water

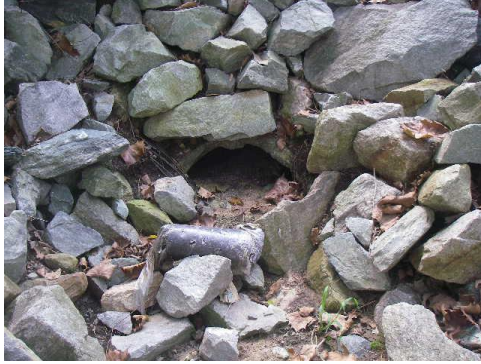
Sample – clogged culvert outlet

- Clean out all culvert outlets.

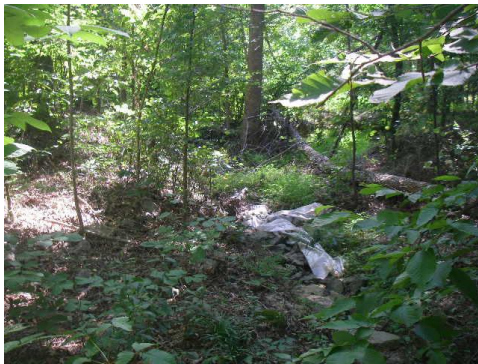
Sample – overgrown open channel

- Clean all open channels – this includes removing small trees that have been allowed to grow, re-establishing the channel by re-grading as necessary and weed killing as needed.

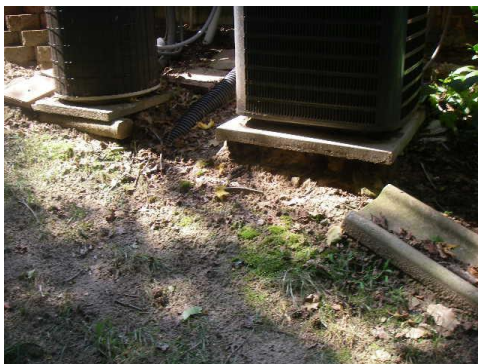
Sample – under eroded air conditioner pad

- Apply erosion control methods behind many of the townhomes. This may involve re-grading and or reseeding with appropriate vegetation. I would recommend erosion control maps where re-seeding is performed

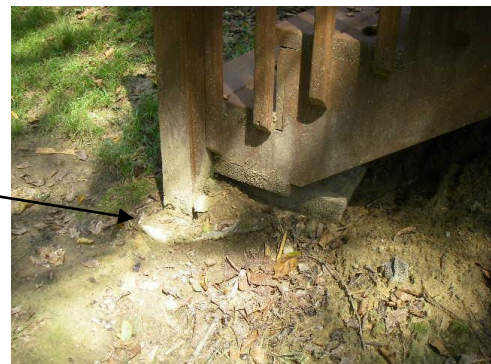
Sample – added support under deck steps

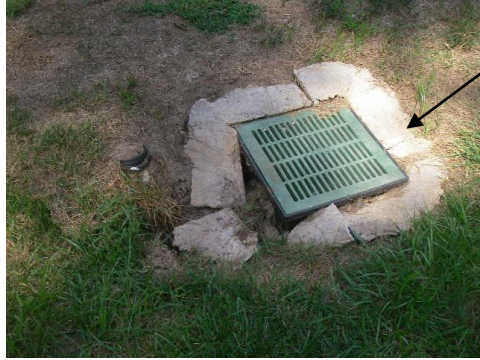
Sample – erosion next to catch basin (below mid point parking area off Long shadow)

- Identify all catch basins – some appear to have been owner installed. In some cases, re-grading may allow for the removal of the basin. The catch basins should be checked for functionality, cleaned as needed and in some cases have the soil around them re-graded.

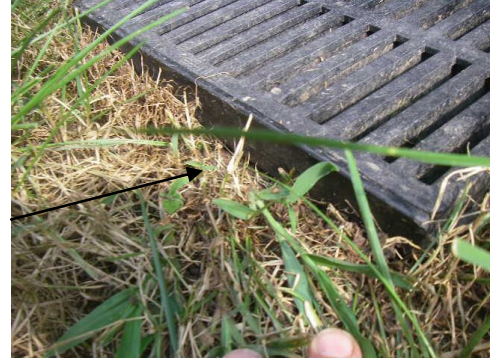
Sample – lip at catch basin – will need re-grading

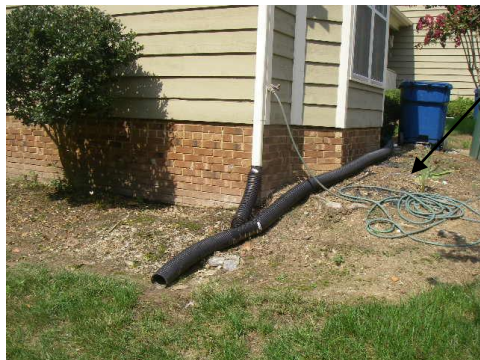
Sample – significant amount of water directed at neighbor's unit

- A comprehensive overview of all the downspout leaders (plastic pipe attached to the downspouts). Each unit should be evaluated to assure the discharge from the pipes is properly directed in regards to the overall drainage of Heritage Woods. Some of the pipe outlets are crushed and or clogged. Burying of the pipes could be done if desired; however, assurance that pipes remain properly positioned needs to be part of the overall drainage plan to assure the discharge remains as desired. The use of the black corrugated pipe makes it imperative that the gutters be kept clean. Gutter debris will clog the pipes and if buried cannot be cleaned.

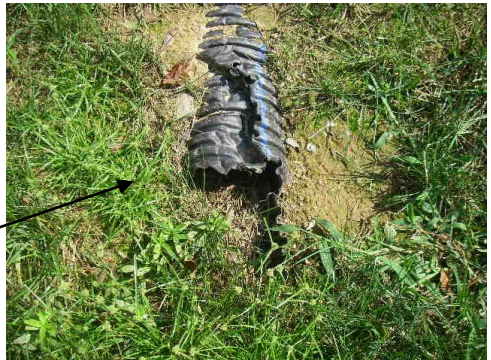
Sample – crushed/clogged leader outlet

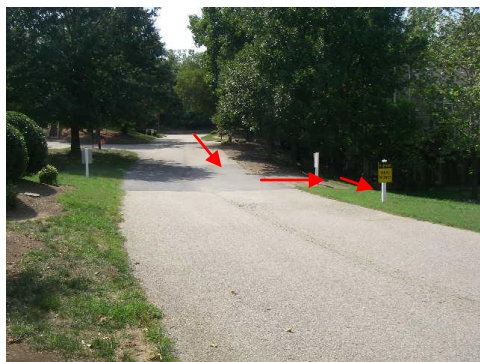
- Due to the roadway slope, the water at along Weathersfield between Timber Ridge and Long Shadow is directed to run over the hillside above the culvert outlet. Curbing could be added to direct the water to a rip/rap lined channel that could be added to direct the run-off into the open channel at the culvert outlet.

Water currently runs over hillside, will cause erosion

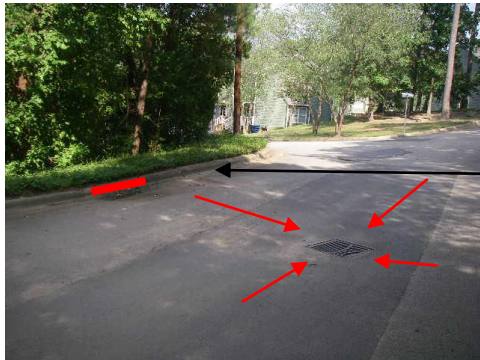
- The roadway grade is such that very little water is entering the catch basin in Weathersfield just above Old Maple (between Long Shadow and Old maple – closer to Old Maple). A curb drain or regrading of the roadway would reduce the volume of water on Old Maple.

Add curb drain or re-grade roadway

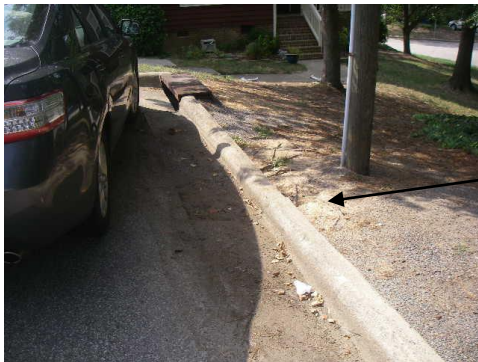
- The curbing and asphalt at the southwest corner of Apple Cross has settled. As a result, water is no longer directed into the curb drain. The water is jumping the curb and eroding the hillside below. The paving and curbing should be “cut out”, re-graded, and replaced.

Settled curb/paving

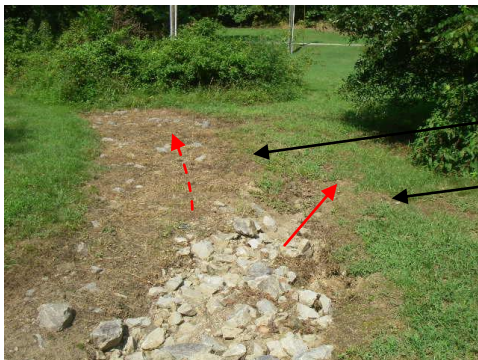
- The open channel below Old Maple and Shady Spring has silted such that the water is now making a new channel. The original channel needs to be cleaned, re-graded, and re-rip/rapped. It may be possible to save the original rip/rap and re-used it.

Original channel
Direction water now flows

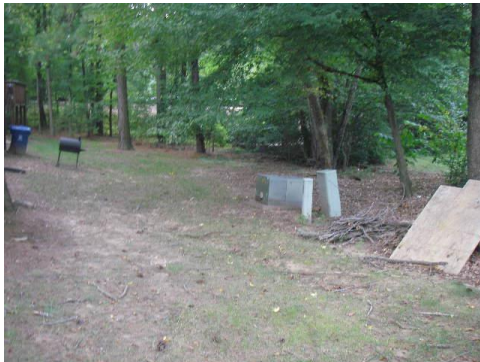
- The open channel behind upper Weathersfield and behind Oak Hollow has become a dumping ground for grass clippings and leaves. This has disrupted the water flow in this area. The area needs to be cleaned and the channel re-established.

Re-generate original open channel

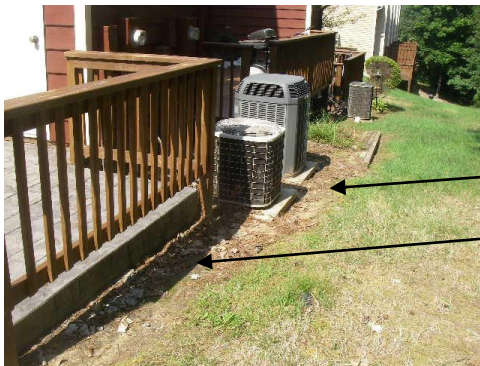
- Two raised patios behind the upper Weathersfield building (east side) have created a drainage swale that is causing erosion under the adjacent unit's air conditioner pad. The water should be re-directed to prevent erosion at the air conditioner pads.

Erosion at pad

Raised patio

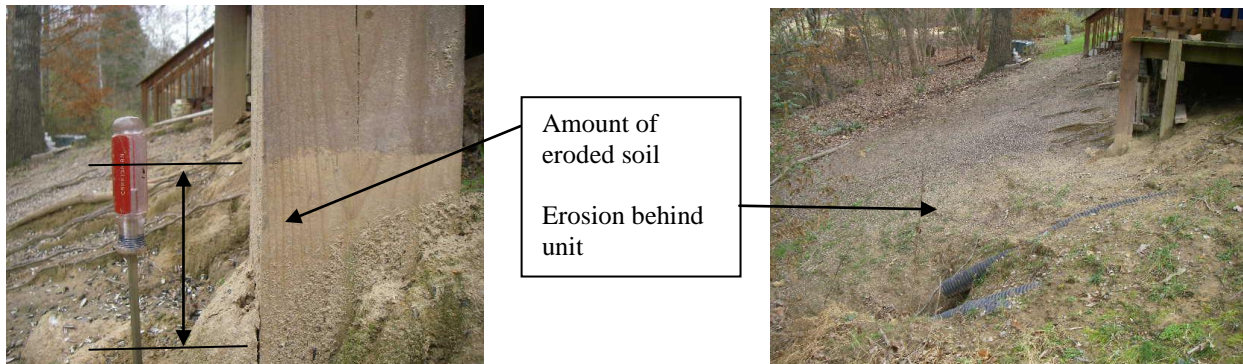
As noted above, there has been erosion around the side/rear of the townhome unit located at 142 Long Shadow Place. Based on the paint line on the upper deck post at the rear corner of this unit, gradual erosion has caused soil to wash away, thus nearly exposing the post footer. At this rate of erosion, the footer would be exposed in approximately one year. There was also significant erosion at the downspout leader discharge in the side yard next to the unit.

Based on the rate of erosion, this area needs to be stabilized. It is likely additional soil will be removed with each rain event. Additional soil should be added to return the soil height to the original position based on the painted line on the deck post. Once the soil grade has been re-established, the area needs to be stabilized. Planting/erosion control matting should be placed on top of the added soil and tacked in place to prevent additional erosion for the short term. Appropriate vegetation needs to be planted/seeded to provide a long-term stabilization of the area. A landscape architect could be consulted about the best vegetation to provide the stabilization needed and the aesthetic look desired.

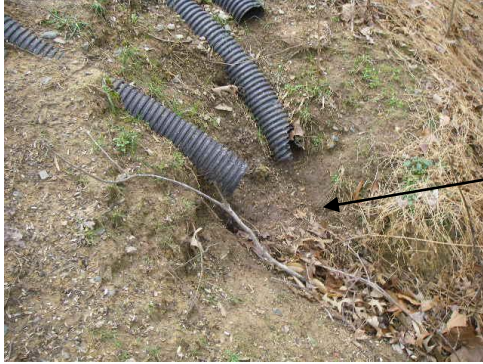
Place rip/rap at
leader discharge

Rip/rap (large stones) should be installed at the downspout leaders noted above to prevent additional erosion in this area.

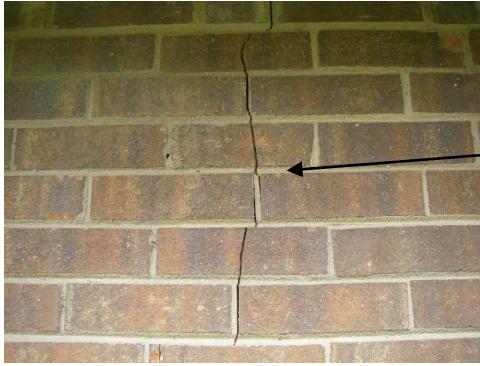
There is a vertical crack in the side foundation wall of the townhome at 142 Long Shadow. The exposed floor framing in the area of the crack was tight and did not indicate any significant movement from the “as built” condition. The dry wall on the walls in this area of the townhome did not indicate any significant movement. Based on these observations (the crack is relatively small, there was no apparent movement of the house framing and no significant corresponding cracking of interior walls in this area), the exterior foundation crack is most likely a settling/soil movement type crack common for this area of North Carolina. The Triangle area of North Carolina is known for its expansive clay soils (soils that expand significantly with moisture and contract significantly with lack of moisture). These soil conditions tend to create more foundation cracks than more stable soils. The crack should be monitored for movement. No structural repairs are required at this time. If the condition of the cracks changes, a re-evaluation will be necessary.

Crack in foundation

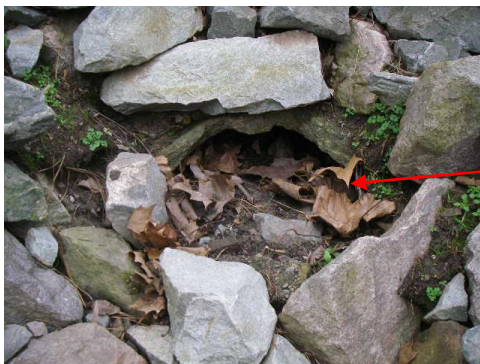
As noted in the June 2010 referenced Raymond Engineering report, the upper creek bed is in relatively good condition. The only additional work necessary in this area is cleaning out the discharge of the culverts. The outlets are clogged with silt and other debris. Of course, regular maintenance of this area will be required: keep the culverts clean and keep weeds and other debris from collecting in the dry creek bed. These items will alter the water flow such that it will no longer be in the established creek bed. This condition can cause erosion and silt build up downstream. Periodically check water flow to make sure it is in the creek bed and adjust as necessary if the water is not flowing into the creek bed.

Culverts needing cleaning

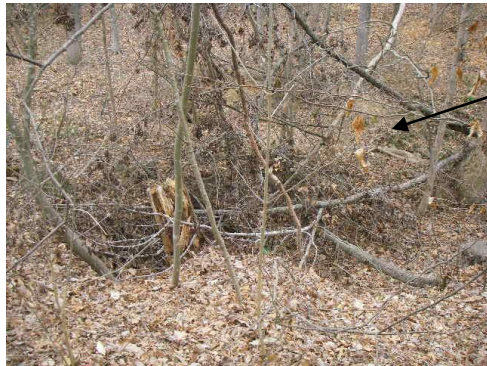
The middle and lower sections have improved since the 2010 inspection. Some of the larger trees have been removed and some collected debris has been removed. Additional work is required to assure the water flow follows the established rock (rip/rap) lined creek bed. The rock lining prevents erosion, which in turn minimizes the buildup of silt. All the saplings in the area should be removed and the grade altered such that the water flows in the established creek bed. Additional rip/rap will be required in some areas. Landscapers should continue to not blow leaves into the creek bed. These only cause small dams, which causes the water flow to jump the creek bed.

Saplings and limbs to be removed

Rip/rap (rock) in eroded depression

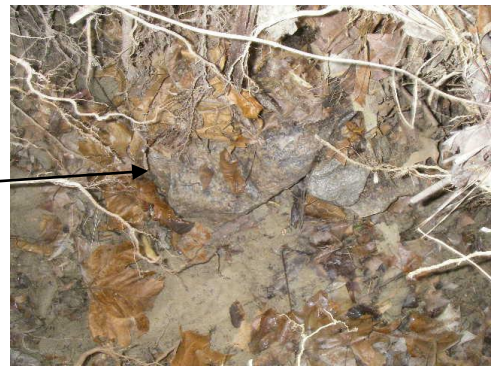
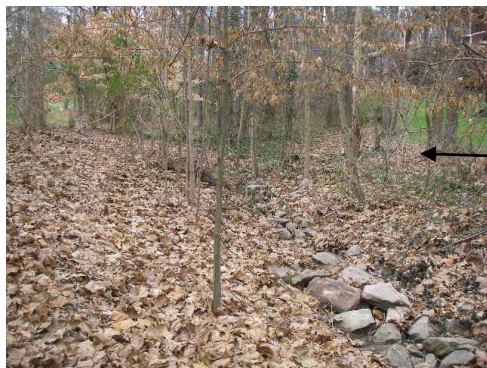
Saplings to be removed
