Reserve Study

Heritage Woods

Durham, NC

Inspection Date:
September 22 & 23, 2008

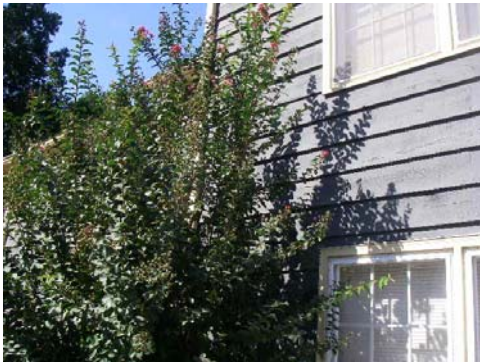
- **Observation:** Vegetation should be kept clear of the buildings. Vegetation close to buildings holds moisture close to the building, and provides an entryway for insects.

Sample of vegetation too close to buildings

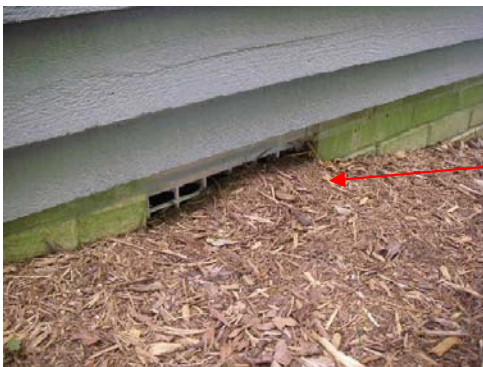
- **Observation:** Many of the foundation vents were closed and some were blocked. Keeping vents opened, except in extreme cold weather, will help the crawl spaces to stay drier. This will reduce the potential of moisture damage and or mold/mildew on the floor framing.

Sample – blocked vent

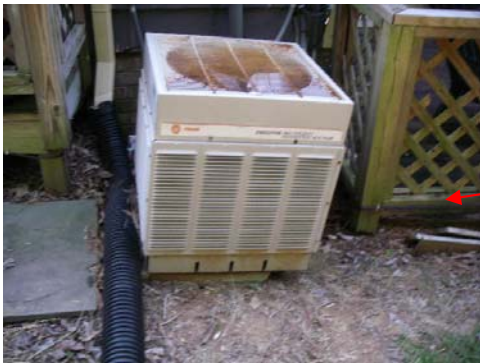
- **Observation:** There were a couple of leaning exterior heat pump units. The units should be re-leveled to prevent damage to the units.

Sample – leaning unit

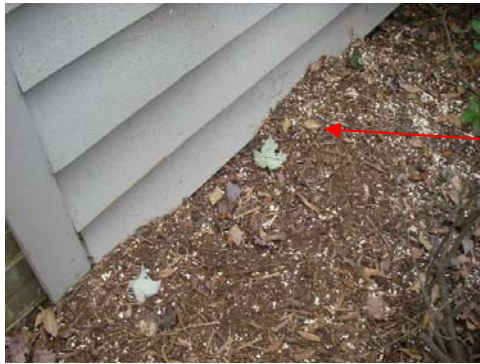
- **Improve:** The siding/trim in several locations is in contact with the landscape covering (mulch). The siding/ground should be modified such that there are a couple of inches of clearance between the ground and the siding. This condition may attract wood destroying insects and promote rot. The clearance will provide an inspection gap to monitor for the presence of wood destroying insects.

Sample – mulch too close to siding/trim

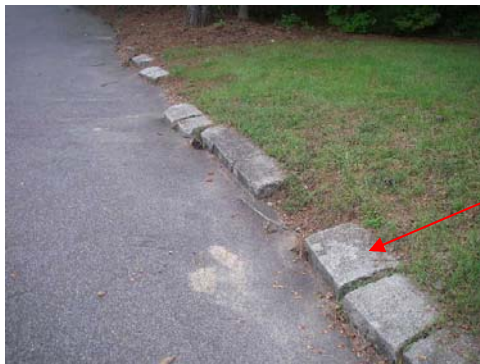
The curbing along the side of Timber Ridge (next to Highgate Road) is cracked and missing. The slope of the grade in this area of the complex does not warrant a curb. The curb can be repaired; however, it is not a necessary repair.

Missing/broken curb, no repair necessary cover

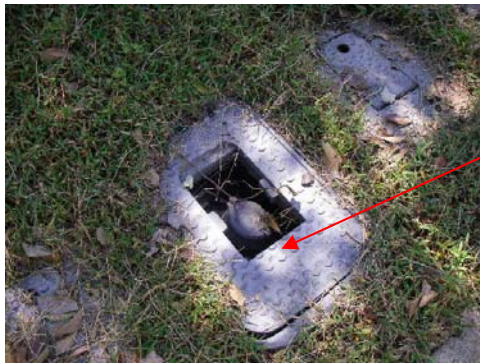
- **Repair:** A water meter cover in front of Weathersfield Building containing Units 100-110 is missing. This is a safety issue (cover needs to be re-installed). This item is not in Table II as the water company should be responsible for replacement.

Missing cover

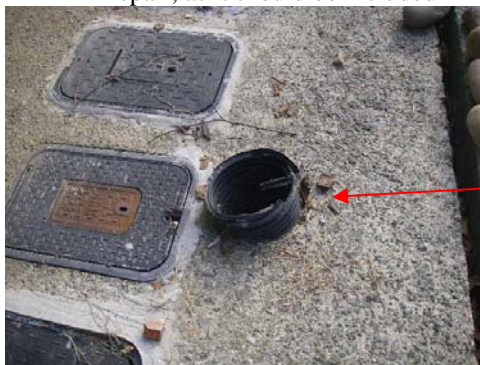
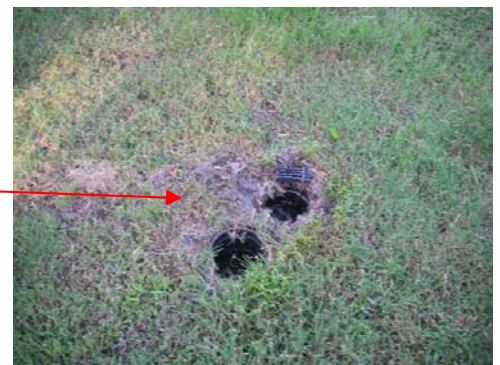
- **Repair:** There are open pipes in front of two buildings in Hidden Oak (building containing units 116- 119 and units 101-109). These need to be properly capped as this is a safety issue (trip hazard). There is no cost estimate for this repair, as it should be included in routine maintenance.

Pipes to be properly capped

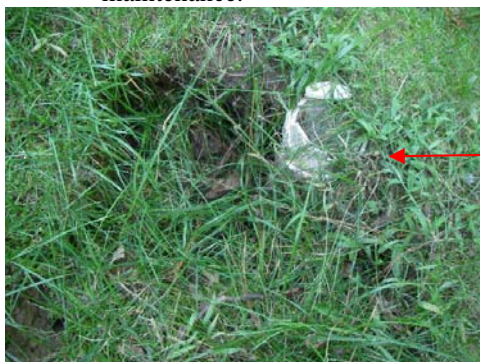
- **Repair:** There is an open sewage pipe and erosion behind Shady Springs building containing units 130-136. This needs to be repaired as it is a safety issue. There is no cost estimate for this repair, as it should be included in routine maintenance.

Open sewage pipe and erosion

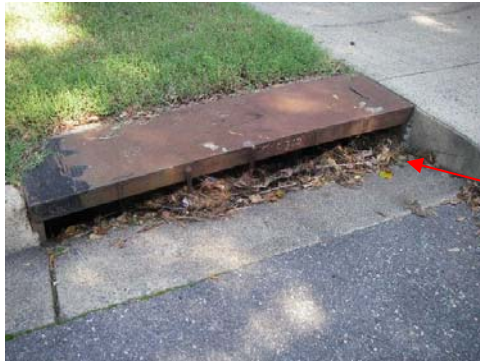
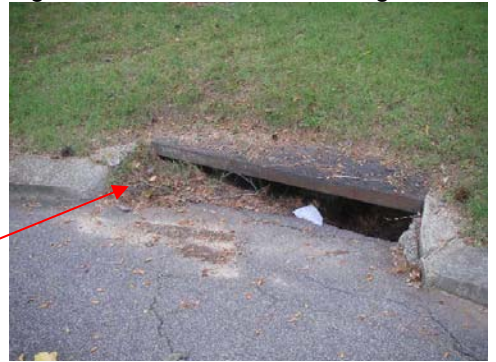
- **Repair:** Storm drains, a catch basin and a culvert need cleaning. A couple of storm drains (see below) should be cleaned (all should be checked for silt build-up). The catch basin on the downhill side of Weathersfeild building containing units 112-120 needs to be re-graded, as the catch basin lip is above grade. The exit of the culvert behind Long Shadow building containing units 141-147 should be cleaned as necessary. The collected debris will cause the drains/culverts to back up. The raised culvert will not collect water as intended.

Sample of storm drains needing cleaning:
Shady Springs
Timber Ridge

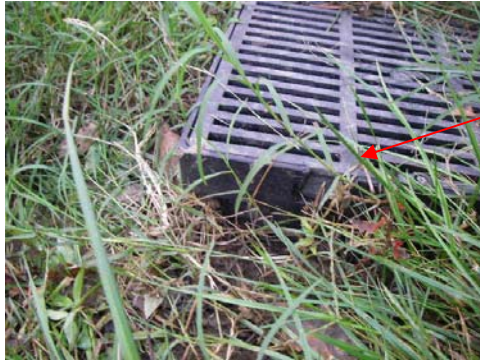
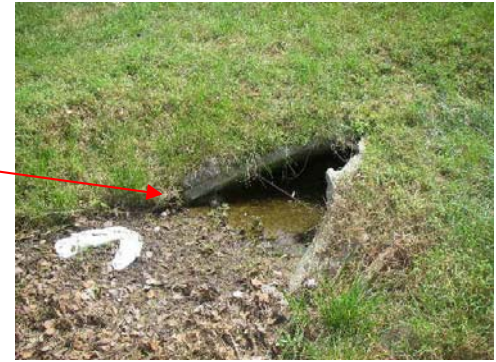
Catch basin raised lip, Weathersfield
Culvert exit needing cleaning, Long Shadow

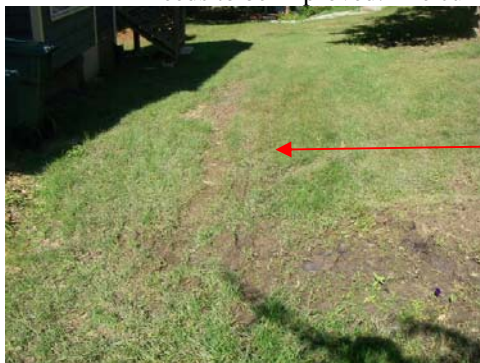
- **Repair:** The grading between Weathersfield building containing units 101 – 109 and building containing units 111 – 121 needs to be improved. The current grade directs water to building containing units 101-109.

Area to be re-graded

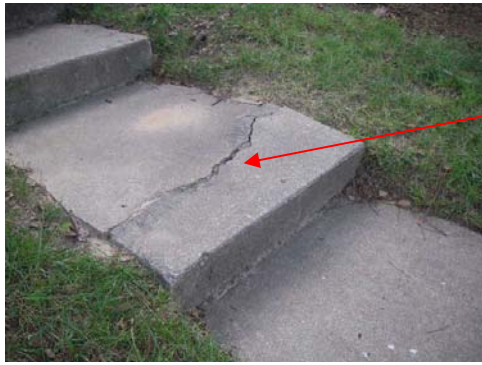
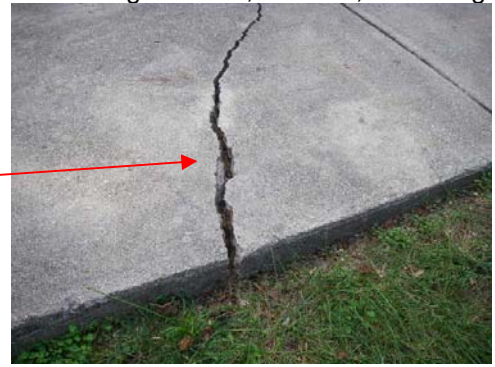
- **Repair:** The sidewalk in front of Hollow Oak building containing units 106 - 114 is uneven and could be a trip hazard. The sidewalk in front of Timber Ridge building containing units 118- 126 is also cracked such that it will likely worsen over time. There is no cost estimate for this repair, as it should be included in routine maintenance.

Uneven sidewalk
Cracked sidewalk

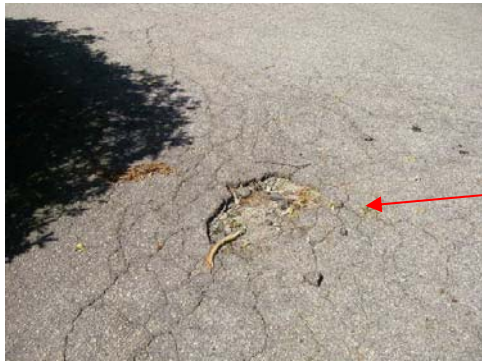
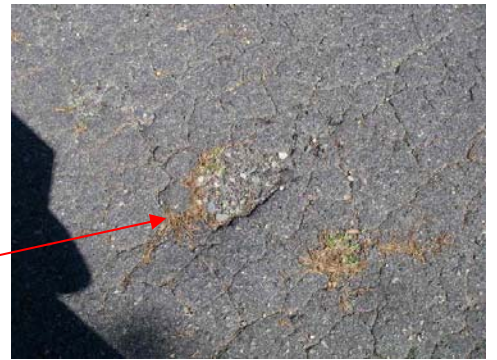
- **Repair:** The roadways at the following locations need minor repair: lower end of Weathersfield, in front of Shady Springs building containing units 106 – 112, in front of Old Maple building containing units 100 – 104, lower end of Old Maple, in front of Long Shadow building containing units 106 – 114, in front of Timber Ridge building containing units 134 – 138, and in front of Apple Cross building containing units 101 – 105. These areas should be patched with asphalt.

Sample – areas
needing
patching:

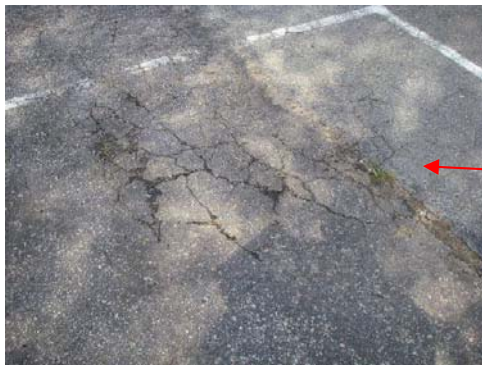
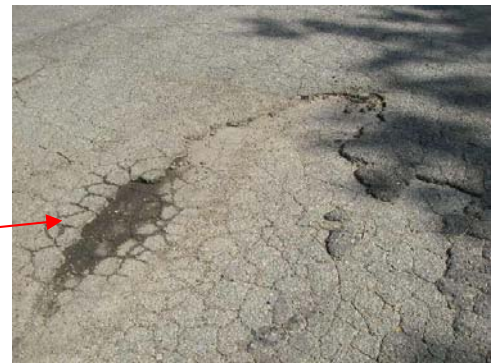
Sample – areas
needing patching:

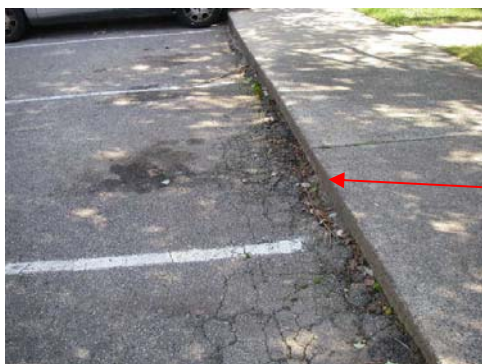
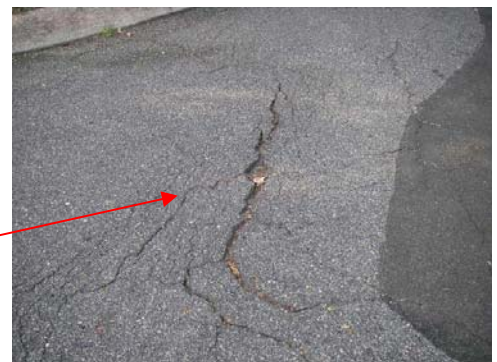
Sample – areas
needing patching:

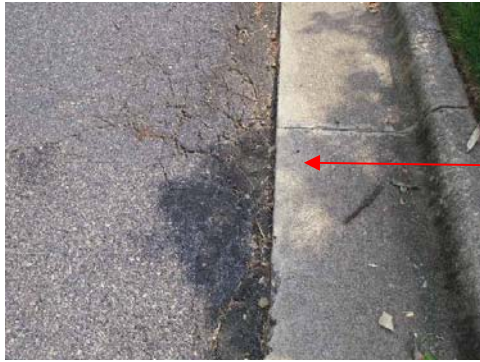
Sample – area needing patching:
Apple Cross

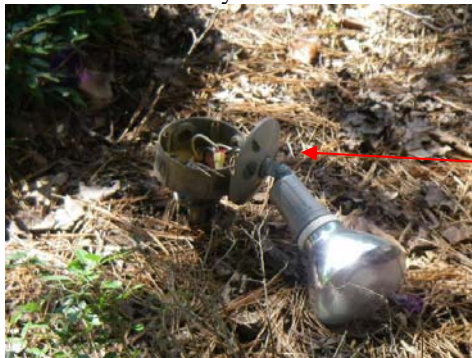
- **Repair:** Several mailboxes were loose to their supports. This is considered normal routine repair and is not included in Table II.
- **Repair:** The front entrance signage light on the east side is broken. This is a safety issue and should be repaired immediately. This is considered normal routine repair and is not included in Table II.

Broken light

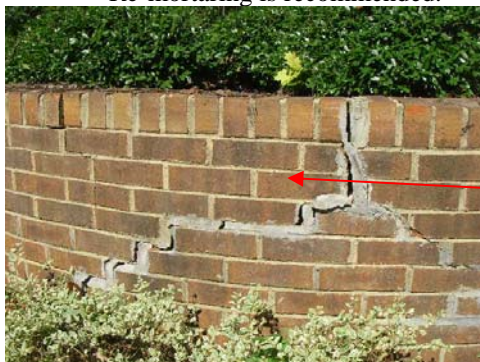
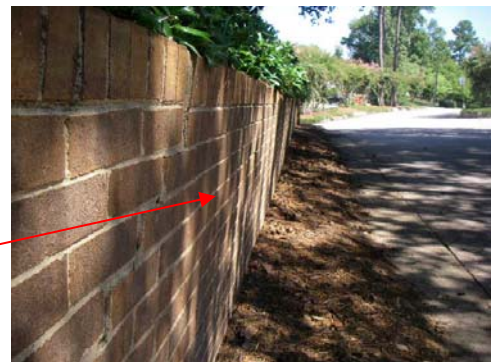
- **Repair:** The front entrance retaining wall is in need of repair. The west wall has split and the wall is leaning. A structural repair could restore the structural integrity and avoid wall replacement. A licensed structural engineer should be consulted for repairs. Estimate in Table II assumes partial re-build with strengthening to preclude replacement of the wall. The cracking in the east side walls is more cosmetic and does not require structural repair. Re-mortaring is recommended.

Entrance wall – area needing repair
Leaning wall

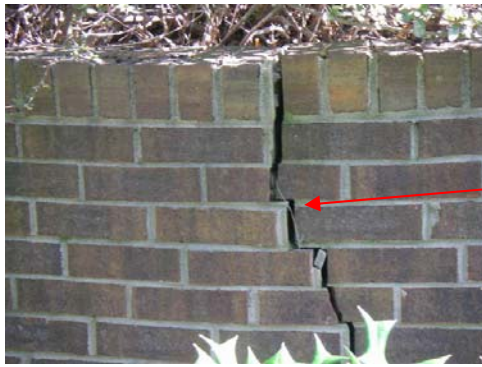
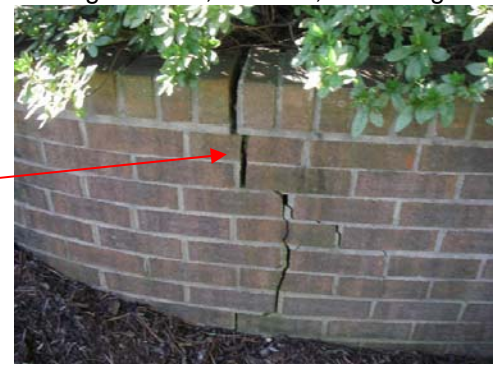
Re-mortar walls

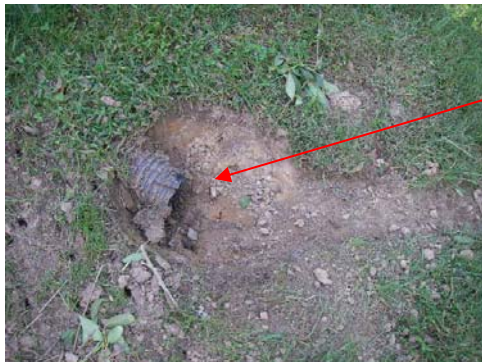
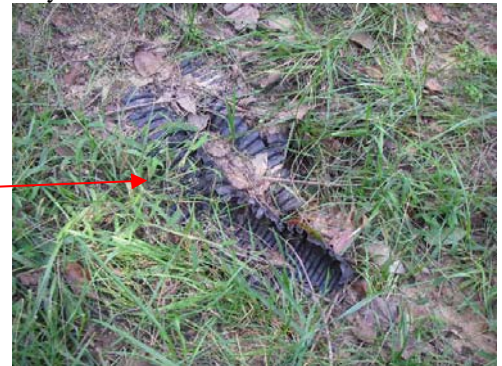
- **Repair:** There was drainage work in process during the inspection. Some of the downspout leaders exit into a hole placed in the soil. Drainage from the hole should be employed. This was the case in several locations throughout the complex. There were damaged leaders at other locations. It is assumed that this is work in process: all damaged leaders are being addressed and proper drainage will be added as necessary.

Leader existing into hole

Sample – damaged leader

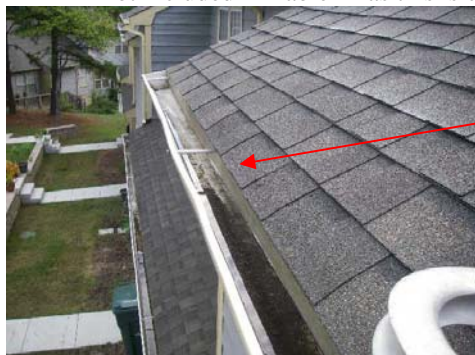
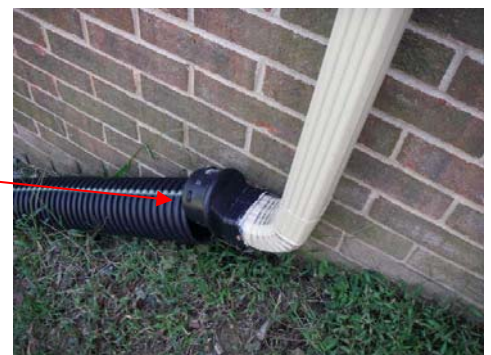
- **Repair:** A qualified repair person should review the gutters and downspouts for the following: there were a couple of loose gutters, downspouts not connected to gutter, and leaders (pipes) not connected to downspouts. The cost is not included in Table II as this is considered normal maintenance.

Loose gutter

Poor downspout to piping connection

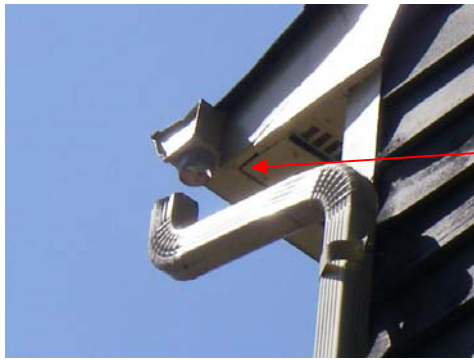
Disconnected downspout

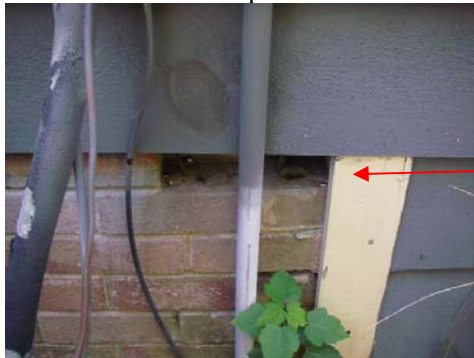
- **Repair:** There is a missing foundation brick in the rear of Weathersfield building containing units 111 – 121. This needs to be replaced. There is no cost estimate for this repair, as it should be included in routine maintenance.

Missing foundation brick

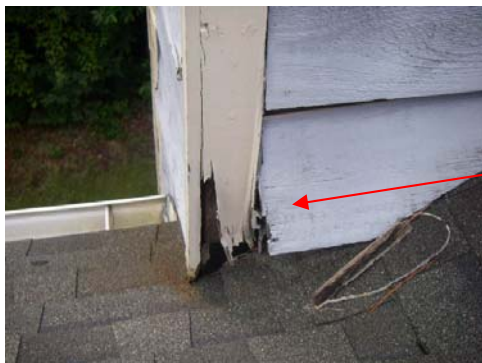
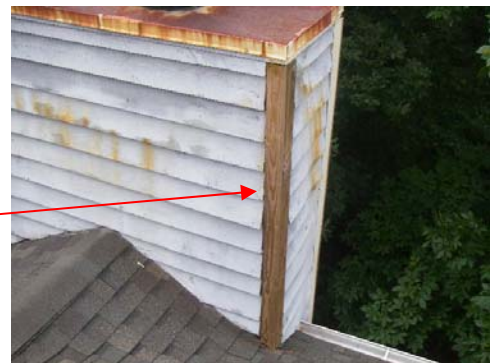
- **Repair:** The wooden chases (chimneys) are in need of repair. Seven roofs were inspected by walking the roofs. This allowed for close examination of 32 chases. All 32 were in need of some repair. Based on this evidence, it is assumed that all 160 chases will need some repair. While performing the inspection of the building exteriors, it was noted that there was damage (rot) at the bottom of some of the chases. This could imply that the damage travels over the entire height of the chase. The decks in these cases will need repair and, as such, chase repair of this larger magnitude is included in the deck replacement. The cost projected is based on an average cost for repair to each chase times all 160 chases. The photographs below provide a representation of the damage noted. A rough estimate of \$400 per chase was used in Table II to provide a budgetary estimate. A contractor should be contacted to quote this effort. Some chases will need extensive work and some will need minor repair.

Samples of Chase conditions:
Rot
Replaced wood, not painted

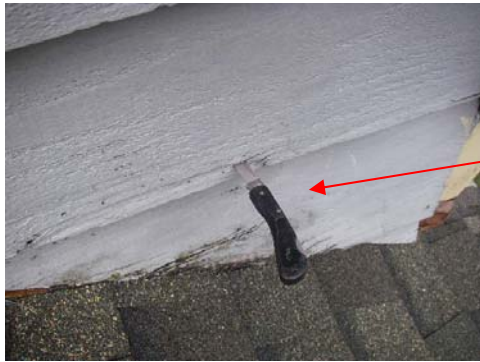
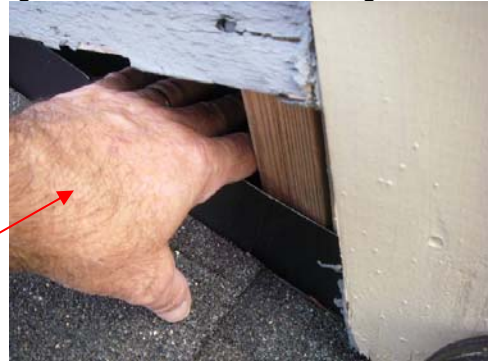
Samples of Chase conditions:
Siding rot (engineer's knife shown)
Missing siding (hand inside chase)

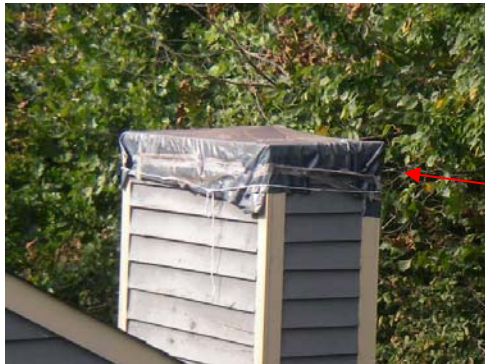
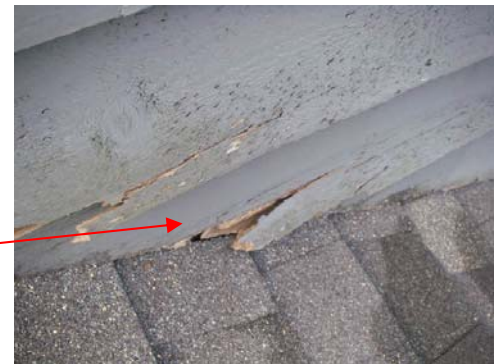
Samples of Chase conditions:
Tarp on chase
Damaged loose siding

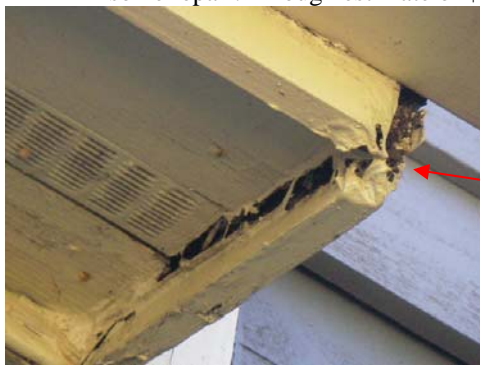
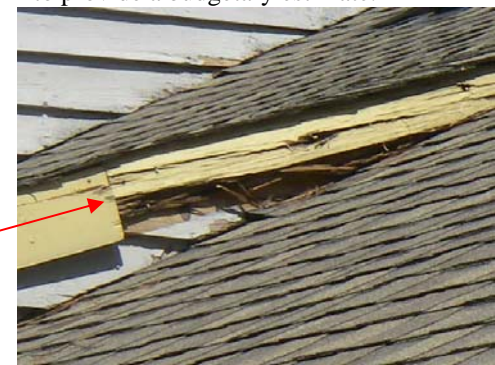
- **Repair:** There are exterior repairs necessary on several buildings. In some locations, paint was applied over rotten wood (windowsills). A competent contractor should review each building and replace damaged wood. Several of the windows in the Apple Cross buildings are in need of re-glazing. This cost is included in the estimate in Table II for windows in Apple Cross building. A contractor should review and provide a quote/estimate. All buildings need some repair. A rough estimate of \$1500 per building was used in Table II to provide a budgetary estimate.

Samples of damaged exterior:
Eave end rot
Rake trim rot

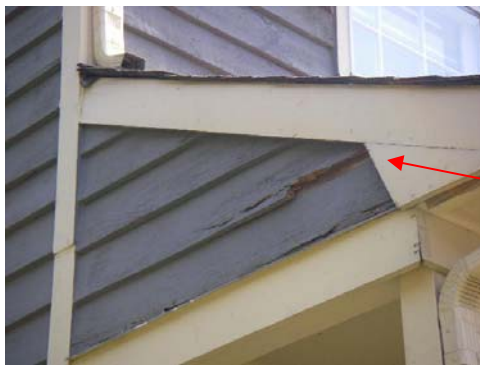
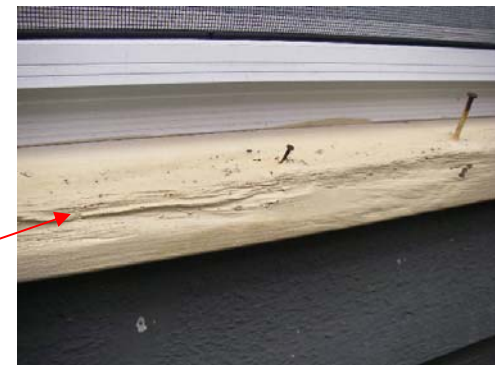
Samples of damaged exterior:
Siding rot
Rotten windowsill painted

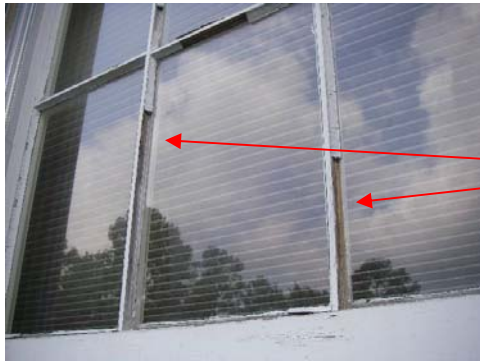
Sample – missing glazing

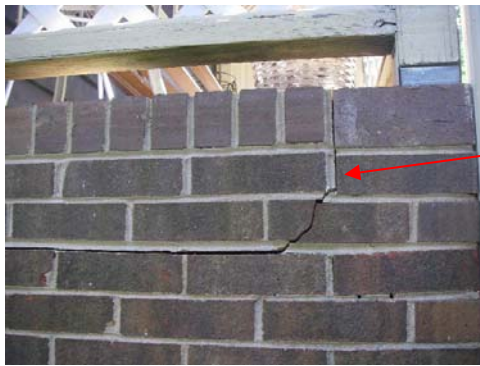
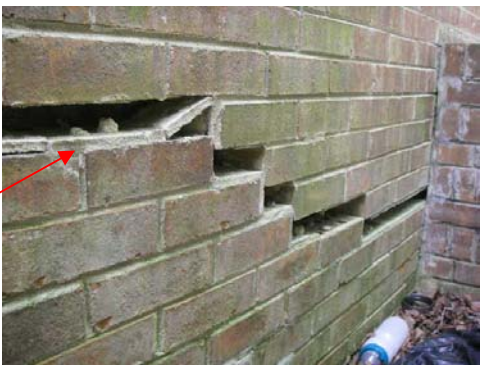
- **Repair:** There is cracking in the front porch of Shady Springs Unit 136 and Long Shadow Unit 129. The condition needs to be reviewed by a licensed structural engineer to determine the cause and the appropriate repair.

Cracking:
136 Shady Springs
129 Long Shadow

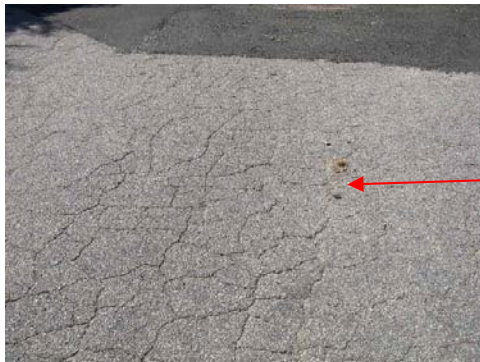
- The pavement is cracking in various locations. As there are several areas in the pavement needing immediate repair as noted above. Sealing the pavement is recommended to extend the life of the pavement. The sealing is recommended to be done two years out. The sealing has an average life of 5 years. Table III assumes repaving is to be performed 5 years after sealing is applied. The paving should be evaluated 5 years after sealing, as re-paving may be postponed a few years beyond the 5-year sealing life.

Sample of pavement

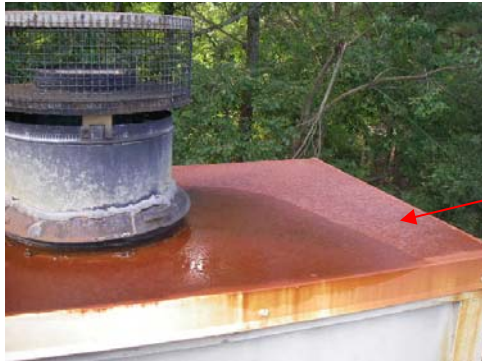
- The Chase (chimney) caps are heavily rusted. Painting with a rust preventative paint will extend the life and be less costly than replacement. Painting has been included in lieu of replacement.

Sample of chase cap

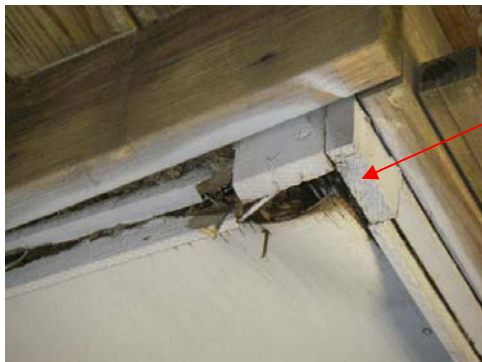
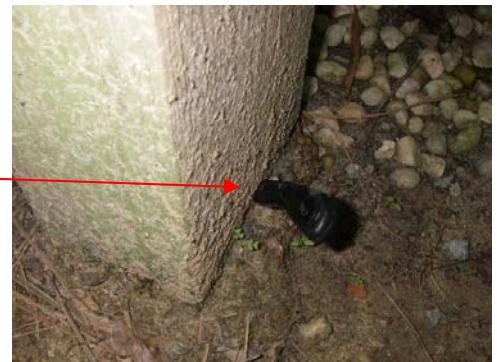
- Most of the decks are in need of repair or replacement. The decks were most likely constructed without proper attachment to the buildings and without proper flashing. In some cases, the attachment to the cantilever chase (chimney) was improper in that the chase was not designed for the attachment of a deck. The higher decks are not properly cross-braced. Some of the step attachments were not properly supported. Several of the original support columns are rotten. It is recommended that a separate quotation from a contractor be obtained for deck repair/replacement, as the cost can vary significantly. The reserve study assumes 152 decks will be replaced:

Rot in chase supporting deck
Rotten support column (engineer's knife shown)

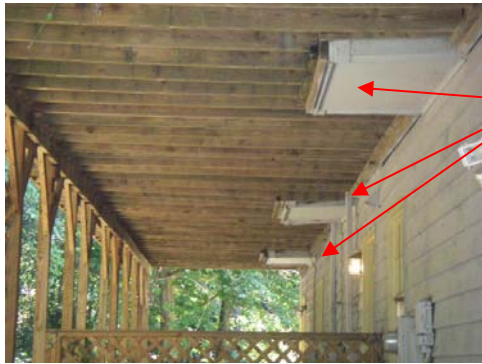
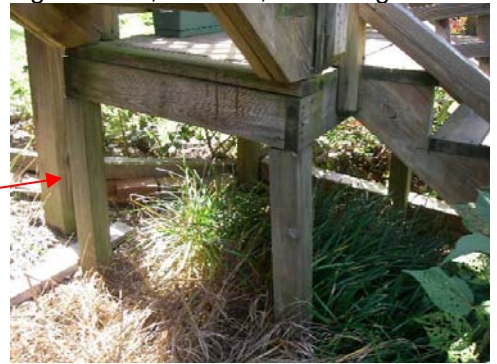
Chases dropped due to applied deck load
Leaning step landing support

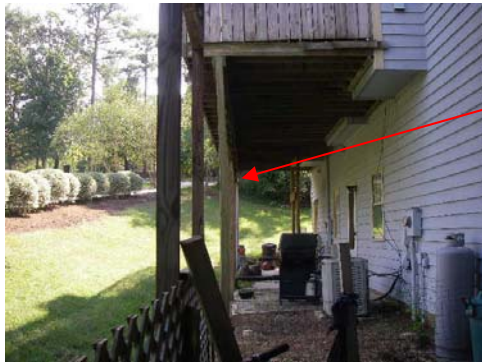
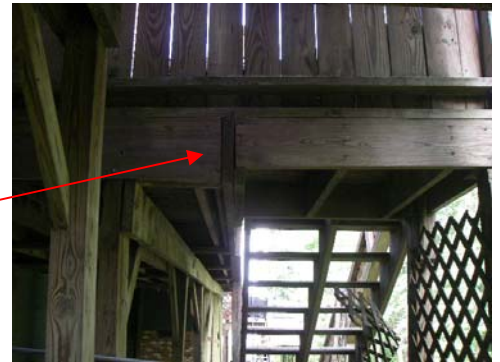
Improper lateral support (bowing column)
Lack of attached stair support

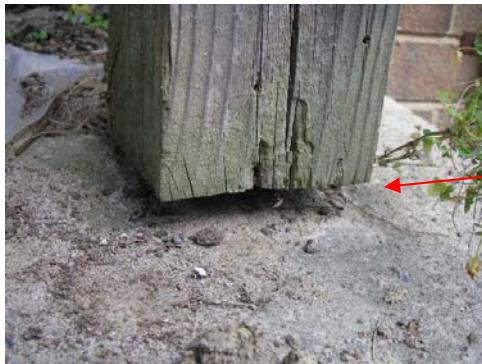
Column not resting on footer
