Drainage Plan

Heritage Woods, Woodcroft

Durham, NC

October 30, 2012 & November 1, 2012
Revised June 22, 2013

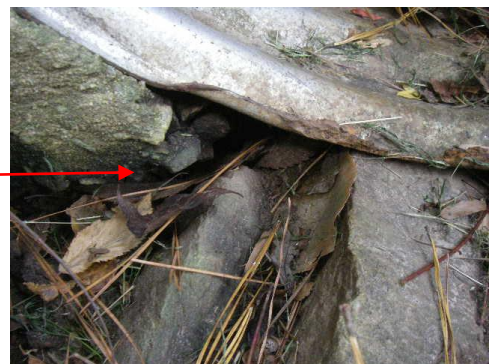
- The culvert behind 128 Shady Spring Place is under-eroded. Hydraulic cement should be added to the eroded area prevent damage to the culvert supporting soils. **This culvert may not be the responsibility of the Heritage Woods HOA.**

Water is running under culvert

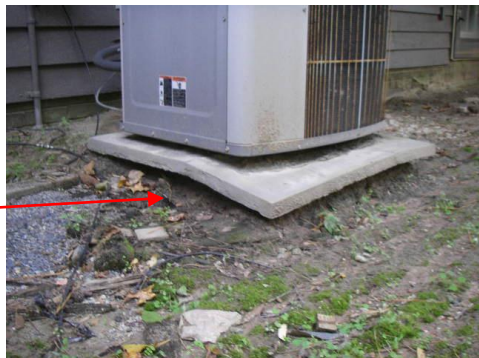
13. Re-grade, mat and re-seed behind 124-136 Shady Spring Place. The lawn in place is a good start; however, there is still erosion occurring and some of the exterior air conditioner units are not properly supported. Re-support of the units should be included.

Sample – erosion
Improperly supported unit

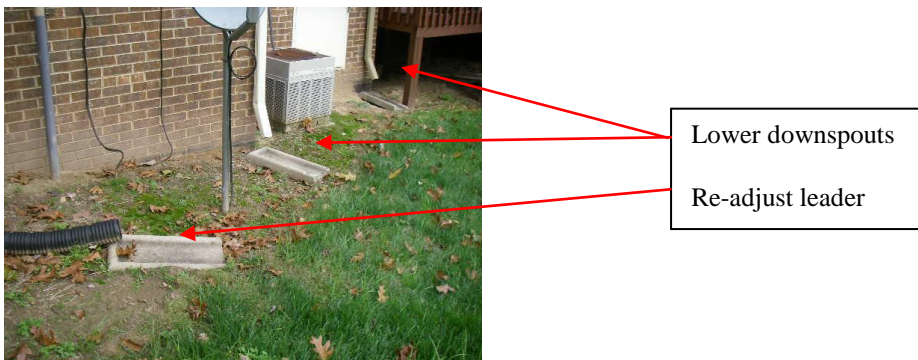
19. There was no access behind 107 -111 Shady Spring Place (wooden fences). This area was not inspected.
20. The rear leader of 100 Old Maple Lane should be re-directed and a swale is to be added in the side yard.
21. The downspouts and leader behind 101 -105 Shady Spring Place need to be adjusted. The downspouts are too high and the leader is uphill at the end. These need to be adjusted to convey water away from the building effectively.

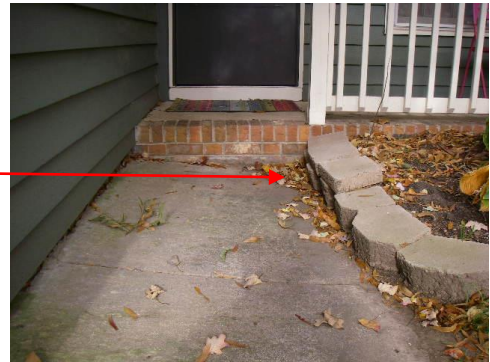
32. The sidewalk in front of 105 Hollow Oak causes water to pond. The sidewalk should be removed and re-installed such that water will be directed to the front yard. Re-grading will be necessary.

Re-slope
sidewalk to
direct water
to front yard

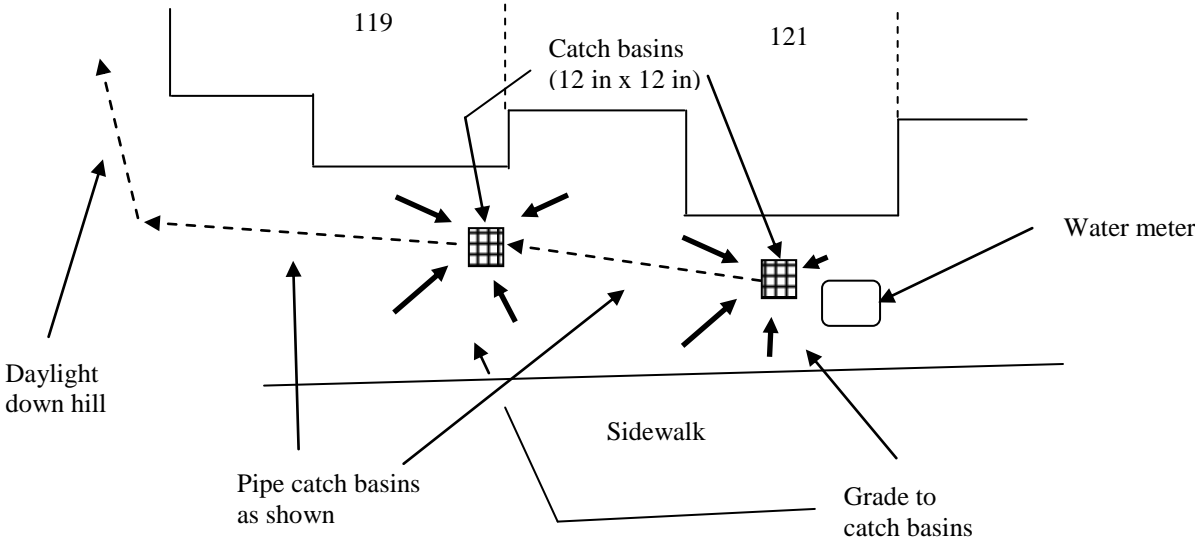
33. The low areas in front of 119 and 121 Hollow Oak should be addressed by adding catch basins as shown below.

Low areas

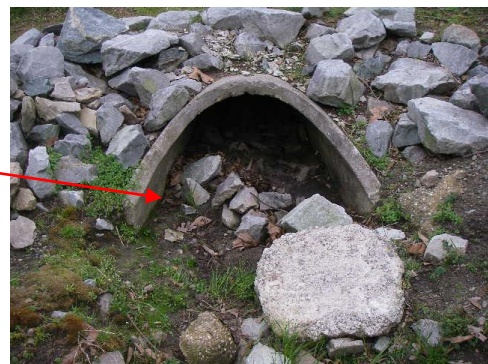
Culverts needing cleaning
